# KUBOTA DUCTILE IRON PIPE

## Repair Manual

# CUTTING OF PIPE

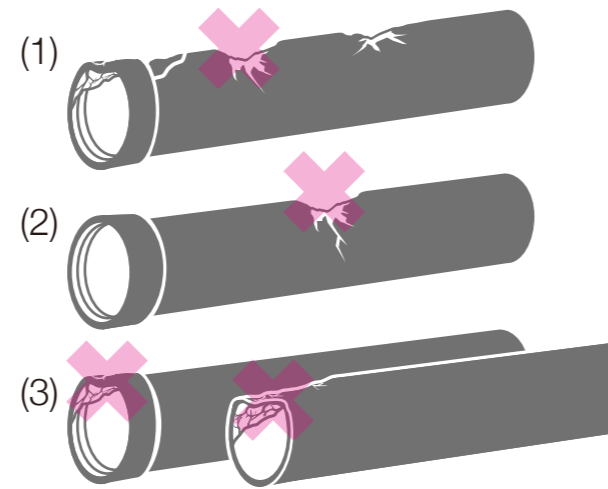
Before cutting, carefully inspect the pipe:

- (1) If the pipe is seriously damaged  
→ reject the pipe.
- (2) If there is a hole or crack in the pipe body  
→ reject or cut off the damaged portion.
- (3) If the socket is deformed or the spigot is seriously damaged  
→ cut off the damaged portion.

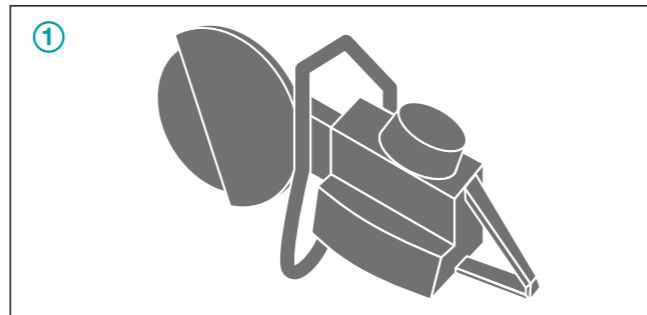
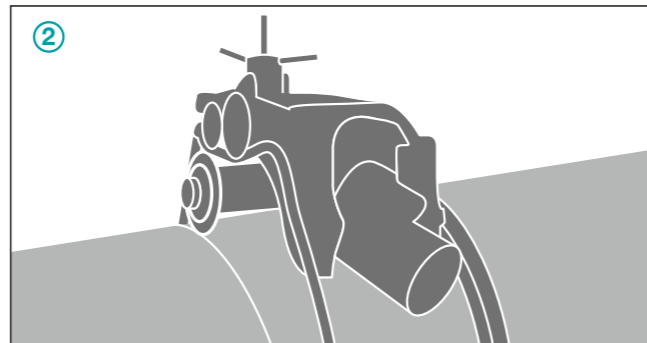
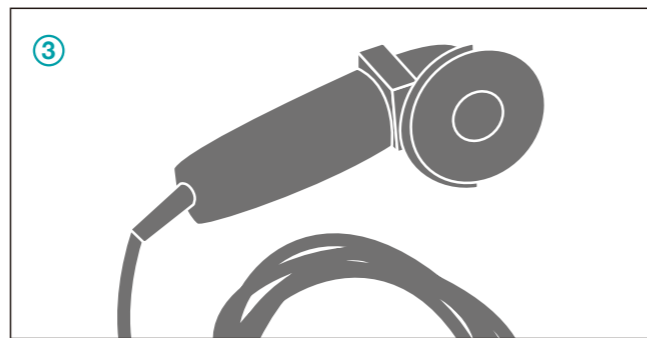
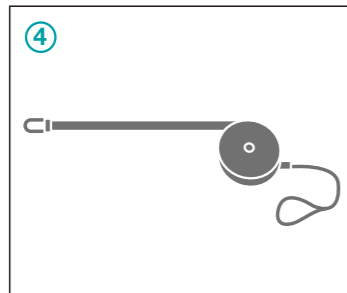
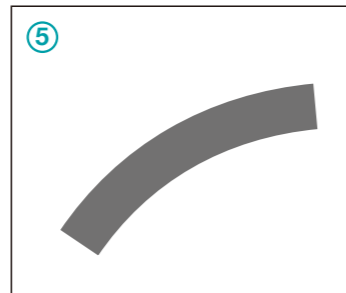
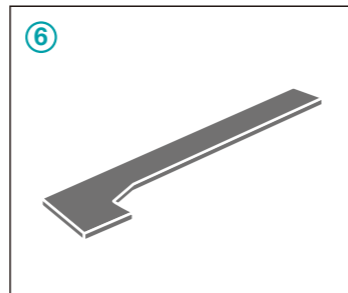
- Engine driven cutter (Picture ①)  
or Power operated metal saw (Picture ②)
- Portable disc grinder (Picture ③)
- Measuring tape (Picture ④)
- Curvature gauge made of plywood, tin plate, plastic, etc.(Picture ⑤)  
• This tool may be made on site using available materials.
- Taper gauge made of plywood, tin plate, plastic, etc.(Picture ⑥)  
• This tool may be made on site using available materials.

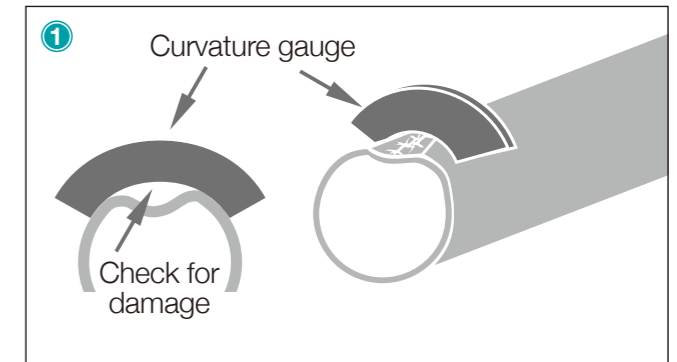
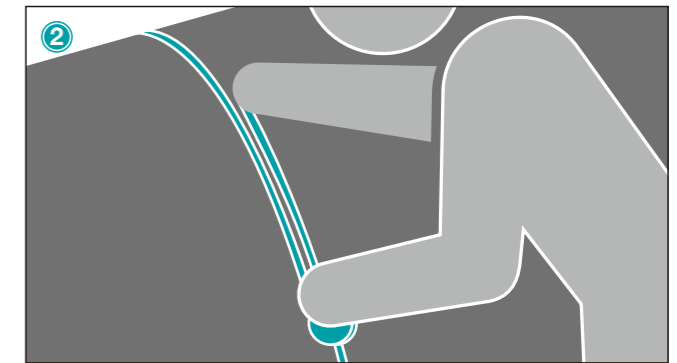
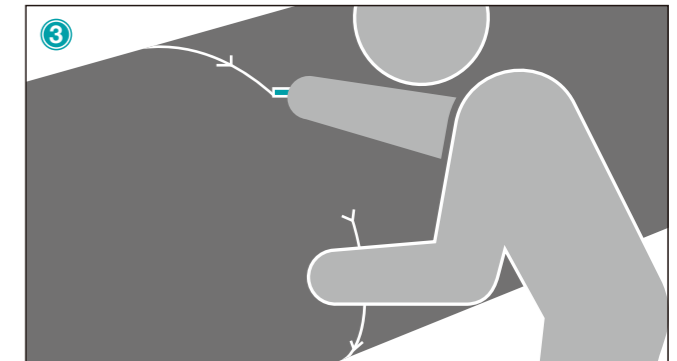
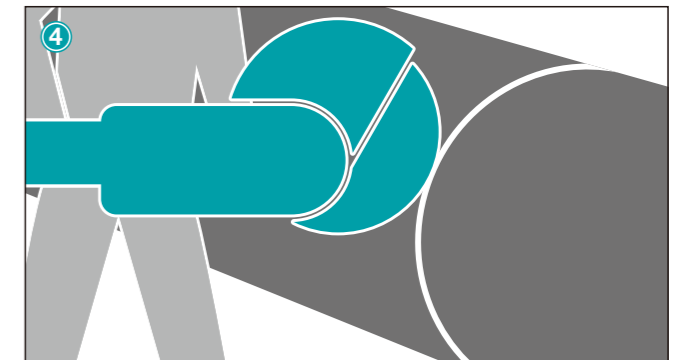
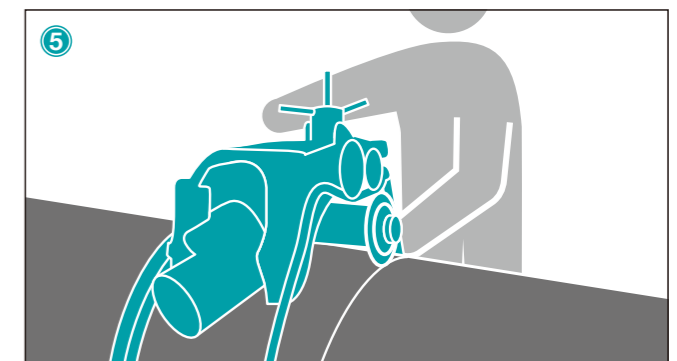
(1) **Check** the deformed portion and identify an undamaged portion with a curvature gauge.(Picture ①)

(2) **Measure** the circumference with a measuring tape.(Picture ②)  
• Dimension must be within the tolerance in Table 1 of page 6. If it is not, find a portion that satisfies the value.

(3) **Draw** a line to indicate where to cut. (Picture ③)

(4) **Cut** the pipe along the line using an engine driven cutter (Picture ④) or a power operated metal saw. (Picture ⑤)

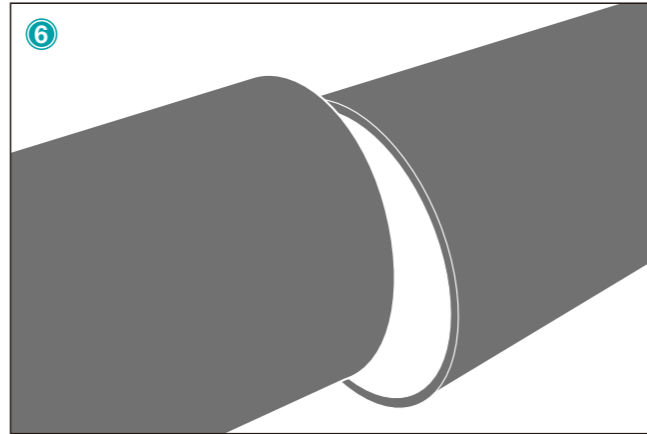
(5) **Completion** of cutting. (Picture 6)

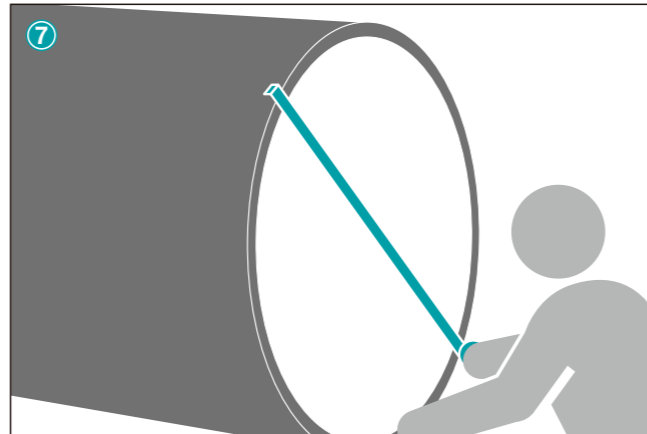
(6) **Measure** the outside diameter in two or more different directions. (Picture 7)

\*The dimensions must be within the tolerance in Table 1 of page 6. If it is not, correct the pipe according to the procedure "Corrections of Deformed Spigot". (See page 8-10)

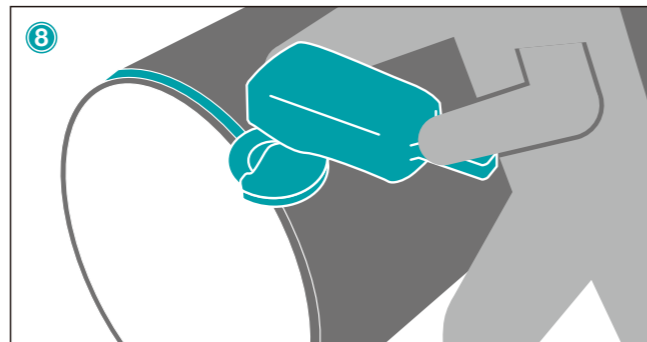
(7) **Taper** the edge of the spigot with a portable disc grinder as per the dimensions specified in Table 2 of page 7. (Picture 8)

\*Taper gauge can be used to easily check the angle of the tapered end.

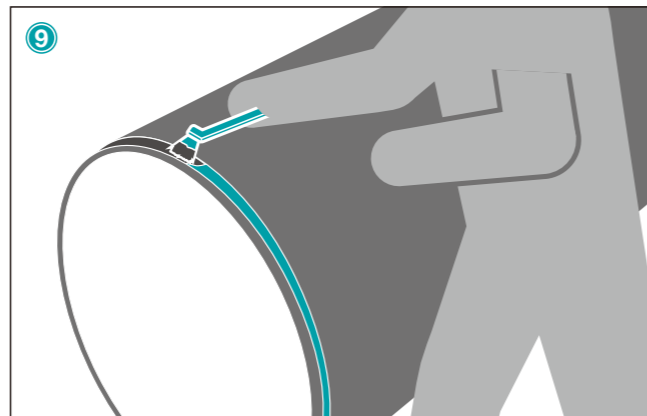
(8) **Apply** the zinc rich paint to the exposed iron surface. And then, apply the bituminous paint to the dried zinc rich coating. (Picture 9)

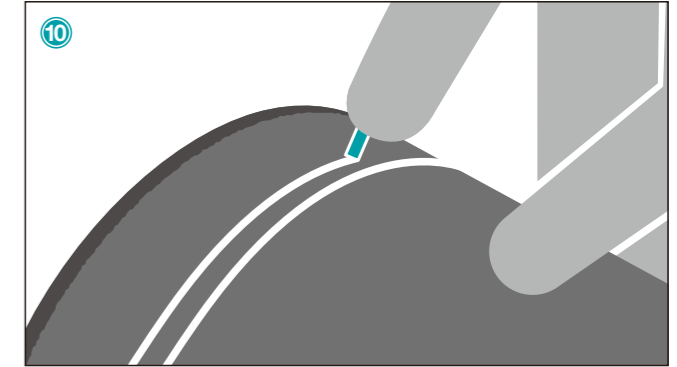
(9) **Draw** white lines for jointing as per the dimensions specified in Table 2 of page 7. (Picture 10)

\*Stenciled lines may be drawn also by spray painting.

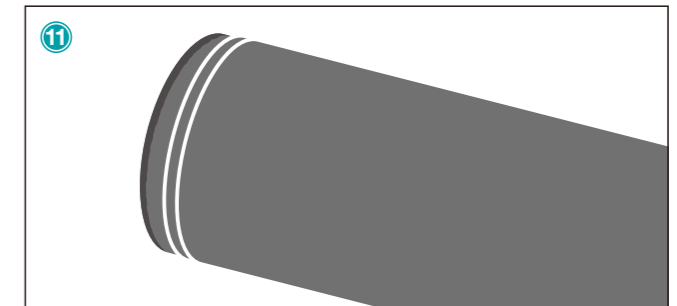
(10) **Completion** of cutting work. (Picture 11)

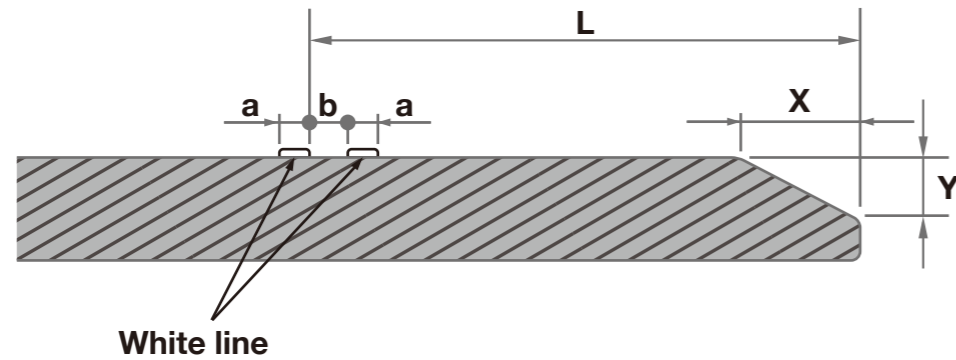
**Table 2** (Dimensions in mm)

## ■ Dimensions of Tapered Spigot for Push-on Joint

DN	Taper		White lines		
	Y	X	L	a	b
80	3	9	82	10	13
100	3	9	86	10	13
150	3	9	95	10	13
200	3	9	110	10	13
250	3	9	115	10	13
300	3	9	120	10	13
350	5	14	135	10	13
400	5	14	135	10	13
450	5	14	135	10	13
500	5	14	140	10	13
600	5	14	145	10	13
700	6	15	160	15	20
800	6	15	165	15	20
900	6	15	180	15	20
1000	7.5	19	190	15	20
1100	7.5	19	205	15	20
1200	7.5	19	220	15	20
1400	8.5	23	250	15	20
1500	8.5	23	265	15	20
1600	8.5	23	280	15	20
1800	9.5	26	310	15	20
2000	9.5	26	340	15	20

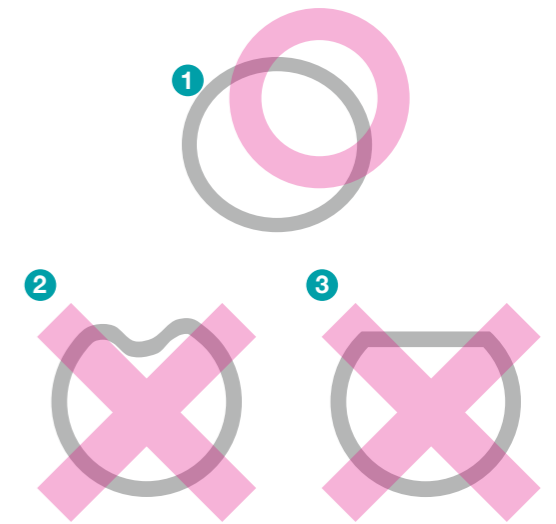
Although ductile iron pipes are tough and strong, they may be accidentally deformed by improper handling. However minor deformations can be repaired by the following method.

Generally only ellipse on the spigot end can be corrected. (Picture ①) However, if the spigot is severely deformed and concave (Picture ②) or extensively flat (Picture ③), generally it can not be corrected. In such a case, the deformed portion need to be cut.

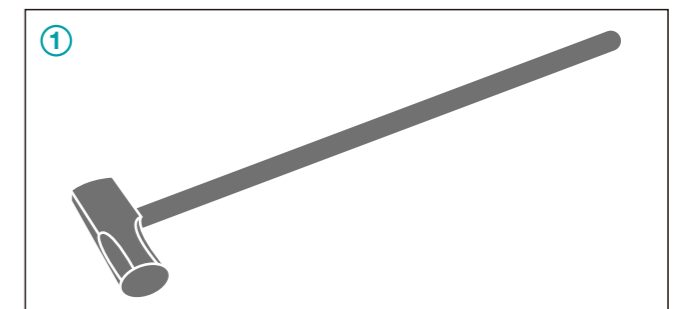
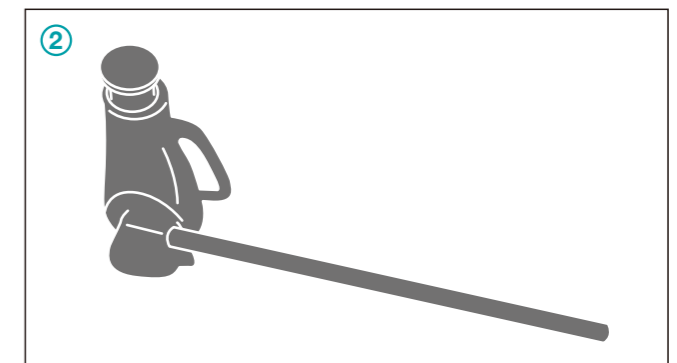
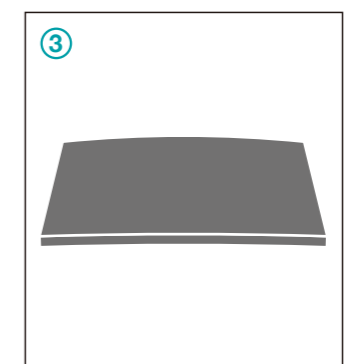
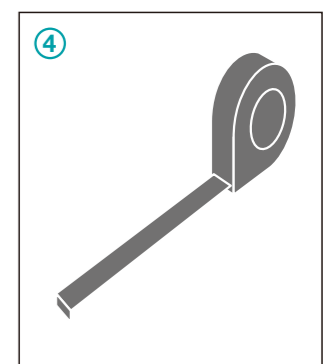
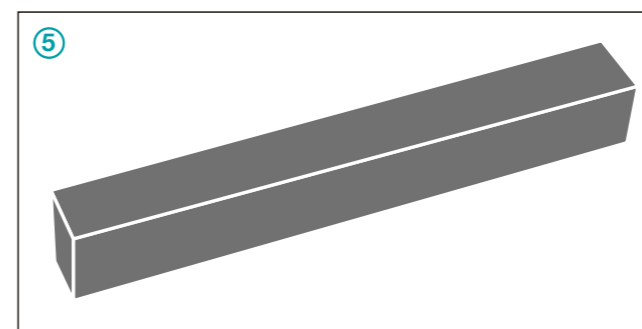
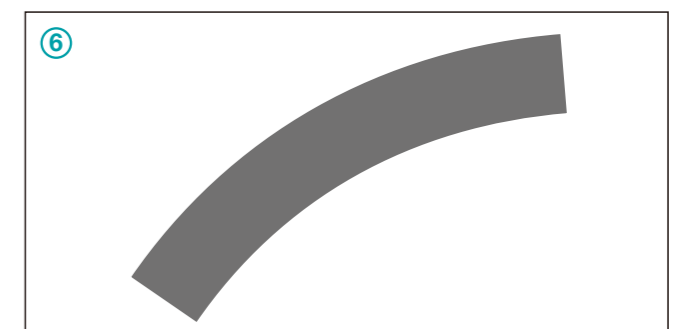
- Hammer (Large) (Picture ①)
- Hydraulic jack (Picture ②)
- Iron plate with curvature that conforms to the inner wall of the repairing pipe. (Picture ③)  
\*This can be made on site by cutting out pieces from rejected pipe or cut pipe, etc.
- Measuring tape (Picture ④)
- Wood block (Picture ⑤)
- Curvature gauge (Picture ⑥) made of plywood, tin plate, plastic, etc.  
\*This can be made on site using available materials.

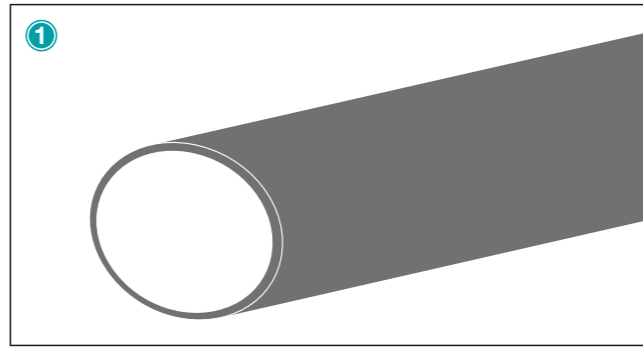
(1) **Position** the pipe so that the minimum diameter point is located vertically. (Picture ①)

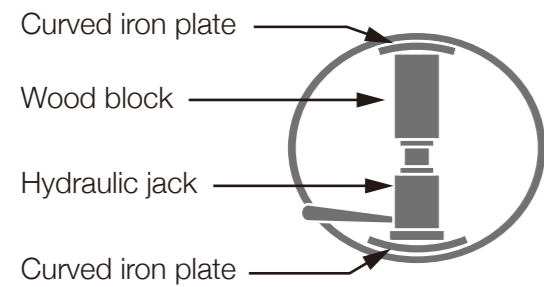
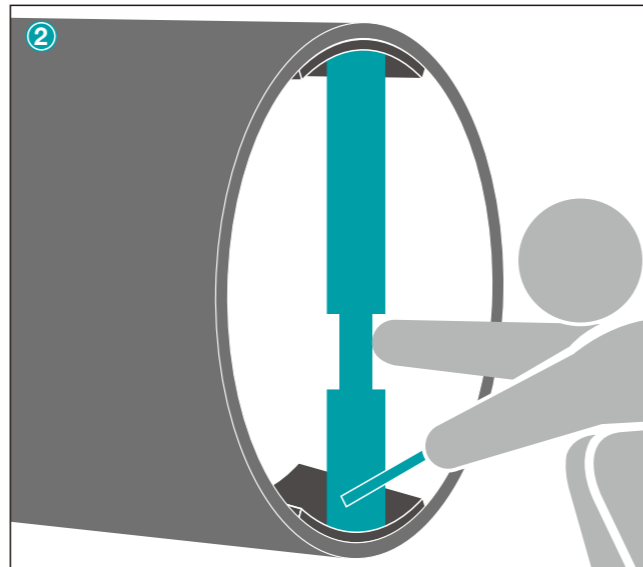
(2) **Set** the hydraulic jack, a wood block and iron plates in the pipe. (Picture ②)

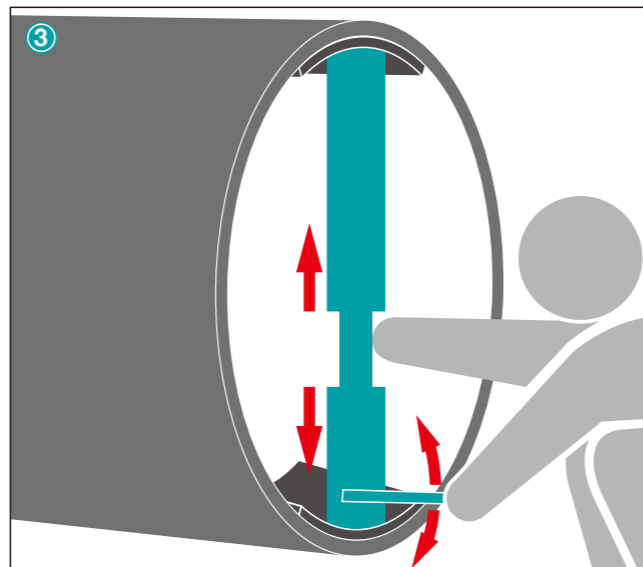
(3) **Gradually** expand the diameter until the diameter slightly exceeds the required dimensions. (Picture ③)

\*Excessive expansion of the pipe diameter will cause the damage to the mortar lining.

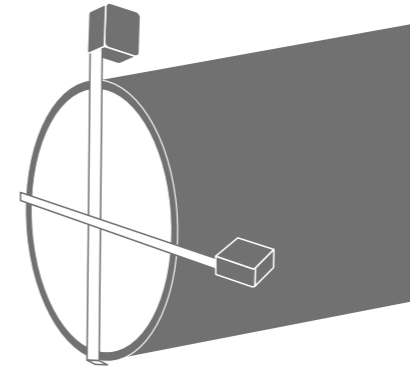
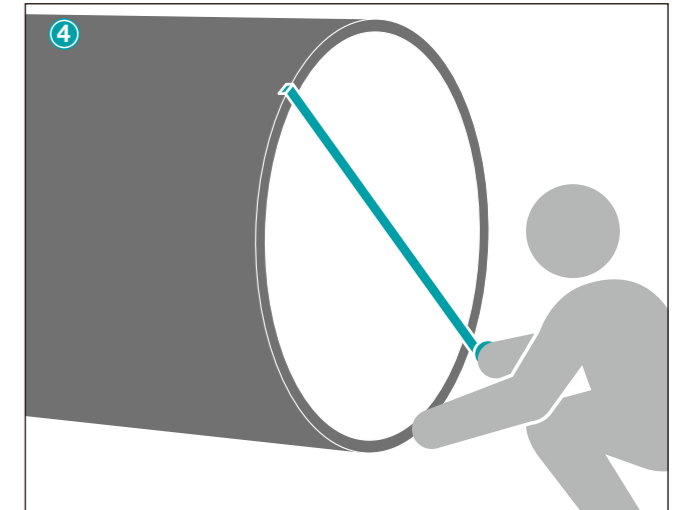
(4) **Release** pressure of the hydraulic jack and measure the diameters in two or more directions and see if they are within the tolerance specified in Table 1 of page 6. (Picture ④) If they are not, repeat (3) and (4).

\*This procedure may be repeated several times until a correct circle is obtained.

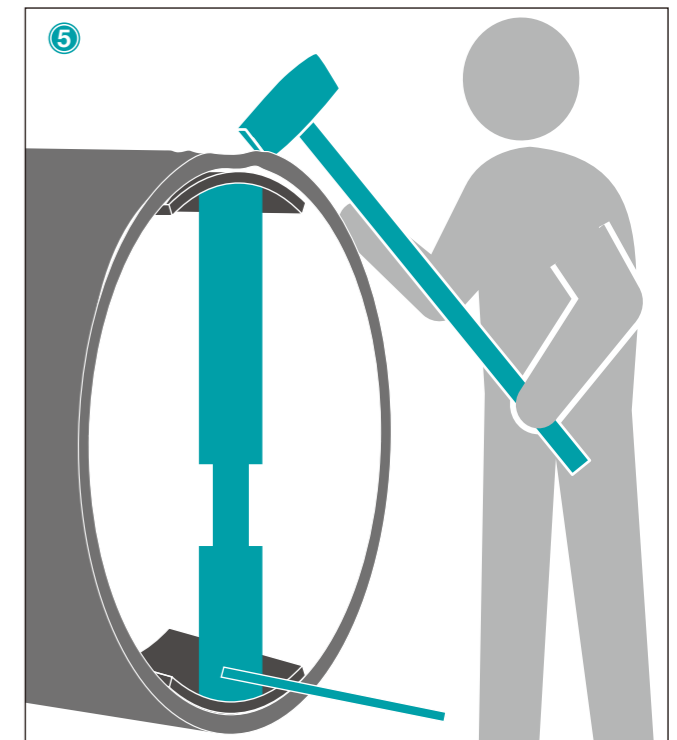
In case there is a deformation on the pipe, correct the deformation with a hammer while expanding the diameter. (Picture ⑤)

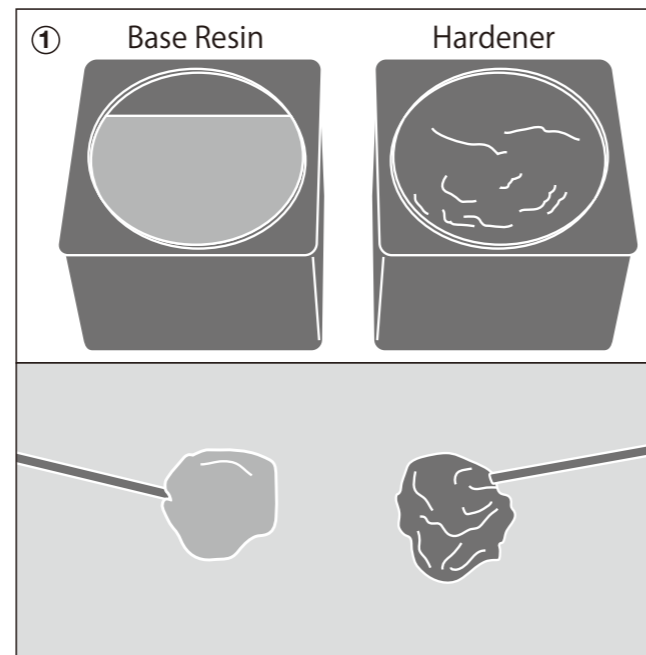
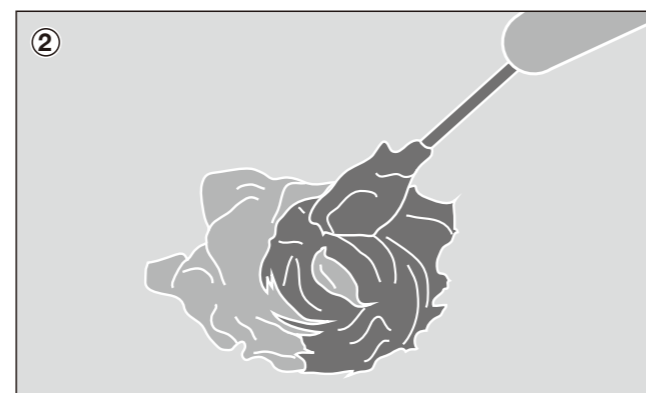
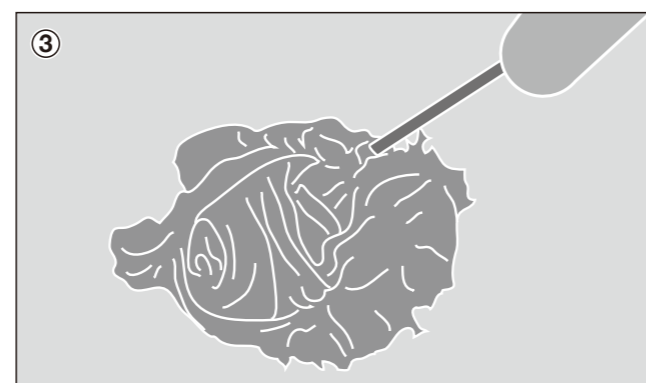
The two different clay-like materials are mixed together and used as putty. The mixing procedure is as follows:

(1) **Prepare** Epoxy Resin compound. And take out appropriate ratio of "Base Resin" and "Hardener" with different spoons. (Picture ①)

(2) **Mix** them well until they become uniform in color (Picture ② and ③).

\*The pot life and condition of the materials vary according to the materials and temperature.

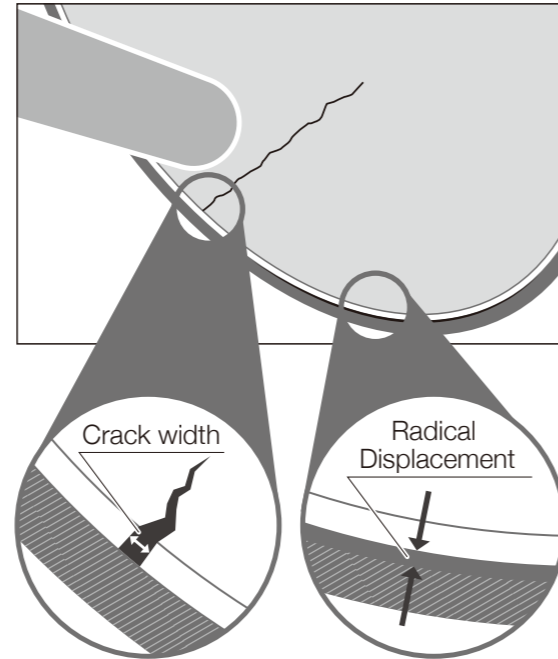
Table 4  
Maximum crack width and radical displacement

Storage of pipes and fittings in a hot, dry environment can cause metal expansion and mortar shrinkage cracks exceeding the width given in Table 4. When the lining is reexposed to water, it will swell by absorption of moisture and the cracks will close to conform to Table 4 and will eventually heal by an autogenous process.

DN	mm
40 to 300	0.4
350 to 600	0.5
700 to 1200	0.6
1400 to 2000	0.8

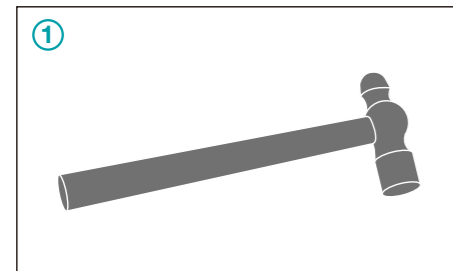
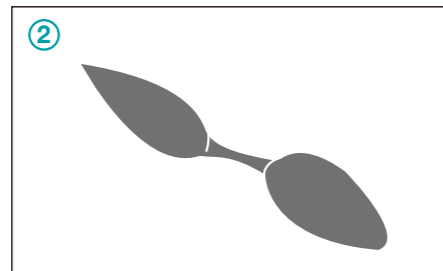
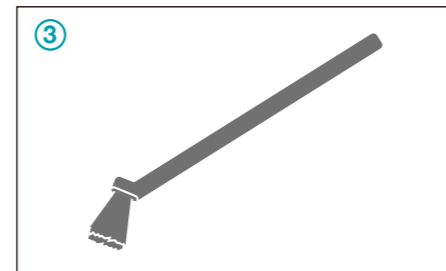
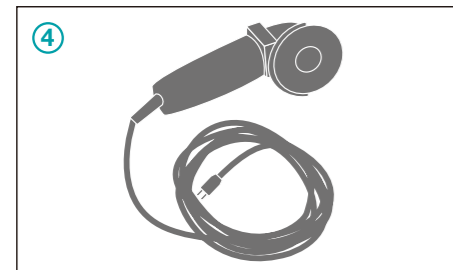
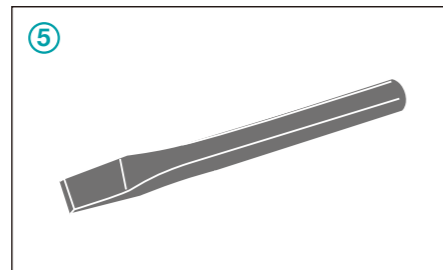
- Hammer (Picture ①)
- Portable disc grinder (Picture ④)
- Spatula (Picture ②)
- Chisel (Picture ⑤)
- Brush (Picture ③)

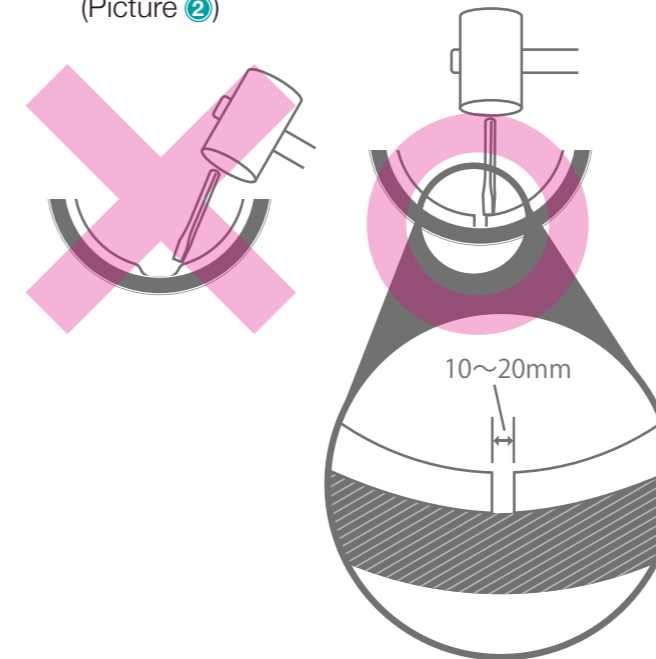
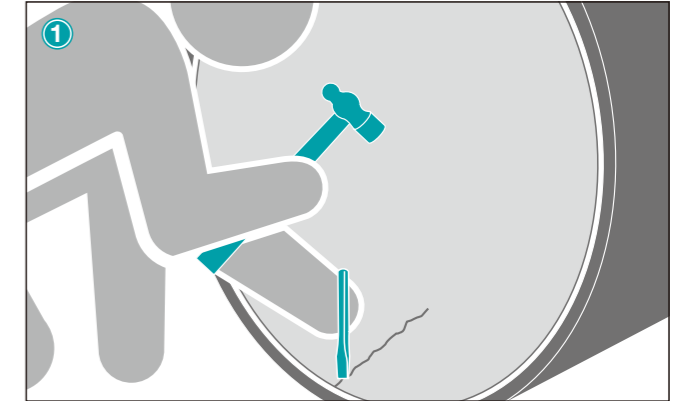
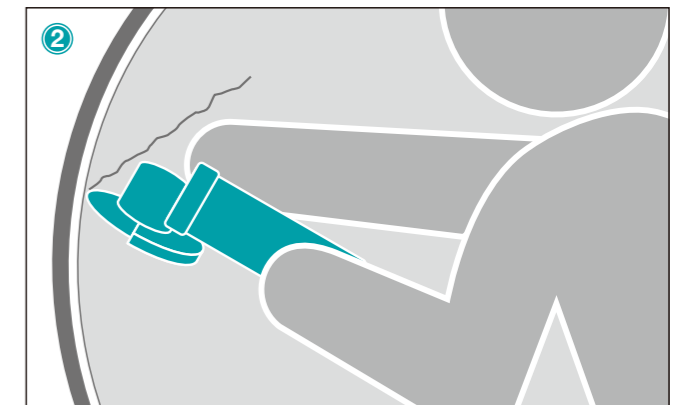
- (1) **Cut** back the lining about 10-20 mm in width with a chisel and hammer. (Picture ①) A portable disc grinder may be used instead of a chisel and hammer. (Picture ④)

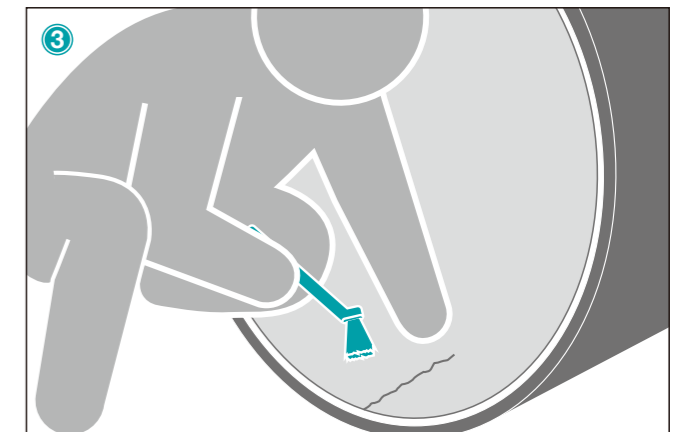
- (2) **Clean** the surface of the cut-back portion with a brush etc. (Picture ③)

\*Remove moisture from the surface.

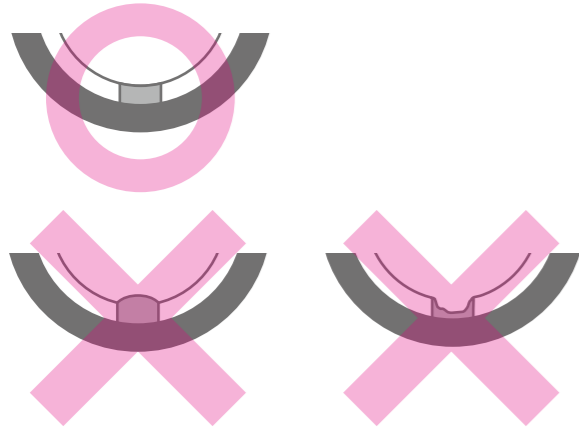
(3) **Fill** the cut-back portion with Epoxy Resin and smooth the surface with a spatula. (Picture ④)

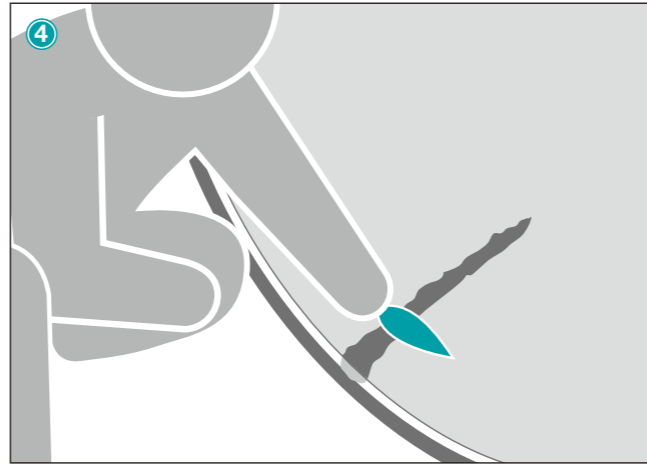
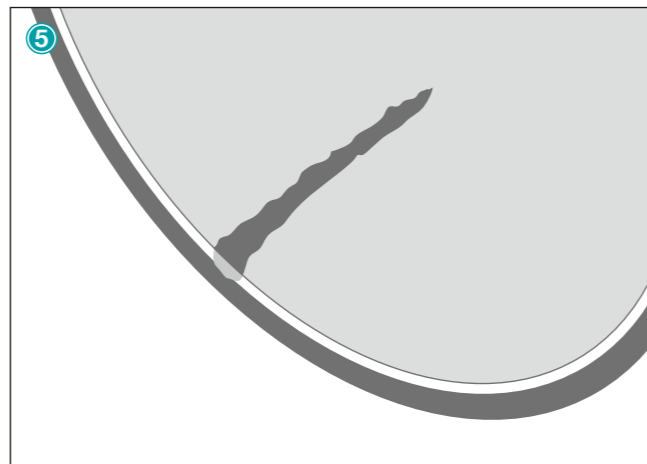
(4) **Inspect** the finished surface (Picture ⑤)

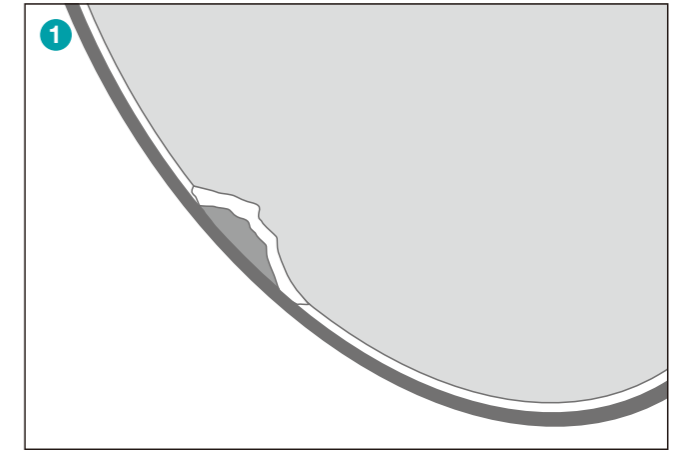
Inspect the damaged area carefully and confirm that there is no deformation or crack on the pipe body. (Picture ①)

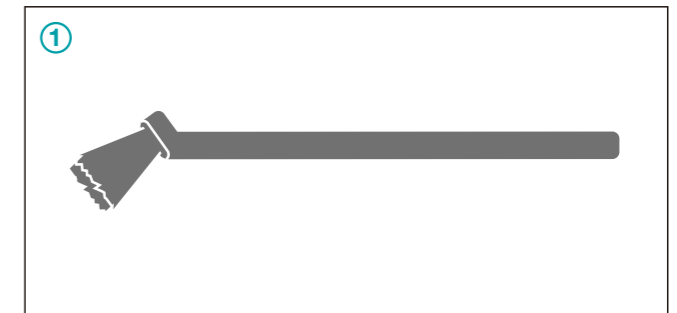
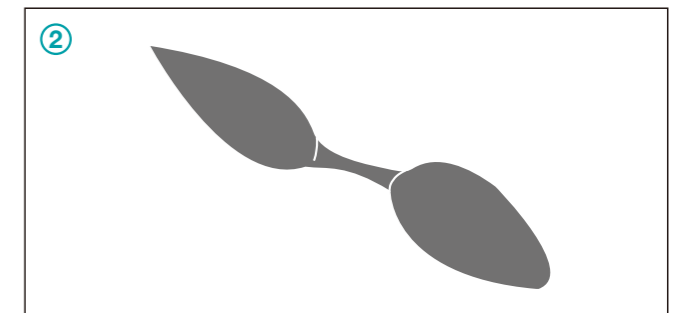
- Brush (Picture ①)
- Spatula (Picture ②)

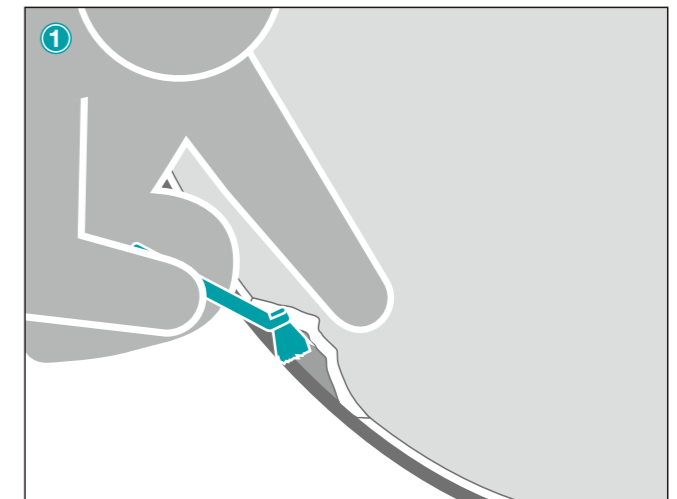
(1) **Clean** the surface of the damaged portion with a brush, etc. (Picture ①)  
\*Remove moisture from the surface.

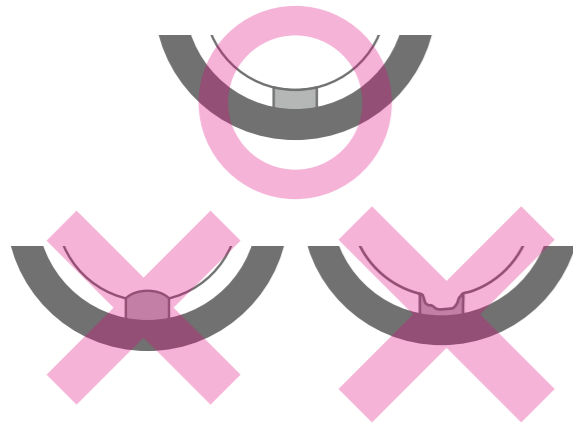
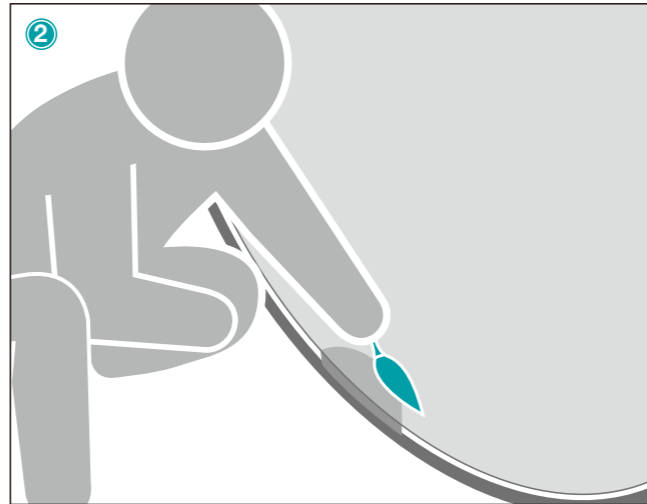
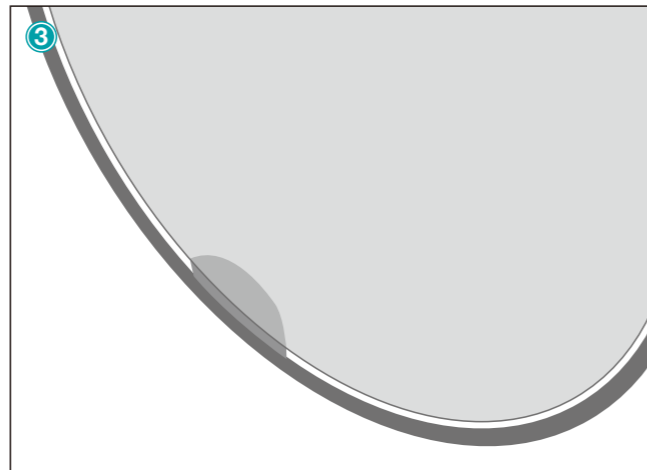
(2) **Fill** the chip with Epoxy Resin (See page 11) and smooth the surface with a spatula. (Picture ②)

(3) **Inspect** the finished surface. (Picture ③)

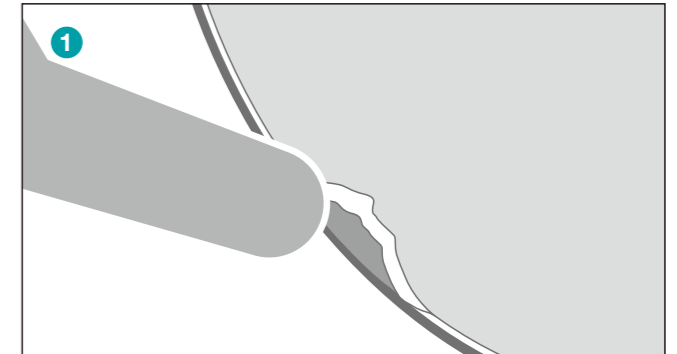
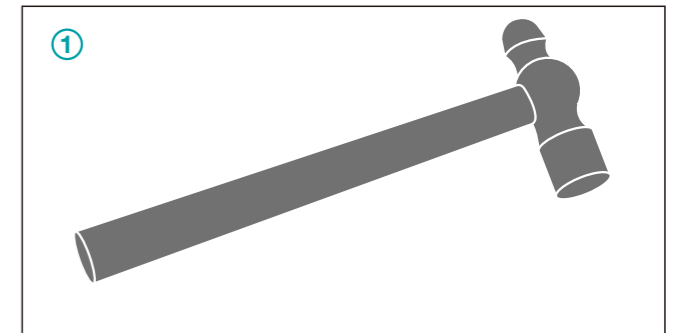
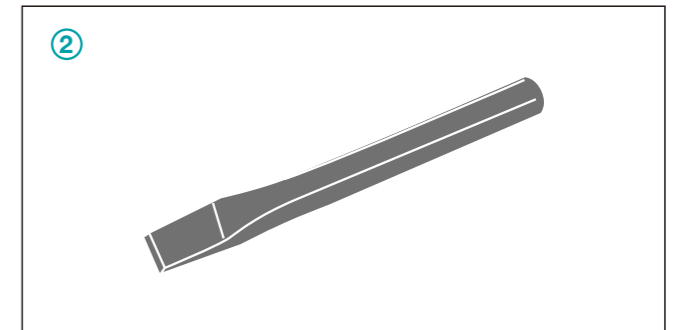
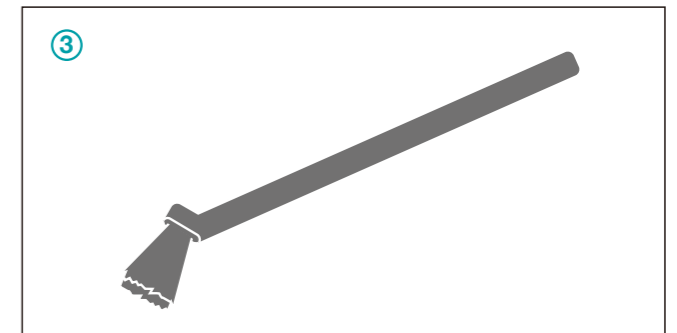
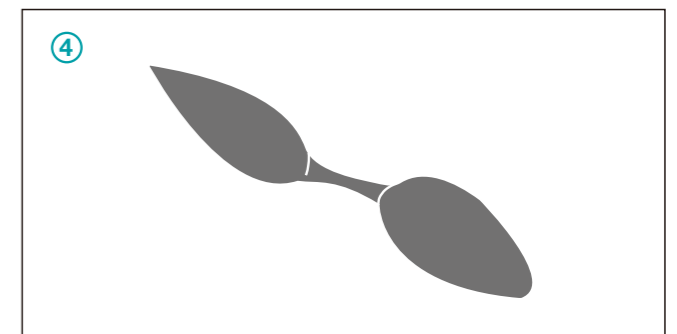
Inspect the damaged area well. If the cement mortar lining is broken off in a large area, cut the pipe to remove the damaged portion. (Picture ①)

- Hammer (Picture ①)
- Chisel (Picture ②)
- Brush (Picture ③)
- Spatula (Picture ④)

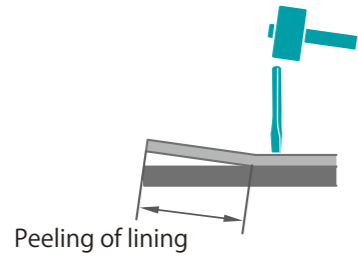
(1) **Cut back** the damaged lining so that the edge of the lining is at right angles to the iron surface. (Picture ①)

\*If the cement lining is peeled off from the iron surface, cut out the affected area.

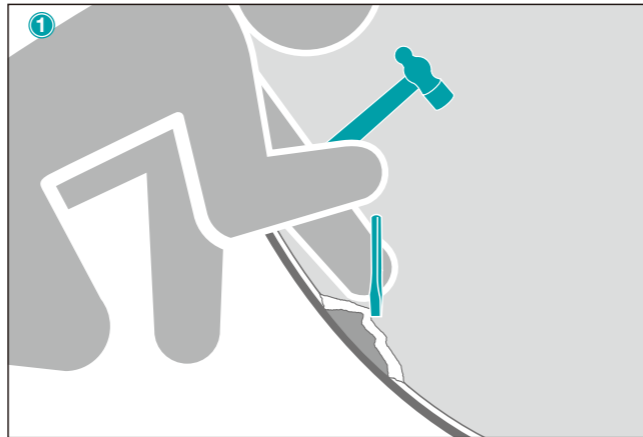
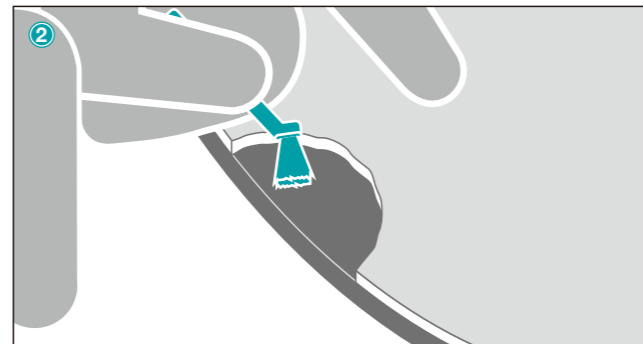
(2) **Clean** the surface of the damaged portion with a brush. (Picture ②)

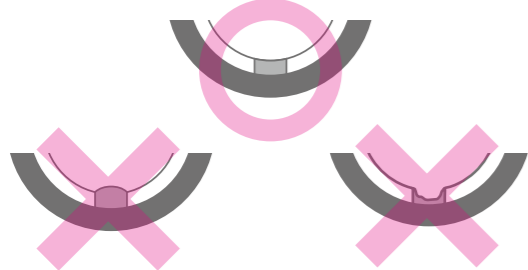
(3) **Fill** the damaged portion with Epoxy Resin and smooth the surface with a spatula. (Picture ③)

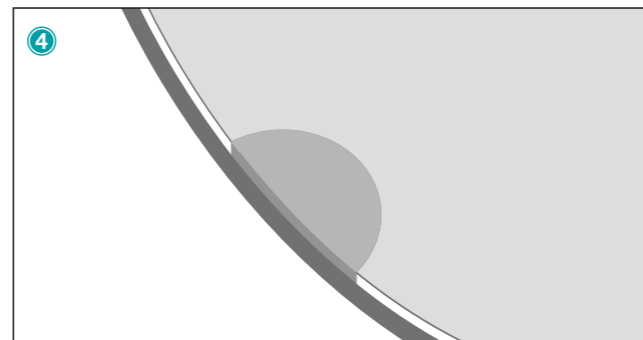
(4) **Inspect** the finished surface. (Picture ④)

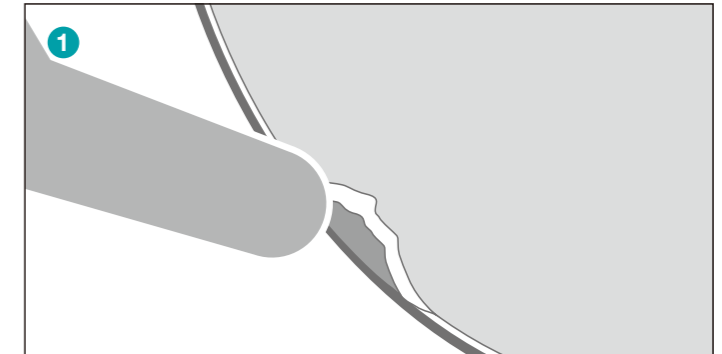
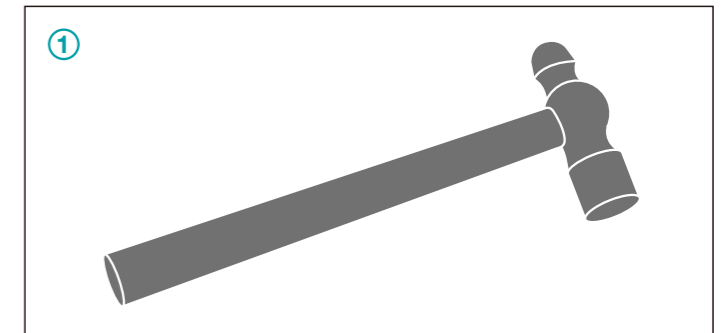
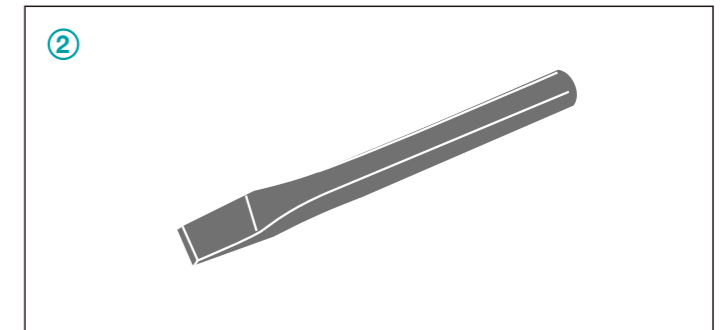
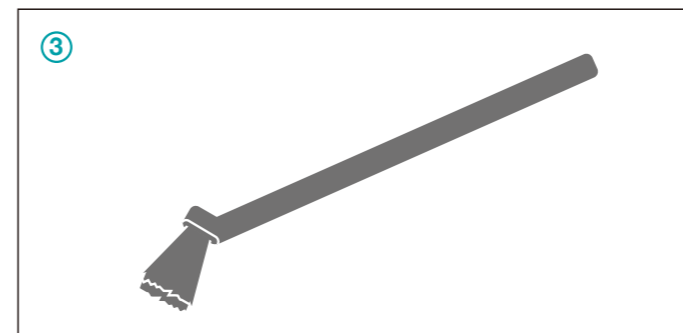
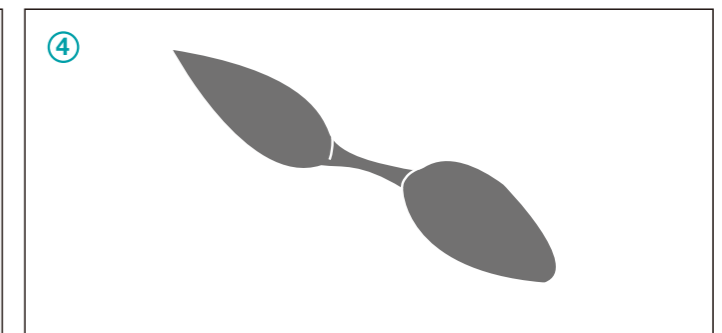
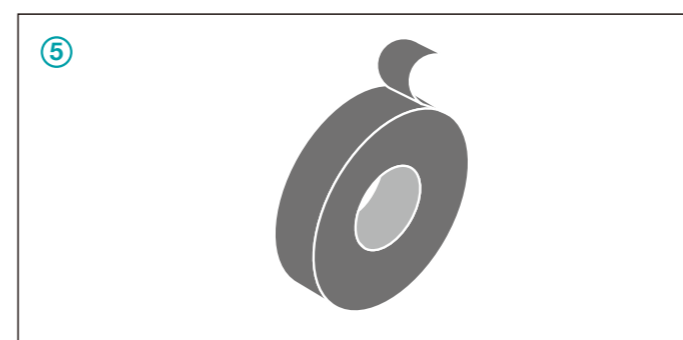
- Hammer (Picture ①)
- Chisel (Picture ②)
- Brush (Picture ③)
- Spatula (Picture ④)
- Adhesive tape (Picture ⑤)
- Plastic sheet (Picture ⑥)

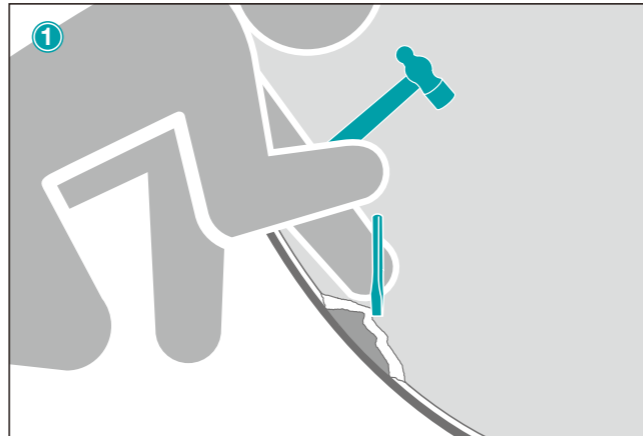
- (1) **Cut back** the damaged lining so that the edge of the lining is at right angles to the iron surface. (Picture ①)

\*If the cement lining is peeled off from the iron surface, cut out the affected area.

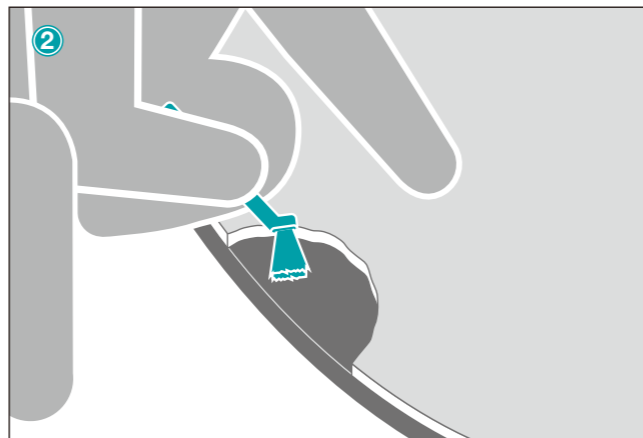
- (2) **Clean** the surface of the damaged portion with a brush. (Picture ②)

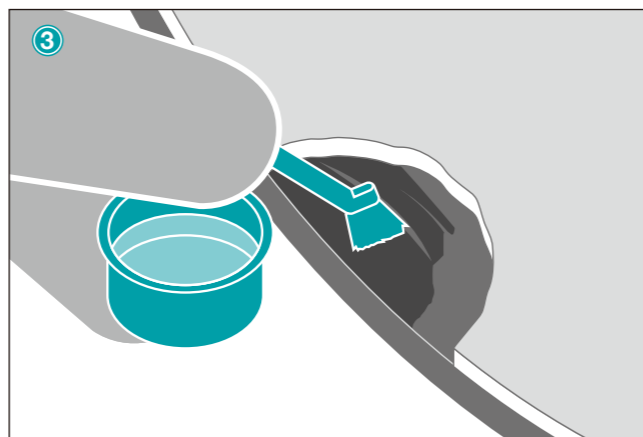
- (3) **Apply** some water to the damaged portion with a brush. (Picture ③)

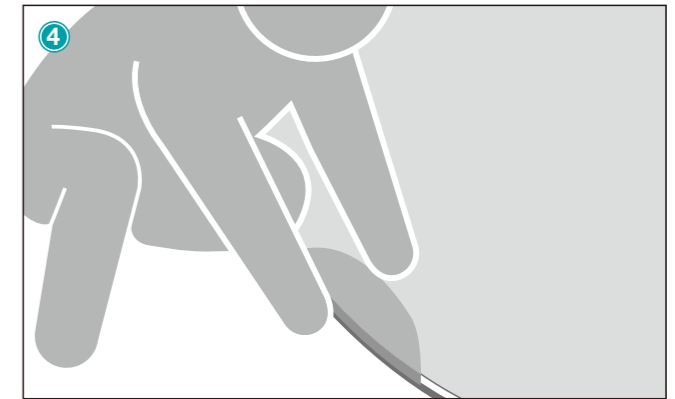
- (4) **Fill** the damaged portion with the cement mortar mixture. (Picture ④)

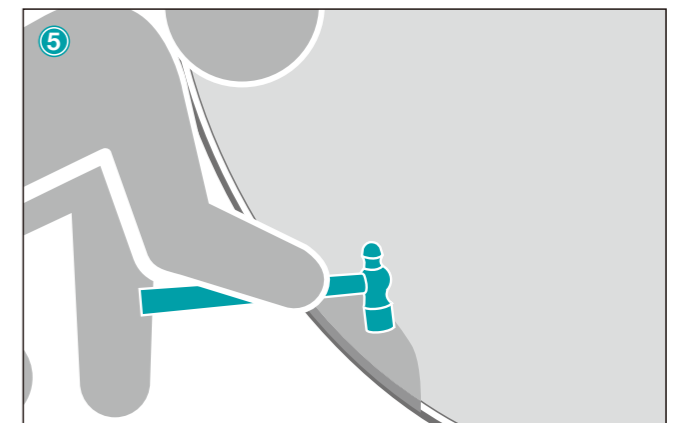
- (5) **Tap** the filled cement mortar mixture gently with a hammer until it is compacted. (Picture ⑤)

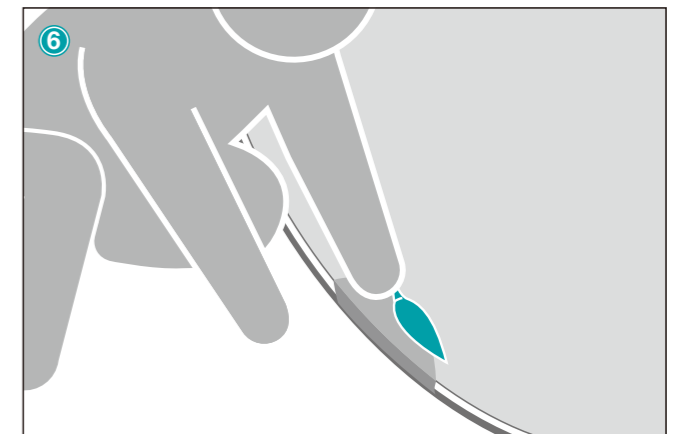
- (6) **Smooth** the surface with a spatula. (Picture ⑥)

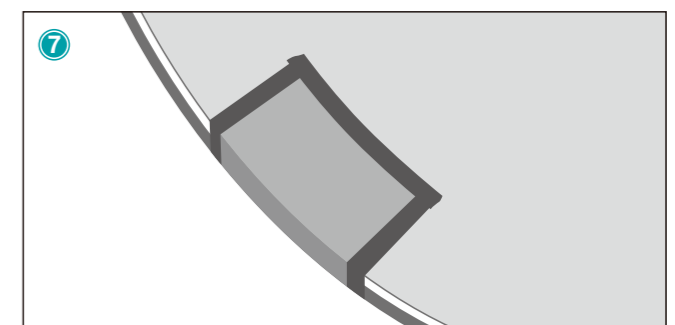
- (7) **Curing:**  
Cover the repaired portion with a wet towel or wet paper, then seal up with plastic film and adhesive tape. Keep it on for more than 24 hours. (Picture ⑦)

\*Other curing methods may be applied according to the condition on site and the supervisor's decision.

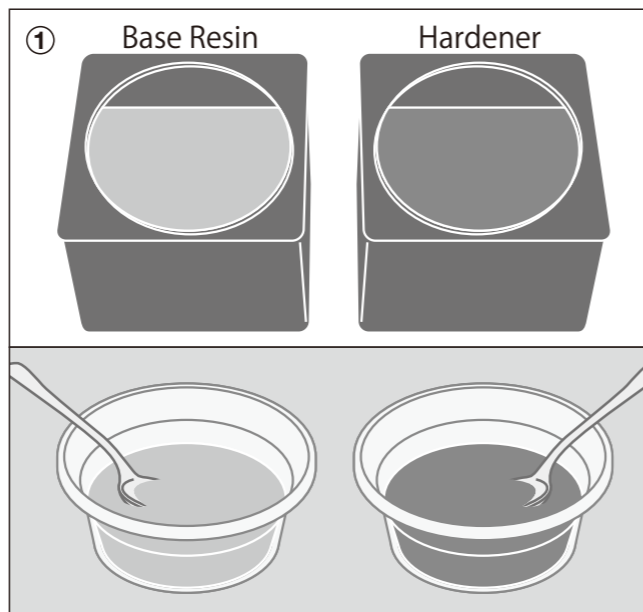
(1) **Prepare** 2-pack epoxy paint. And take out appropriate ratio of "Base Resin" and "Hardener" with different spoons. (Picture ①)

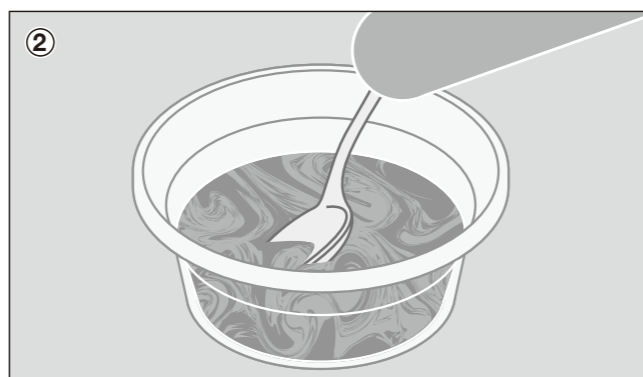
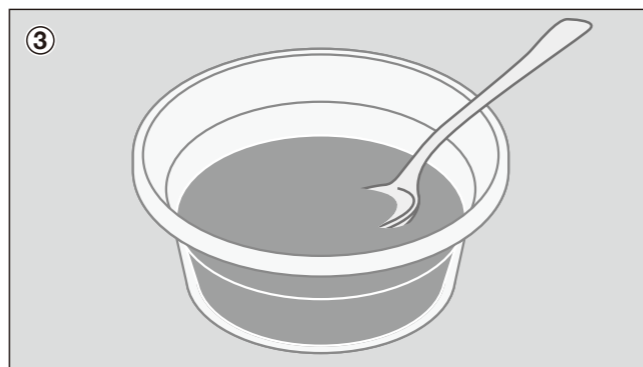
(2) **Mix** them well in a container until they become uniform in color. (Picture ② and ③)

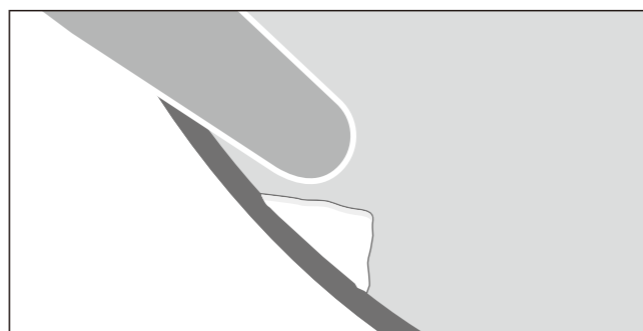
Inspect the fusion bonded epoxy coating. If the fusion bonded epoxy coating is damaged, repair of the fusion bonded epoxy coating is required.

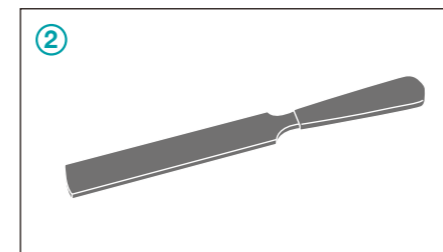
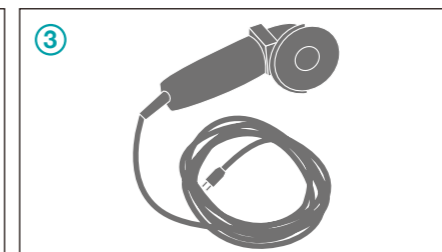
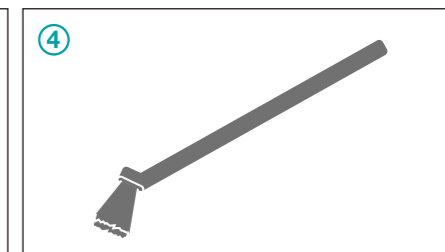
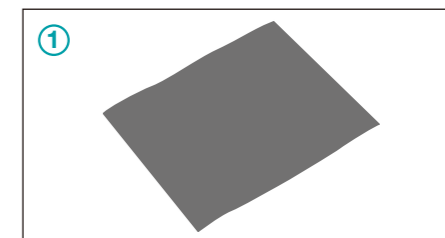
- Sandpaper (Picture ①)
- File (Picture ②)
- Portable disc grinder (Picture ③)
- Brush (Picture ④)
