# KUBOTA DUCTILE IRON PIPE

## Repair Manual

# CUTTING OF PIPE

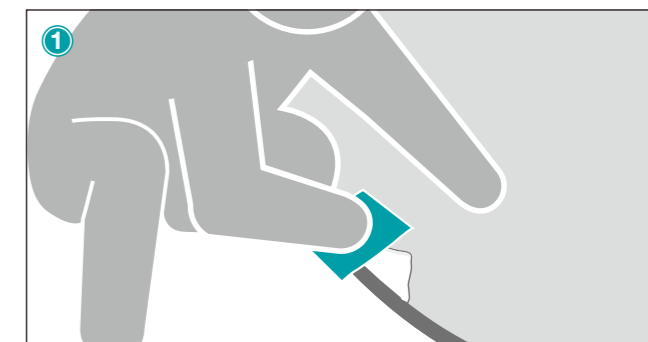
(1) **Roughen** the sound coating around the damaged area with a sandpaper, file or portable disc grinder to the extent of 10mm to 20mm. (Picture ①)

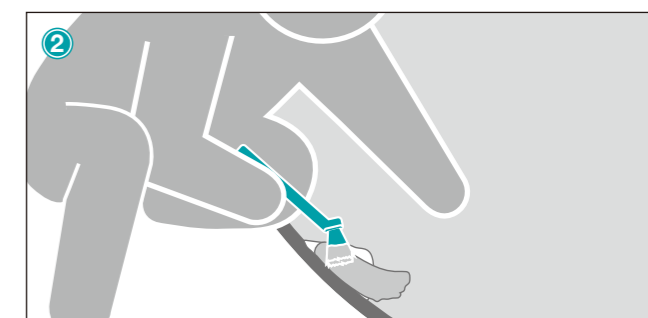
(2) **Clean** the surface of the damaged area with a brush, etc. (Picture ②)

\*The area to be repaired shall be clean and free from sand, dust, moisture, etc.

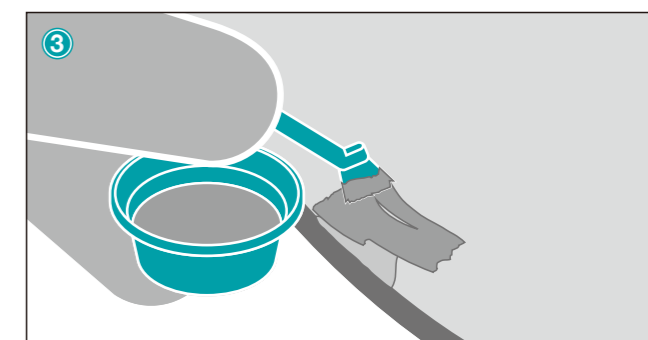
(3) **Apply** the 2-pack epoxy paint to the damaged area and the roughened surrounding coating with a brush. (Picture ③)

\*Paint several times at intervals to obtain the specified dry film thickness.

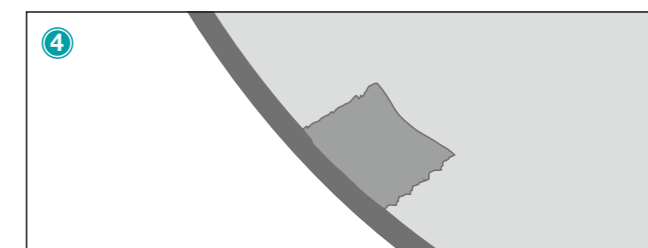
(4) **Inspect** the finished surface. (Picture ④)

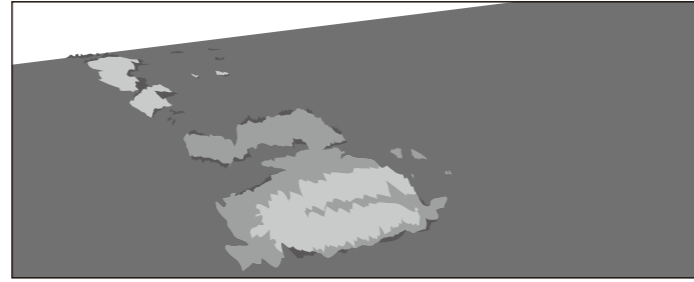
Inspect the external coating. If the external coating is damaged, repair of the external coating is required.

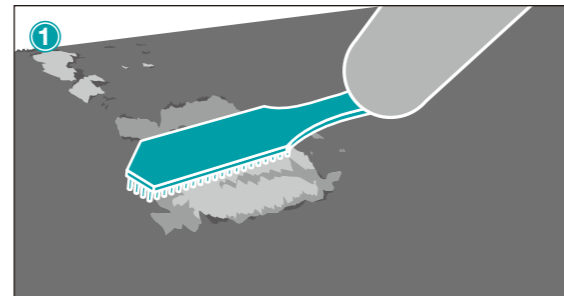
(1) **Remove** foreign materials and clean the surface. (Picture ①)

\*If the surface is rusted, use wire brush or sandpaper to remove the rust, then wipe off with a cloth.

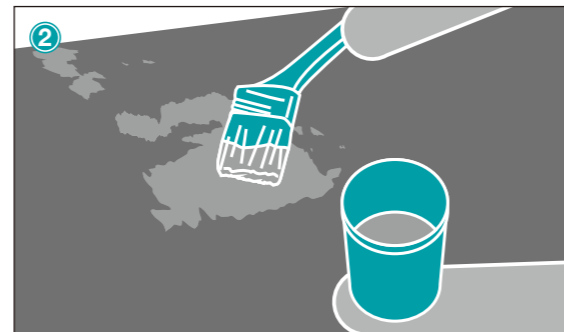
(2) **Apply** the zinc rich paint to the cleaned iron surface with a brush. (Picture ②)

\*Zinc rich paint shall not be applied to the wet or moist iron surface or over the existing bitumen coating.

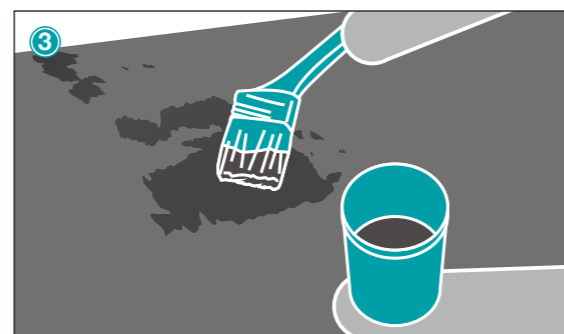
(3) **Apply** the bituminous paint to the dried zinc rich coating with a brush. (Picture ③)

\*The bituminous paint can be thinned with the specific thinner when the viscosity of the bituminous paint is too high to apply with a brush.
