KUBOTA DUCTILE IRON PIPE

Repair Manual

Damage to ductile iron pipes, caused by improper handling during transportation, may be rectified by applying certain repair procedures.

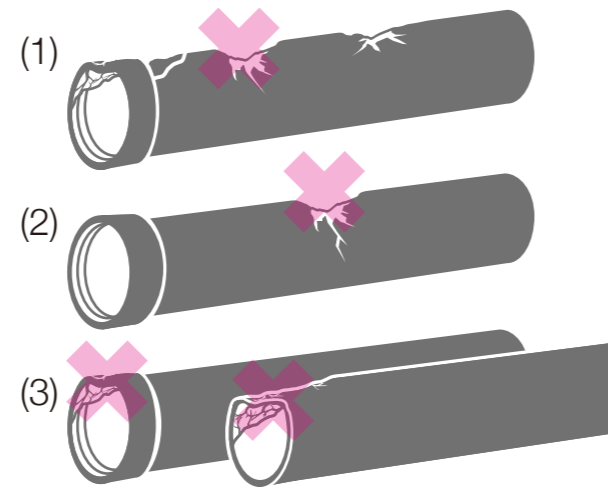
Inspection

Before cutting, carefully inspect the pipe:

- (1) If the pipe is seriously damaged
→ reject the pipe.
- (2) If there is a hole or crack in the pipe body
→ reject or cut off the damaged portion.
- (3) If the socket is deformed or the spigot is seriously damaged
→ cut off the damaged portion.

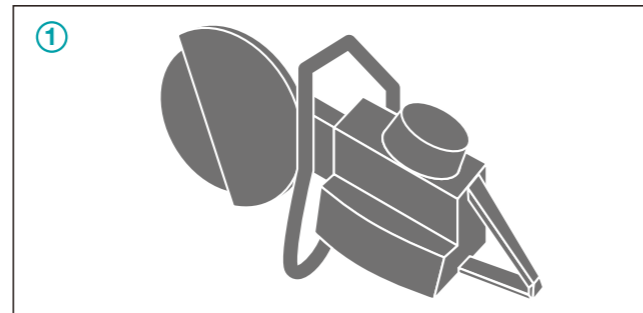
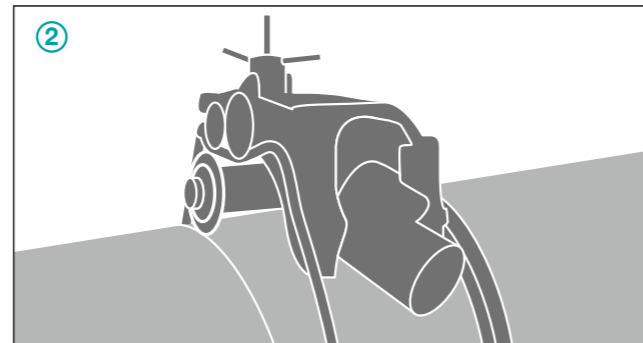
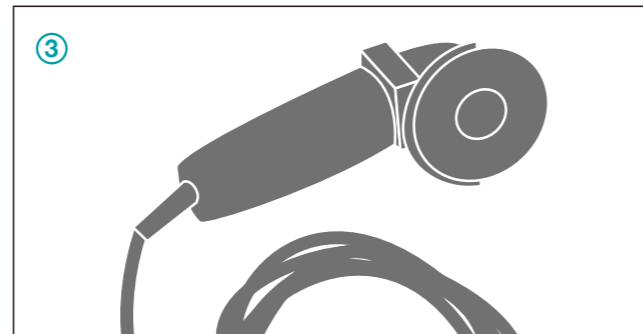
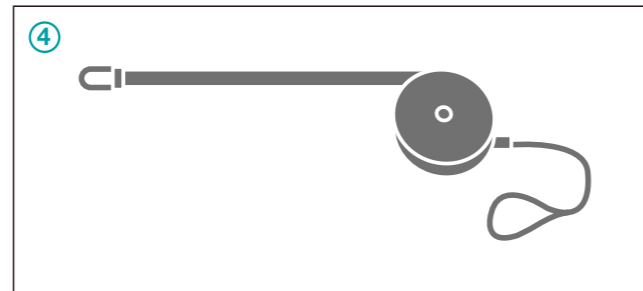
Tools and Equipment

- Engine driven cutter (Picture ①)
or Power operated metal saw (Picture ②)
- Portable disc grinder (Picture ③)
- Measuring tape (Picture ④)

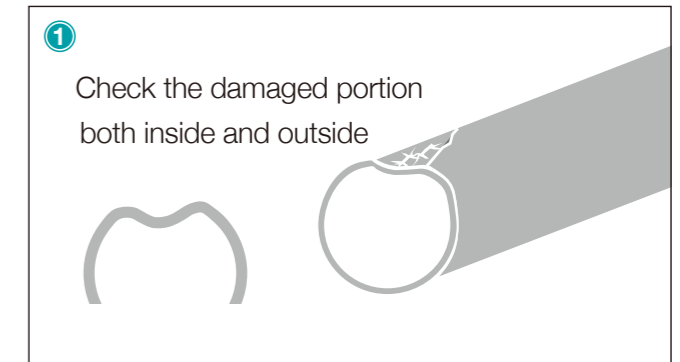
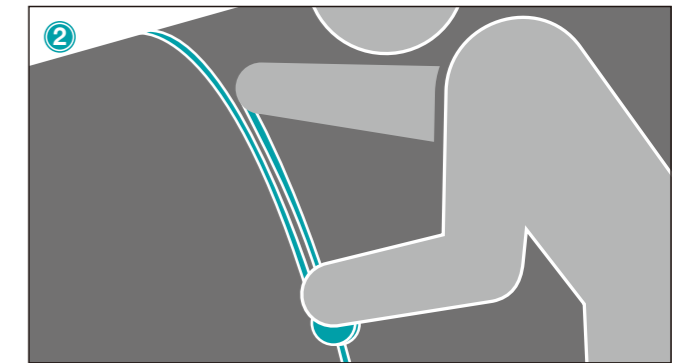
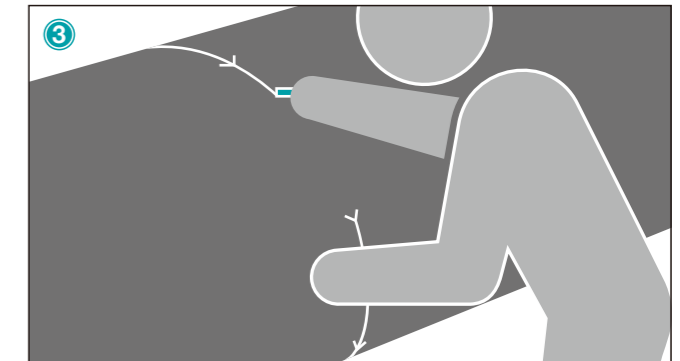
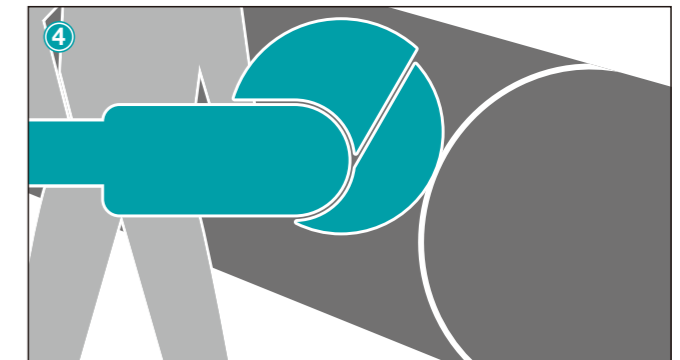
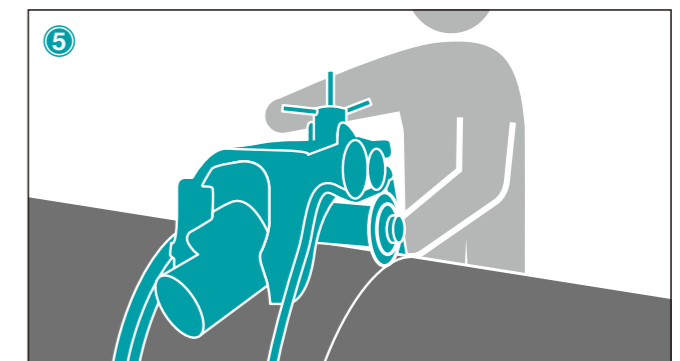
Procedure

(1) **Identify** the deformed portion (Picture ①).

(2) **Measure** the circumference with a measuring tape (Picture ②).
• Dimension must be within the tolerance in Table 1 of page 6. If it is not, find a portion that satisfies the value.

(3) **Draw** a line to indicate where to cut (Picture ③).

(4) **Cut** the pipe along the line using an engine driven cutter (Picture ④) or a power operated metal saw (Picture ⑤).

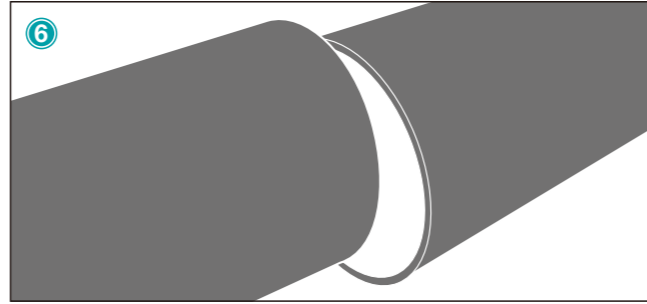
(5) **Completion** of cutting (Picture ⑥).

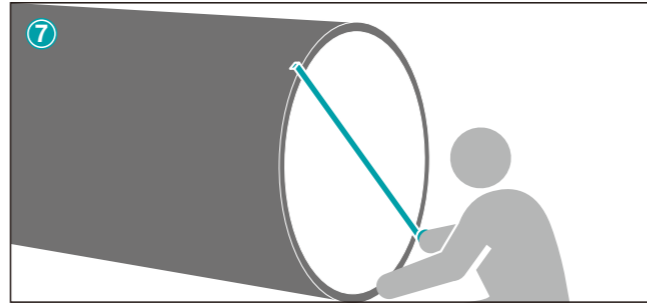
(6) **Measure** the outside diameter in two or more different directions (Picture ⑦).

*The dimensions must be within the tolerance in Table 1 (In case of JWWA pipe size)/ Table 2 (In case of AWWA pipe size) of page 6. If it is not in the tolerance, correct the outside diameter according to the procedure "Corrections of Deformed Spigot" (See page 7, 8). (JWWA:Japan Water Works Association)

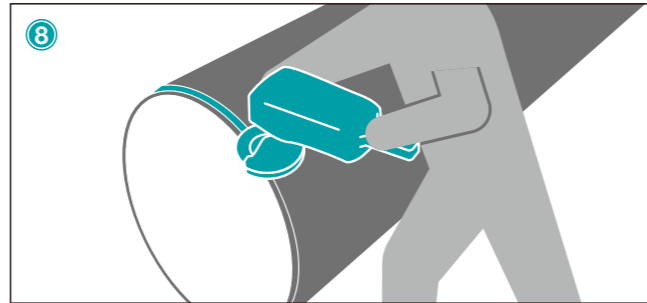
(7) **Bevel** the edge of the spigot end with portable disc grinder (Picture ⑧).

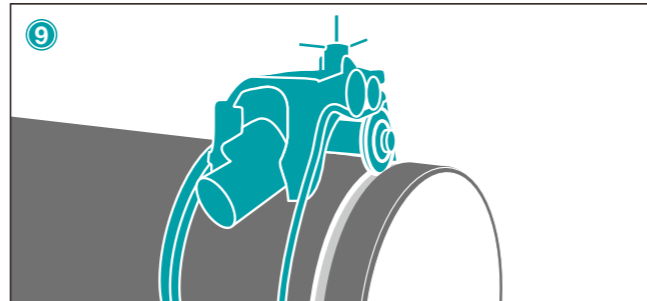
(8) **Make** the groove with Power operated metal saw same as original pipe (Picture ⑨).

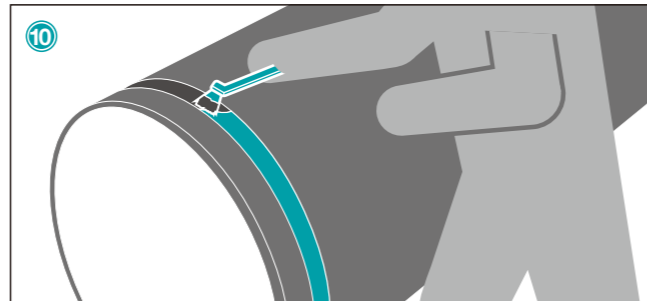
(9) **Clean** the surface of cutting portion, then apply the epoxy paint (Picture ⑩).

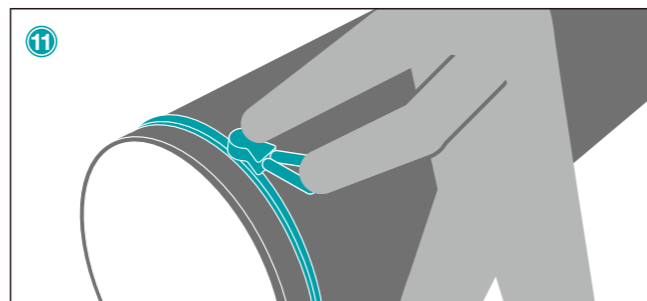
(10) **Make** the spigot projection as per assembling manual (Picture ⑪).

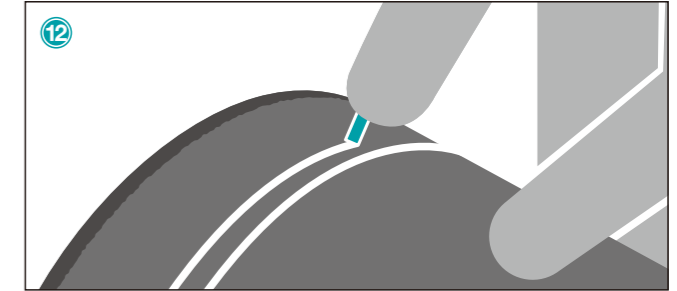
(11) **Draw** white lines for assembling same as the original spigot (Picture ⑫).

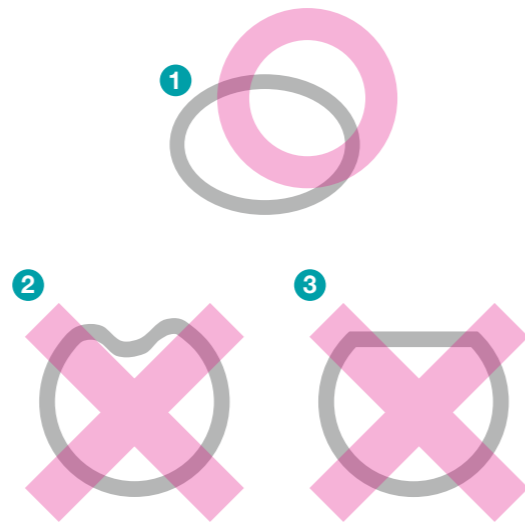
Although ductile iron pipes are tough and strong, they may be accidentally deformed by improper handling. However minor deformations can be repaired by the following method.

Generally only ellipse on the spigot end can be corrected (Picture 1). However, if the spigot is severely deformed and concave (Picture 2) or extensively flat (Picture 3), generally it can not be corrected. In such a case, the deformed portion need to be cut.

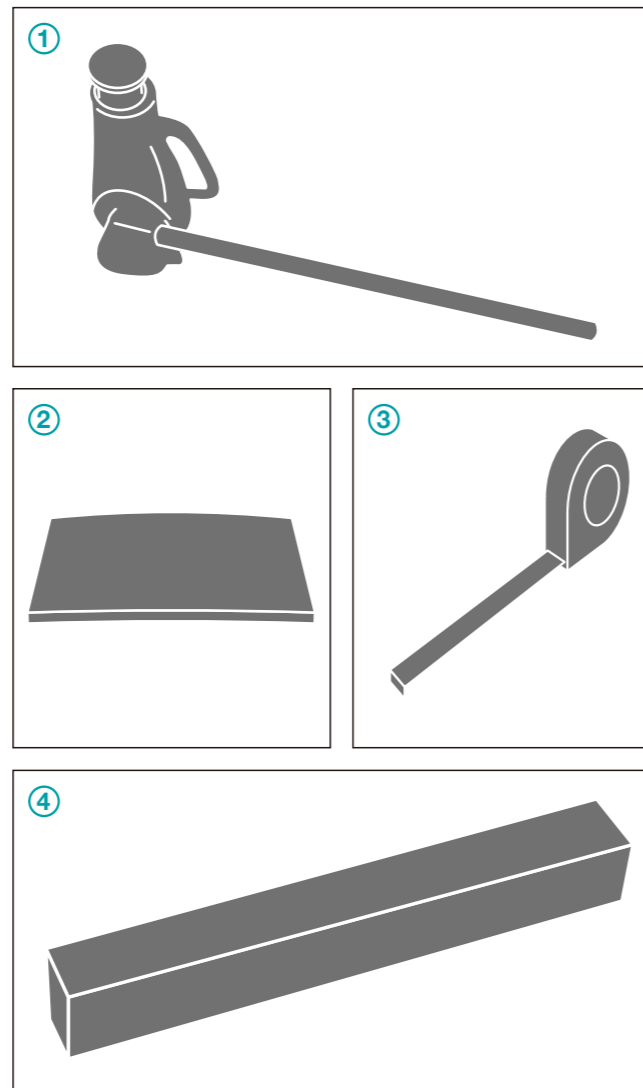
Tools and Equipment

- Hydraulic jack (Picture 1)
- Rubber sheet/iron plate/wood (Picture 2)
- *This is for prevention of lining damage.
- Measuring tape (Picture 3)
- Wood block (Picture 4)

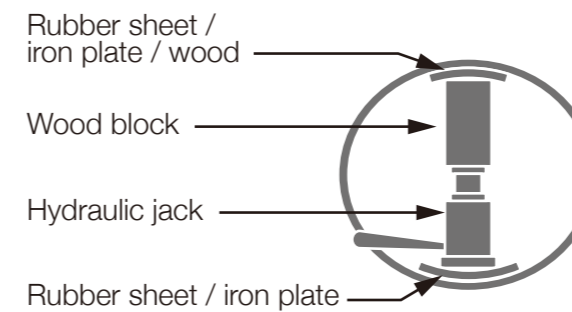
(1) **Place** the pipe so that the minimum diameter point is located vertically (Picture 1).

(2) **Place** the hydraulic jack, a wood block and rubber sheets/iron plates in the pipe (Picture 2).

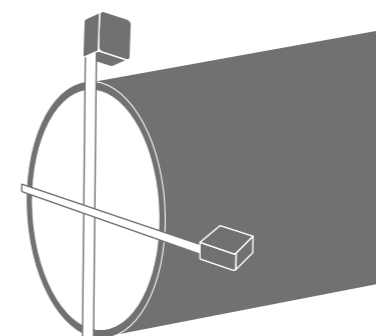
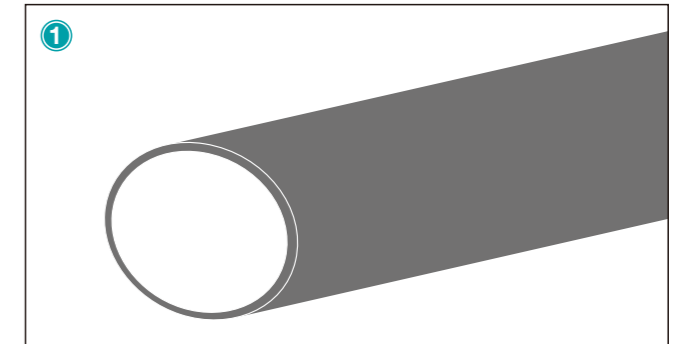
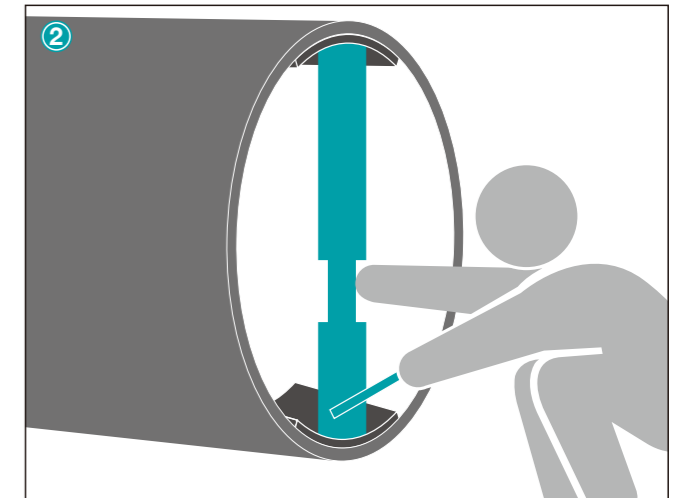
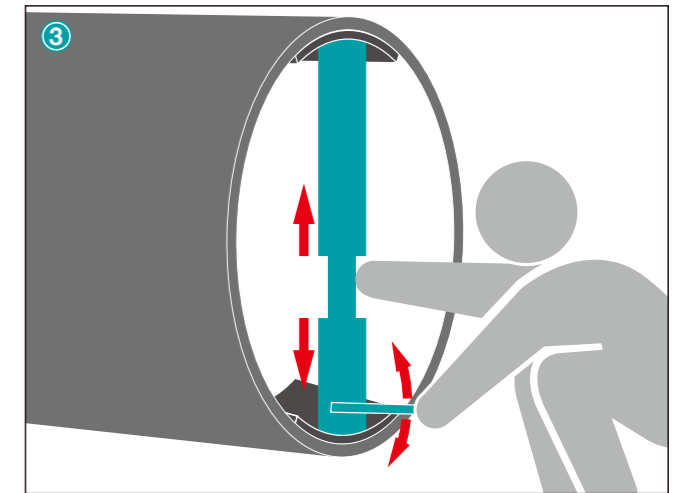
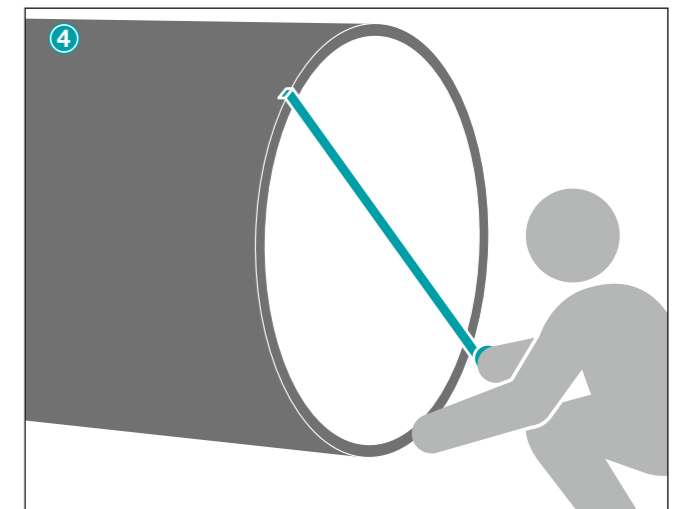
(3) **Gradually** expand the diameter until the diameter slightly exceeds the required dimensions (Picture 3).

*Excessive expansion of the pipe diameter will cause the damage to the mortar lining.

(4) **Release** pressure of the hydraulic jack and measure the diameters in two or more directions and see if they are within the tolerance specified in Table 1 of page 6 (Picture 4). If they are not, repeat (3) and (4).

*This procedure may be repeated several times until a correct circle is obtained.

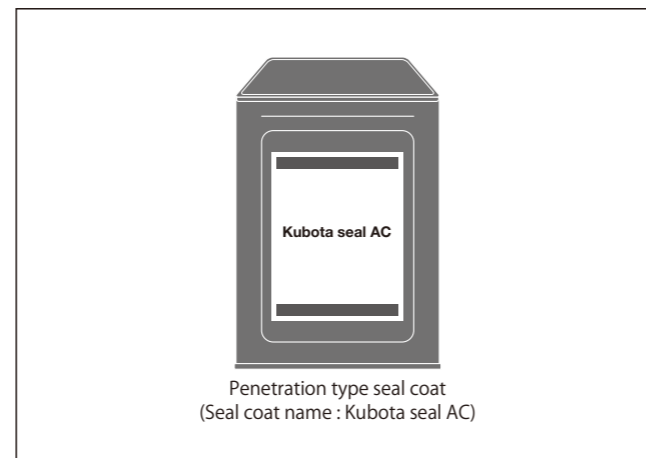
Seal Coat

It is recommended to use Kubota providing seal coat for the repair. The seal coat must be approved for DIP by NSF.

(1)**Stir** thoroughly until resin component is mixed with solvent component well.

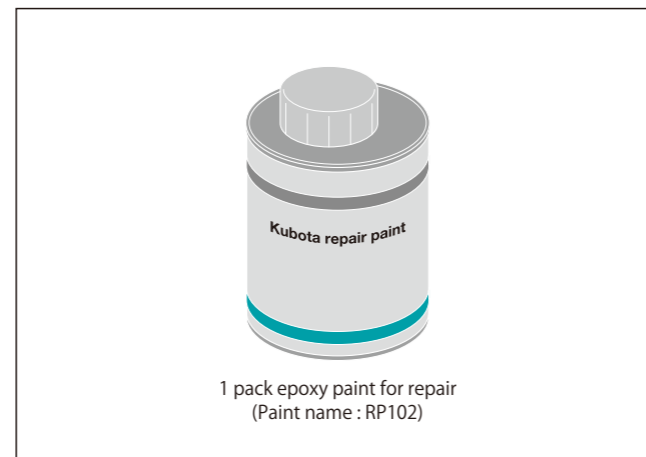
Epoxy Paint

It is recommended to use 1 pack epoxy paint provided by Kubota for the good workability. The epoxy paint must be approved for DIP by NSF.

(1)**Stir** thoroughly until resin component is mixed with solvent component well.

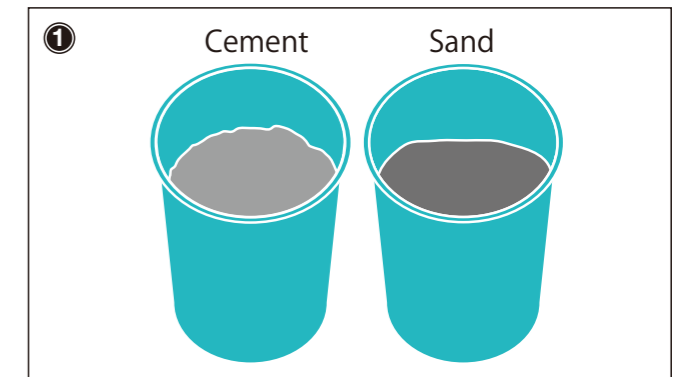
It is recommended to select cement of the same quality as that used for the cement mortar lining. (e.g. Portland cement, sulphate resisting cement, etc.)

(1)**Prepare** cement and sand in the ratio of 1:1 by weight (Picture ①).

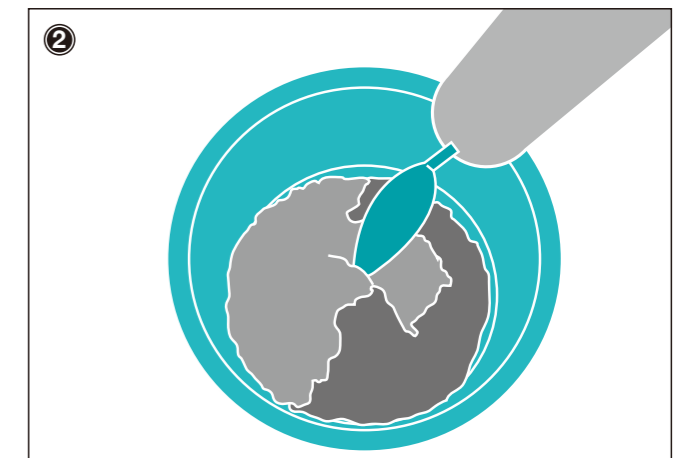
(2)**Mix** them well in a container (Picture ②).

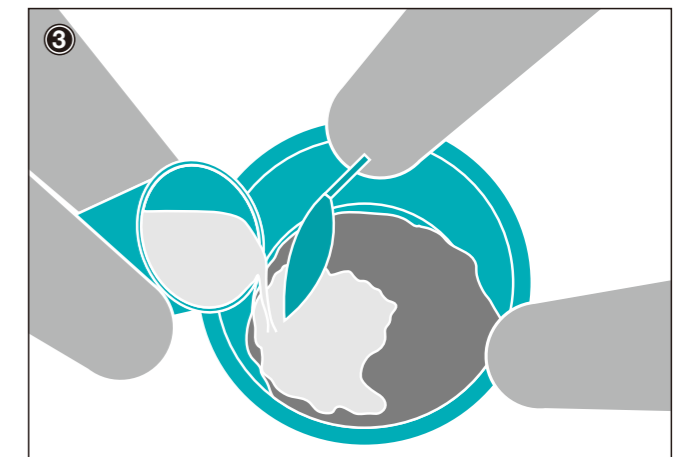
(3)**Add** water in small amounts to the mixture and continue to mix them (Picture ③).

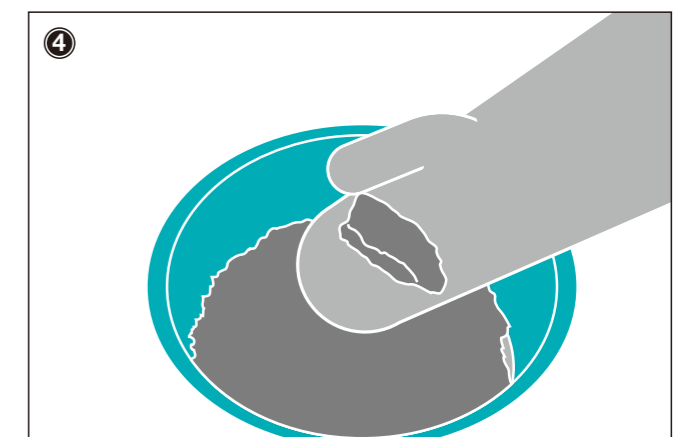
(4)**Keep** mixing until the mixture* becomes such that it can be formed into a lump when grasped firmly in one hand (Picture ④).

*Use the mixture within one hour.

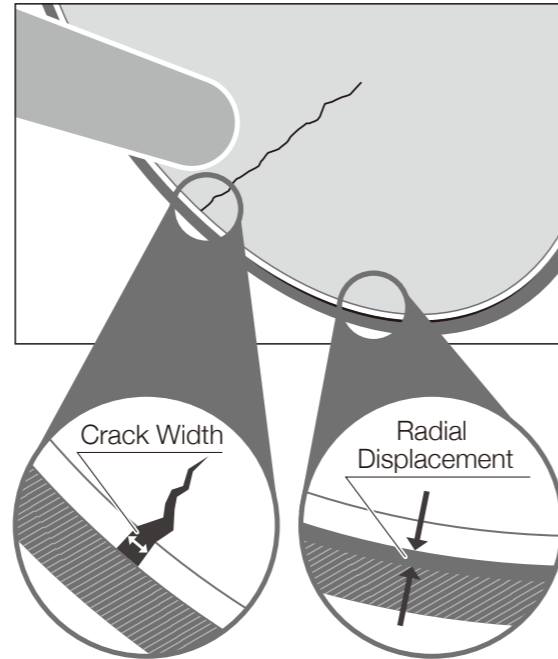
- (1) Inspect the cement mortar lining. When the cement mortar lining has large cracks, deformation of pipe body is expected. In this case, correction of the pipe is necessary prior to the repair of the lining.
- (2) After the concern of deformation is cleared, check the crack width and radial displacement. If the pipe has cracks and radial displacement less than the width specified in ISO 4179 (Table 4), it is not necessary to repair the surface crazing and the small cracks.
- (3) If the cement mortar lining has cracks and radial displacement exceeding the width given in Table 4, Kubota would recommend repairing them.

On contraction of the lining, the formation of the cracks and radial displacements cannot be avoided. These cracks and radial displacements, together with other isolated cracks which may result from manufacture or may develop during transportation, are acceptable if their width does not exceed the values in Table 4. Cracks shall not be detrimental to the mechanical stability of the lining.

It is known that these cracks and radial displacements will close and heal when the lining comes into contact with water due to re-swelling of the lining and continued hydration of the cement.

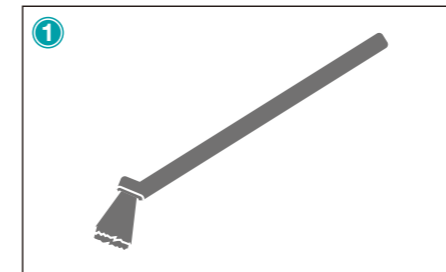
- Brush (Picture ①)

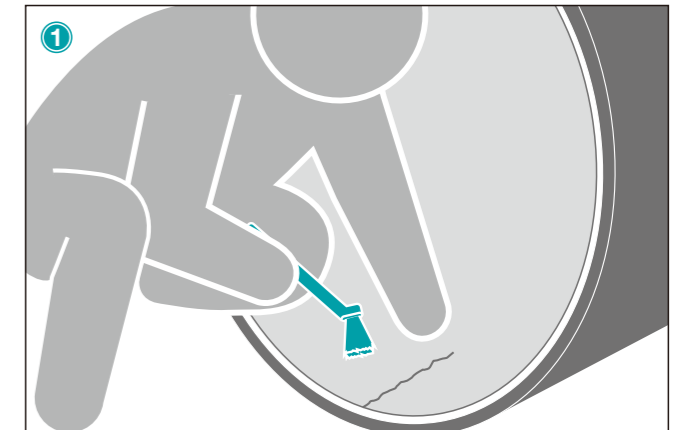
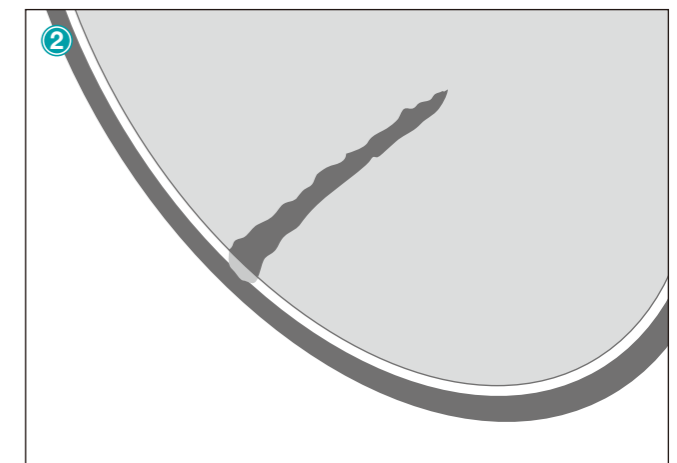
- (1) **Clean** the surface of the crack portion with a brush, etc. (Picture ①).

*The area to be painted shall be clean and free from sand, dust, moisture, etc.

- (2) **Apply** the seal coat/ epoxy paint to the cracked area.

*When it is difficult to have enough coating thickness at one time, it is recommended to paint twice.

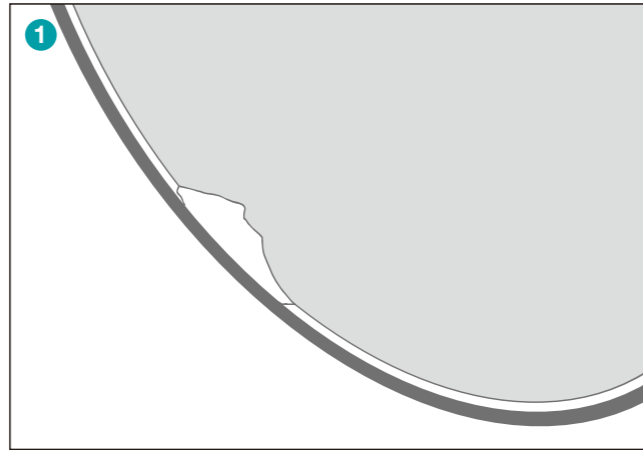
Inspect the damaged area carefully and confirm that there is no deformation or crack on the pipe body (Picture ①).

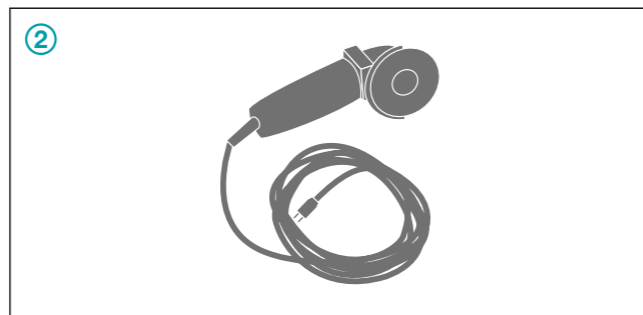
Tools and Equipment

- Brush (Picture ①)
- Portable disc grinder (Picture ②)

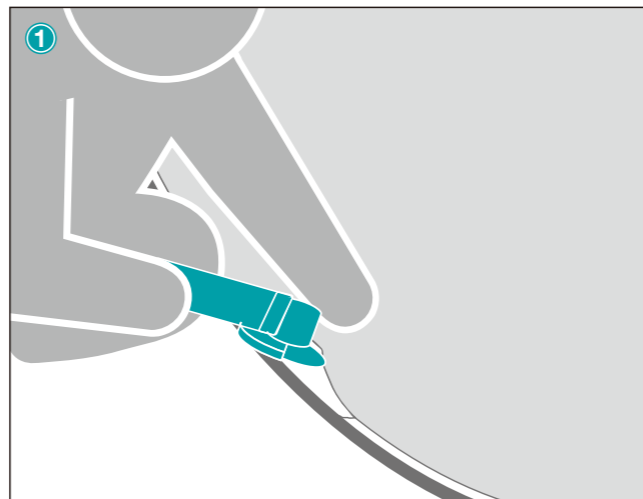
(1) **Make** the chip portion smooth with portable disc grinder (Picture ①).

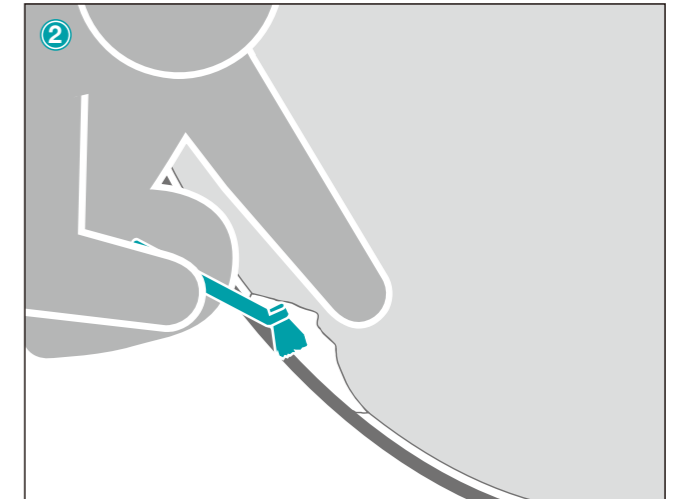
(2) **Clean** the surface of the damaged portion with a brush, etc (Picture ②).

*Remove sand, dust or moisture from the surface.

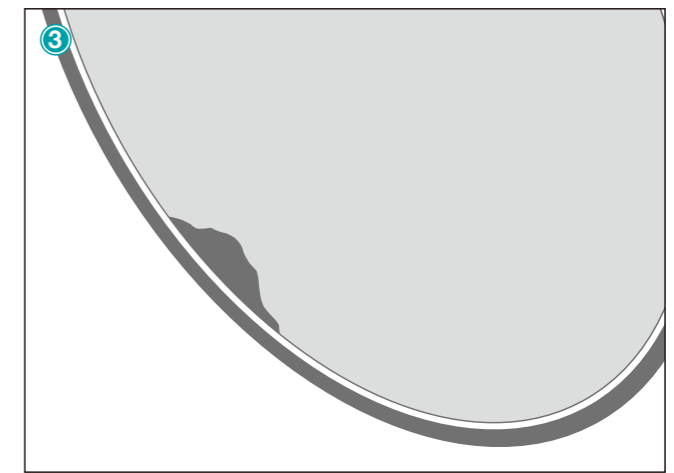
(3) **Apply** the epoxy coating to damaged portion (Picture ③).

*When it is difficult to have enough coating thickness at one time, it is recommended to paint twice.

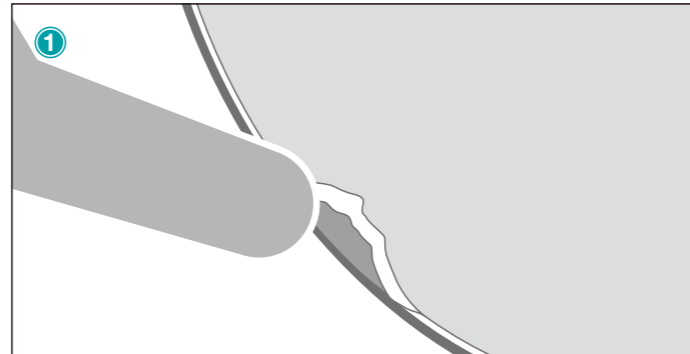
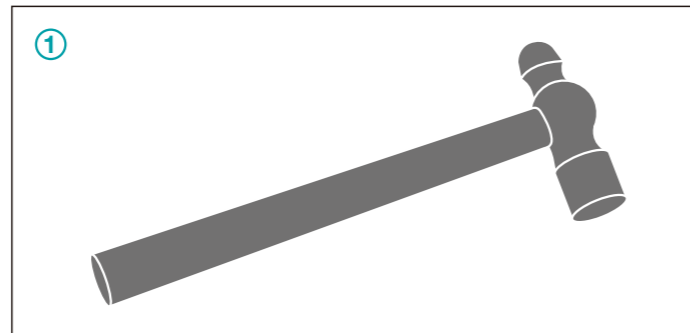
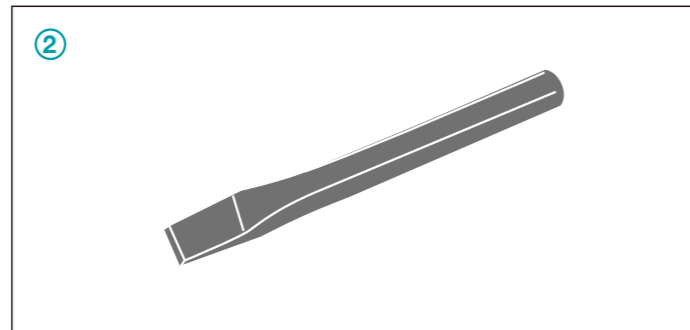
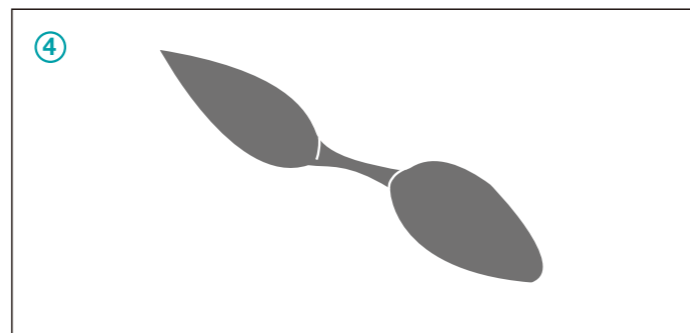
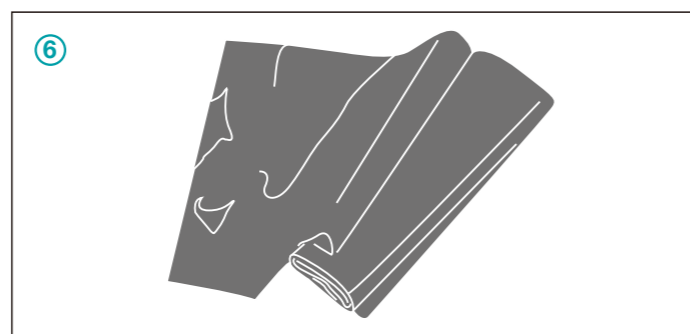
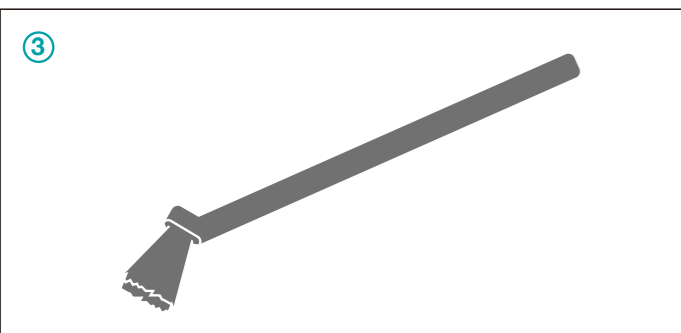
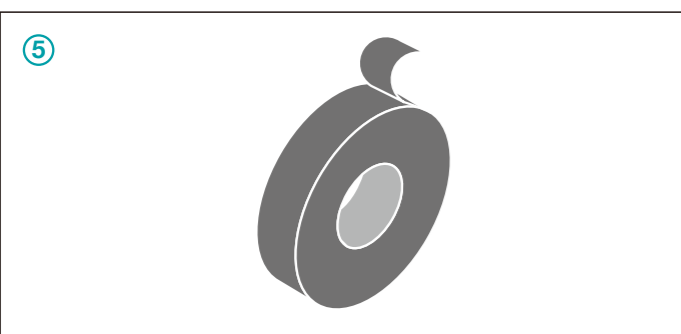
- Hammer (Picture ①)
- Chisel (Picture ②)
- Brush (Picture ③)
- Spatula (Picture ④)
- Adhesive tape (Picture ⑤)
- Plastic sheet (Picture ⑥)

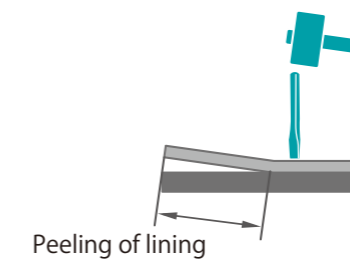
(1) **Cut back** the damaged lining so that the edge of the lining is at right angles to the iron surface (Picture ①).

*If the cement lining is peeled off from the iron surface, cut out the affected area.

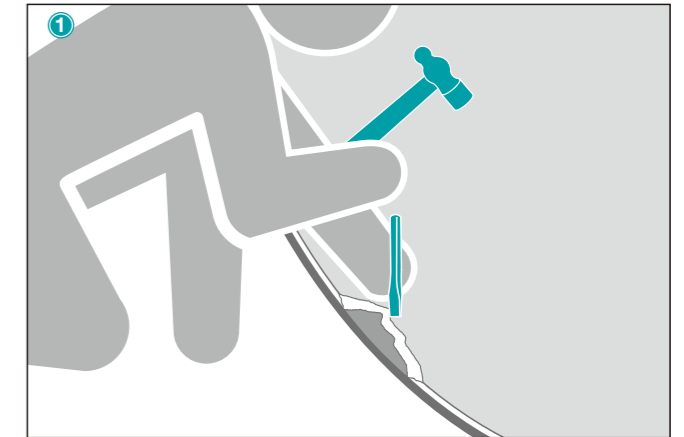
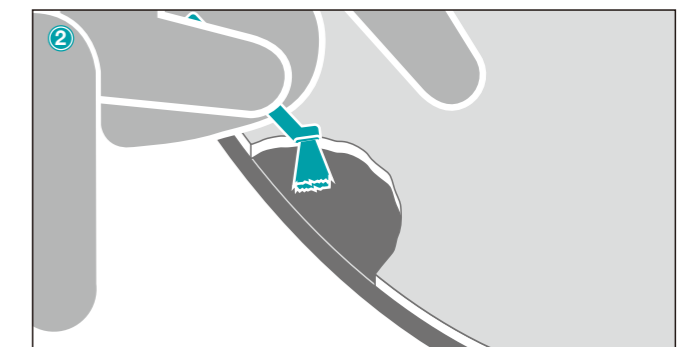
(2) **Clean** the surface of the damaged portion with a brush, etc (Picture ②).

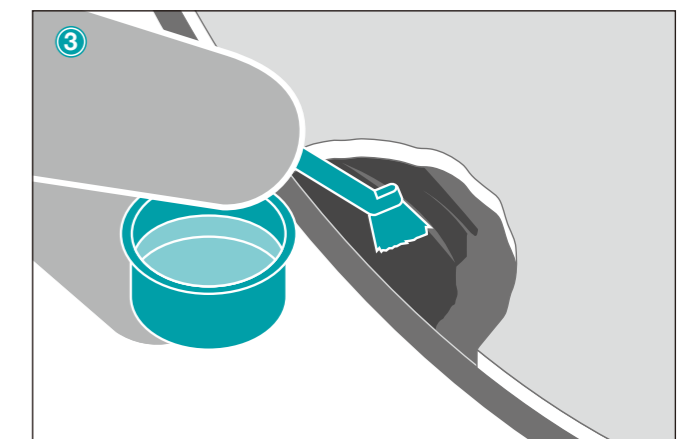
(3) **Apply** some water to the damaged portion with a brush (Picture ③).

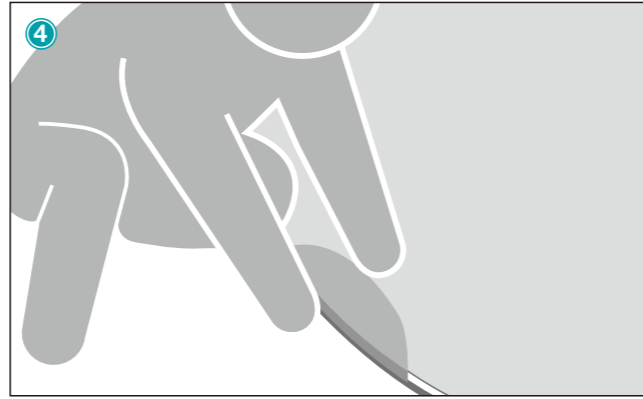
(4) **Fill** the damaged portion with the cement mortar mixture (Picture ④).

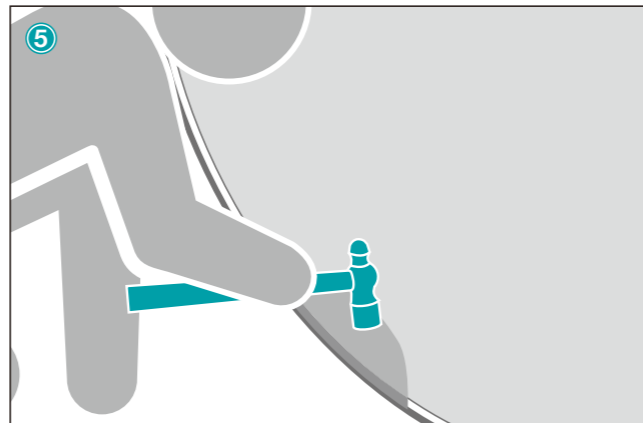
(5) **Tap** the filled cement mortar mixture gently with a hammer until it is compacted (Picture ⑤).

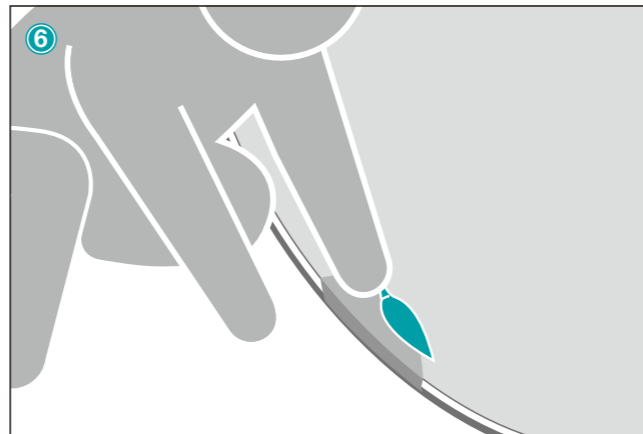
(6) **Smooth** the surface with a spatula (Picture ⑥).

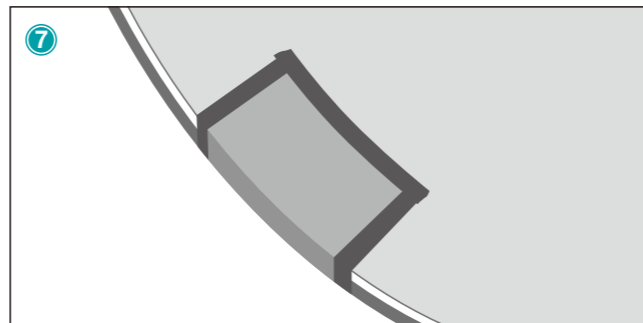
(7) **Curing:**

Cover the repaired portion with a wet towel or wet paper, then seal up with plastic sheet and adhesive tape. Keep it on for more than 24 hours (Picture ⑦).

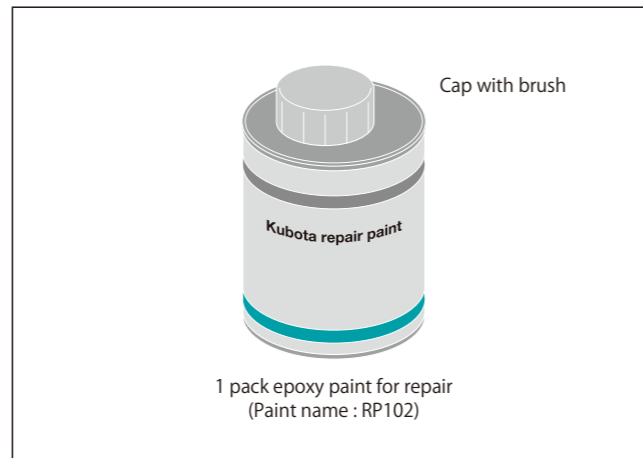
(1) **Stir** thoroughly until resin component is mixed with solvent component well.

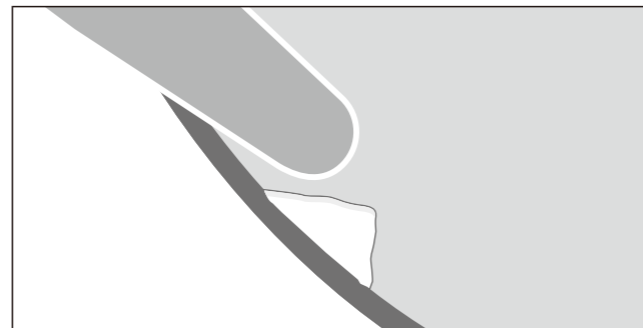
Inspect the epoxy coating.

If the epoxy coating is damaged, repair of the epoxy coating is required.

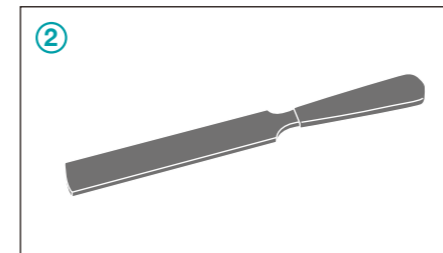
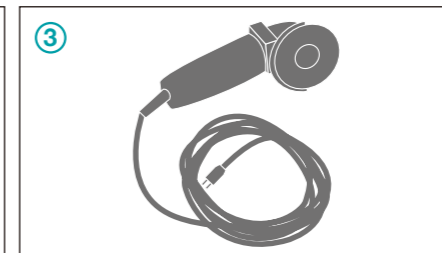
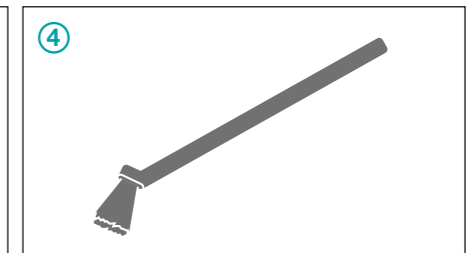
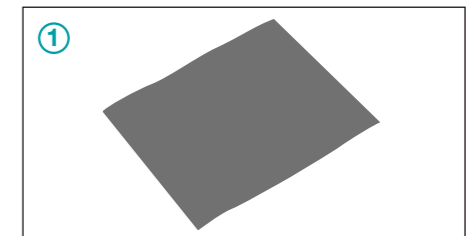
- Sandpaper (Picture ①)
- File (Picture ②)
- Portable disc grinder (Picture ③)
- Brush (Picture ④)

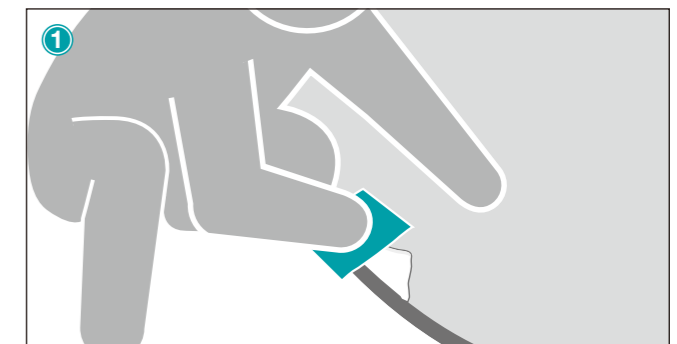
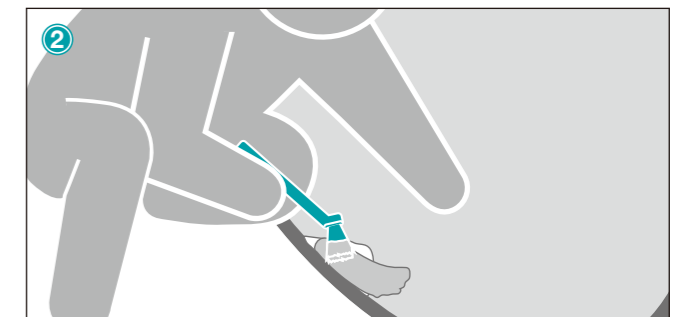
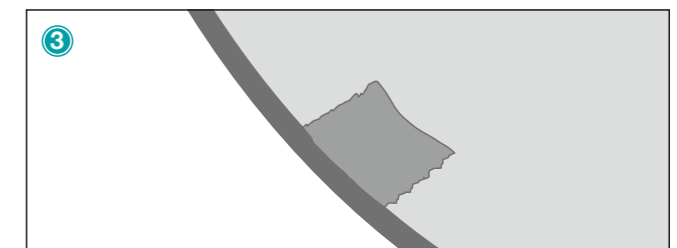
(1) **Roughen** the sound coating around the damaged area with a sandpaper, file or portable disc grinder to the extent of 1 inch (Picture ①).

(3) **Apply** the epoxy paint to the damaged area (Picture ②).

(4) **Inspect** the finished surface (Picture ③).

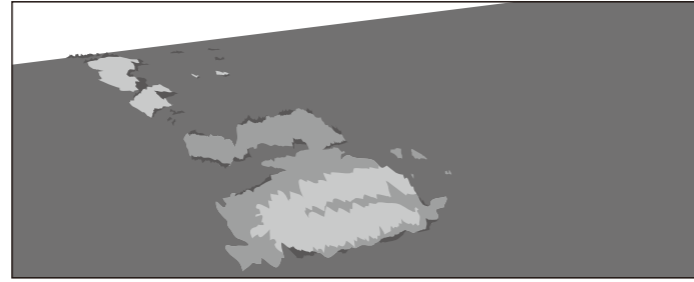
Inspect the external coating. If the external coating is damaged, repair of the external coating is required.

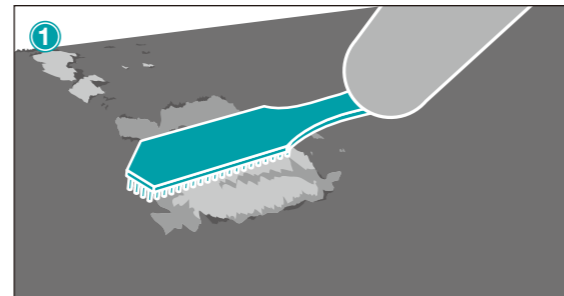
(1) **Remove** foreign materials and clean the surface (Picture ①).

*If the surface is rusted, use wire brush or sandpaper to remove the rust, then wipe off with a cloth.

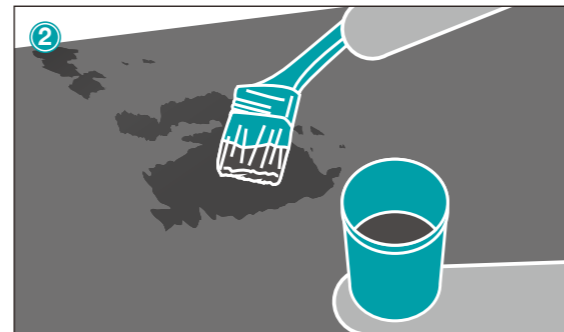
(3) **Apply** the synthetic resin paint to the damaged portion with a brush (Picture ②).

*When bare iron is exposed at damaged portion, use 1 pack epoxy coating provided by Kubota.

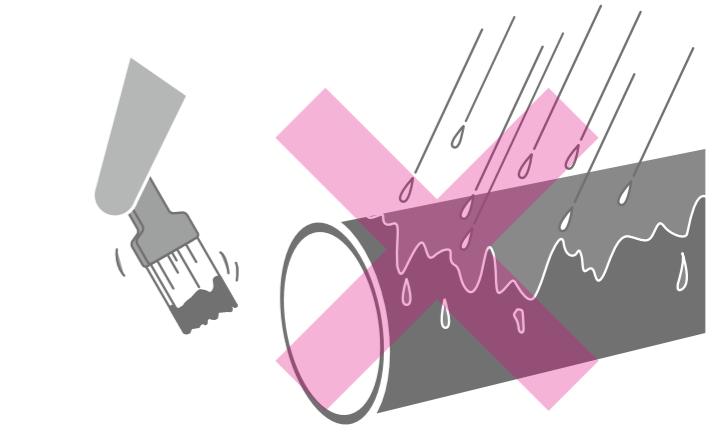
(1) **Do not apply** coating when the pipe surface is wet. The coated surface has to be completely dried before installation.
