# KUBOTA DUCTILE IRON PIPE

## Repair Manual

### KUBOTA Corporation

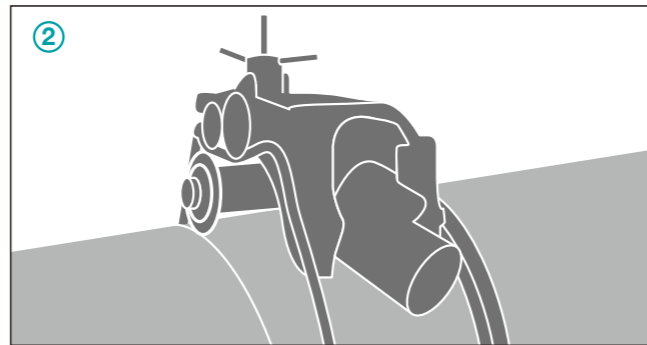
## Tools and Equipment

- Engine driven cutter (Picture ①)  
or Power operated metal saw (Picture ②)
- Portable disc grinder (Picture ③)
- Measuring tape (Picture ④)
- Curvature gauge made of plywood, tin plate, plastic, etc.(Picture ⑤)
  - This tool may be made on site using available materials.
- Taper gauge made of plywood, tin plate, plastic, etc.(Picture ⑥)
  - This tool may be made on site using available materials.

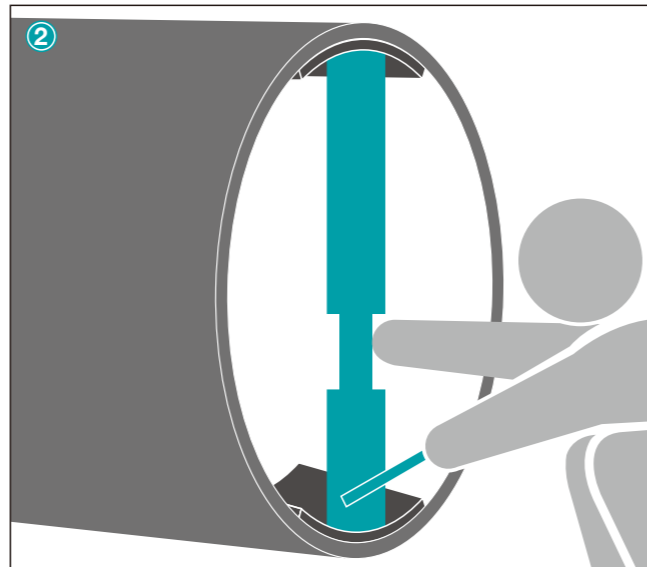
(2) **Set** the hydraulic jack, a wood block and iron plates in the pipe. (Picture ②)

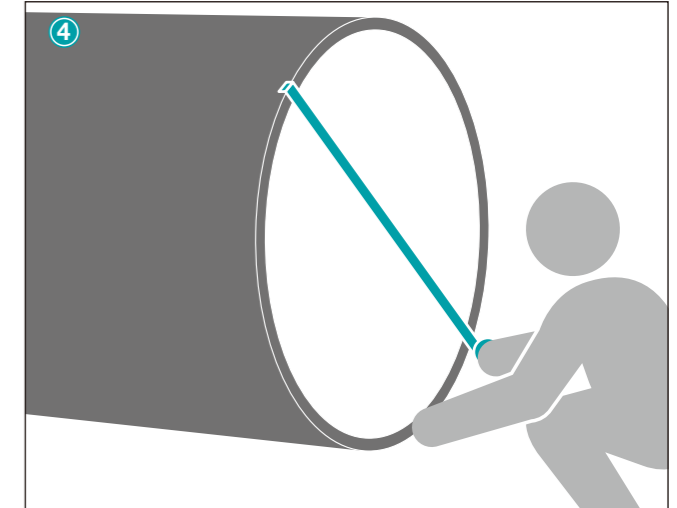
(4) **Release** pressure of the hydraulic jack and measure the diameters in two or more directions and see if they are within the tolerance specified in Table 1 of page 6. (Picture ④) If they are not, repeat (3) and (4).

\*This procedure may be repeated several times until a correct circle is obtained.

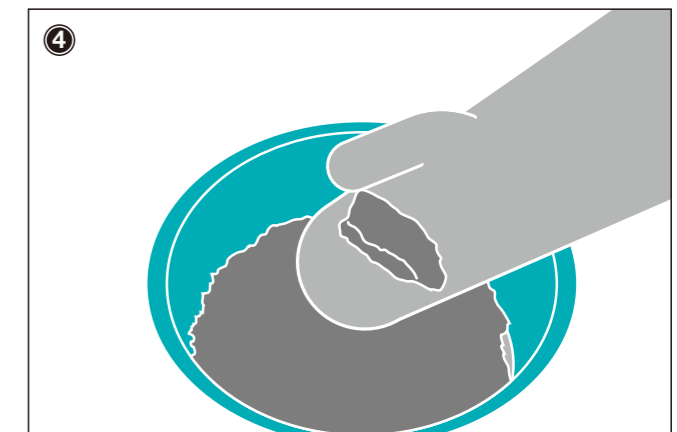
(4) **Keep** mixing until the mixture\* becomes such that it can be formed into a lump when grasped firmly in one hand. (Picture ④)

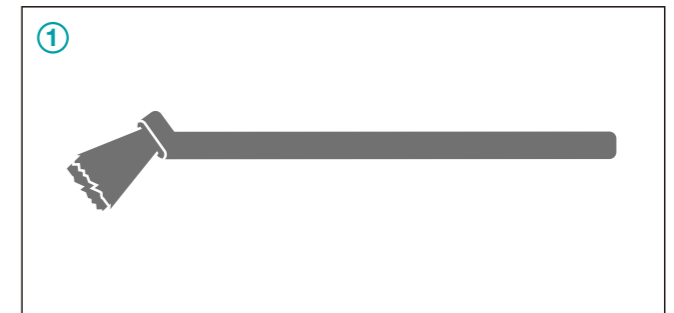
- Brush (Picture ①)
- Spatula (Picture ②)

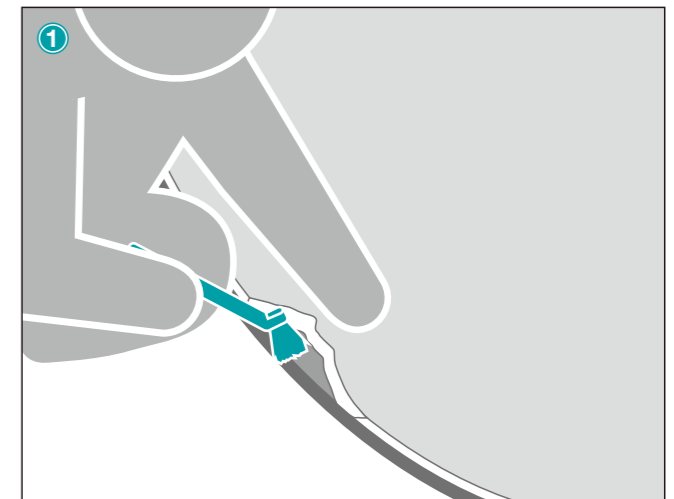
- (1) **Clean** the surface of the damaged portion with a brush, etc. (Picture ①)  
\*Remove moisture from the surface.

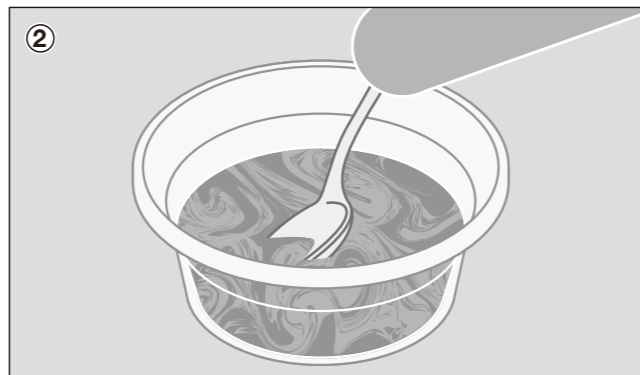
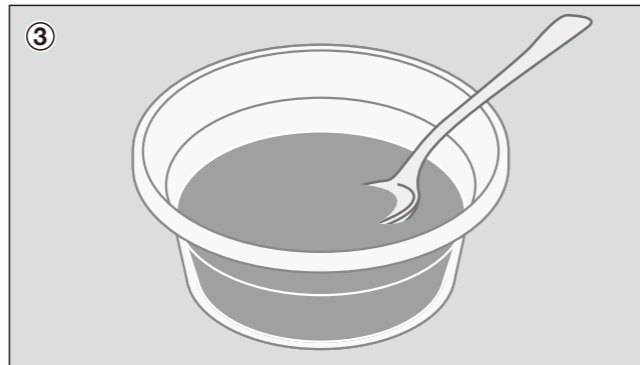
(2) **Mix** them well in a container until they become uniform in color. (Picture ② and ③)
