KUBOTA DUCTILE IRON PIPE

Repair Manual

■ PREFACE	1
■ REPAIR FLOWCHART	2
■ CUTTING OF PIPE	3
■ CORRECTION OF DEFORMED SPIGOT	8
■ REPAIR OF INTERNAL LINING (CEMENT MORTAR LINING)	11
□ Crack	13
□ Chip	16
□ Break	18
■ REPAIR OF INTERNAL LINING (FUSION BONDED EPOXY COATING)	23
■ REPAIR OF EXTERNAL COATING	25

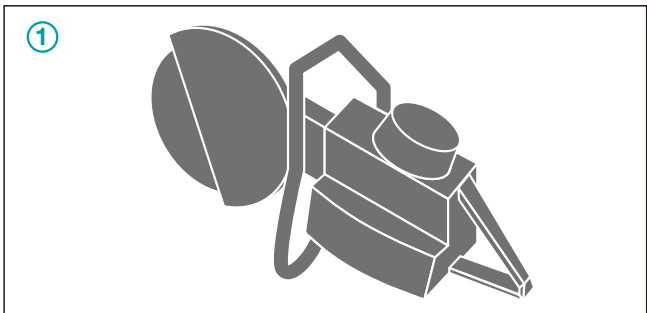
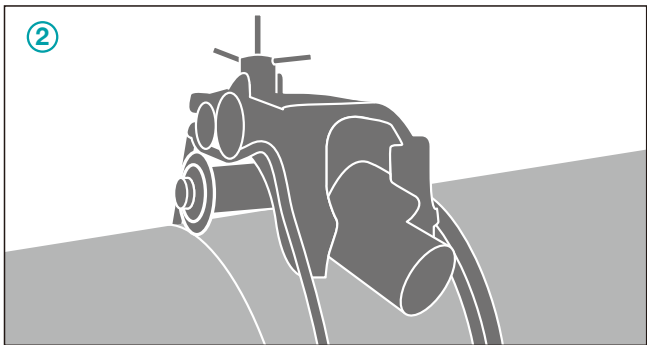
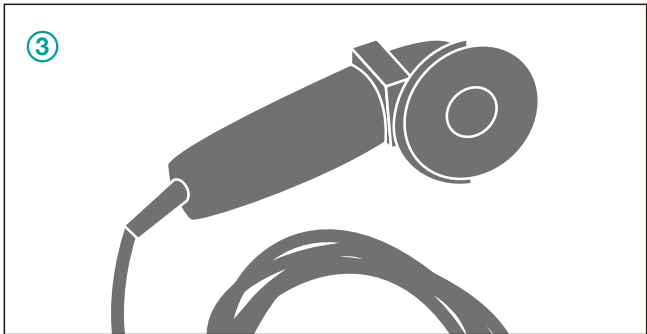
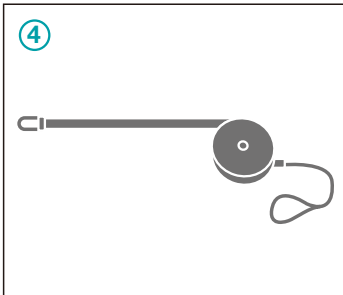
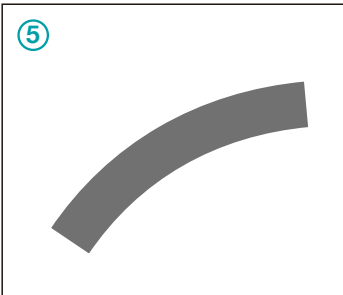
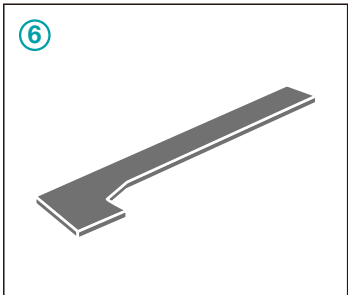
- Engine driven cutter (Picture ①)
or Power operated metal saw (Picture ②)
- Portable disc grinder (Picture ③)
- Measuring tape (Picture ④)
- Curvature gauge made of plywood, tin plate, plastic, etc.(Picture ⑤)
•This tool may be made on site using available materials.
- Taper gauge made of plywood, tin plate, plastic, etc.(Picture ⑥)
•This tool may be made on site using available materials.

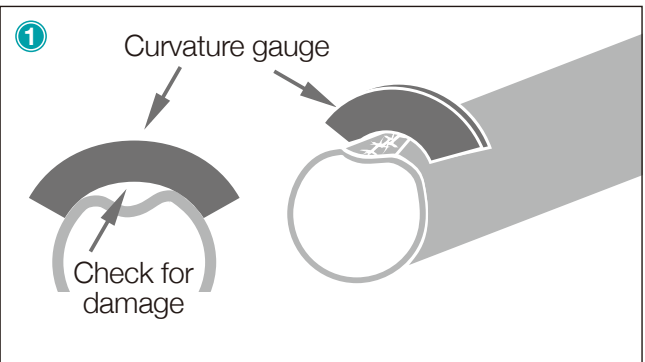
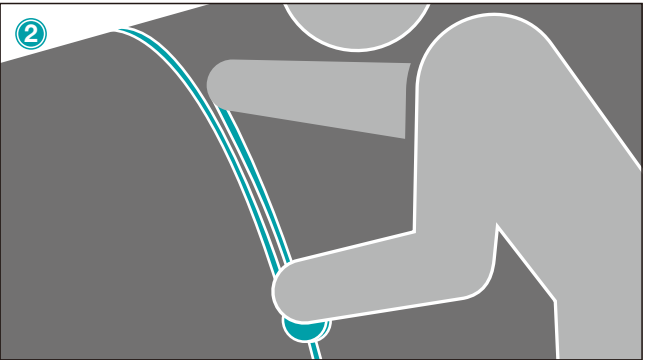
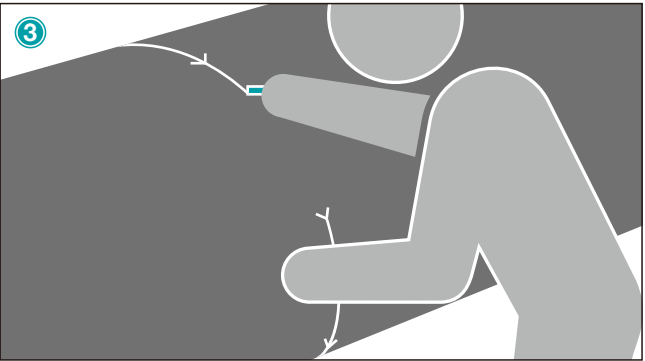
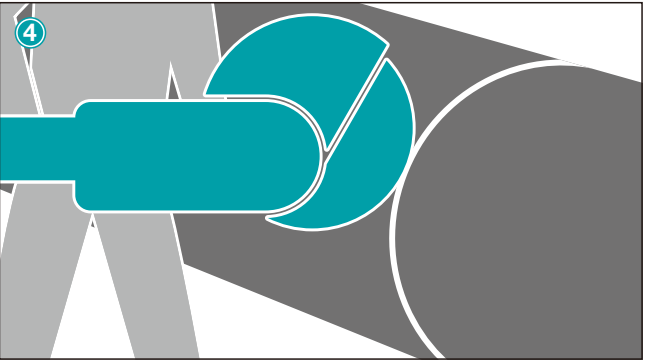
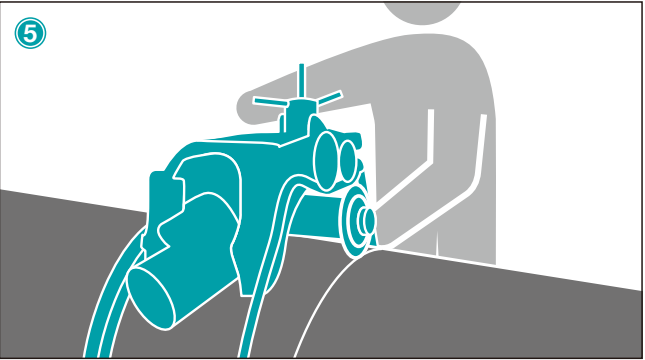
- (1)**Check** the deformed portion and identify an undamaged portion with a curvature gauge.(Picture ①)

- (2)**Measure** the circumference with a measuring tape.(Picture ②)
•Dimension must be within the tolerance in Table 1 of page 6. If it is not, find a portion that satisfies the value.

- (3)**Draw** a line to indicate where to cut. (Picture ③)

- (4)**Cut** the pipe along the line using an engine driven cutter (Picture ④) or a power operated metal saw. (Picture ⑤)

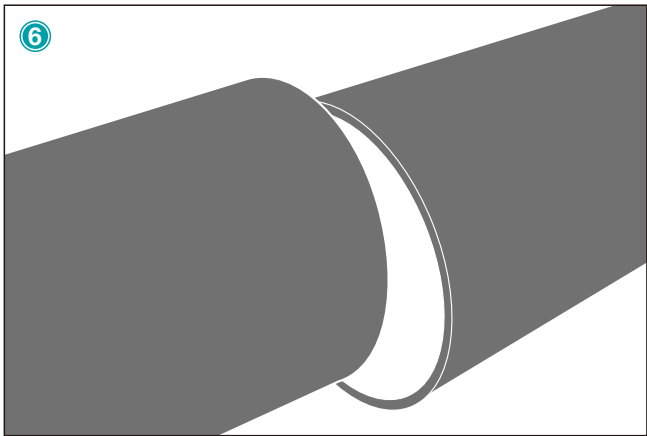
(5)**Completion** of cutting. (Picture ⑥)

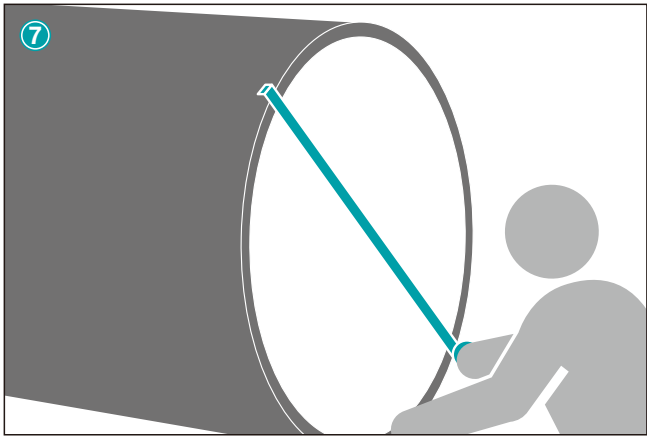
(6)**Measure** the outside diameter in two or more different directions. (Picture ⑦)

*The dimensions must be within the tolerance in Table 1 of page 6. If it is not,correct the pipe according to the procedure “Corrections of Deformed Spigot”. (See page 8-10)

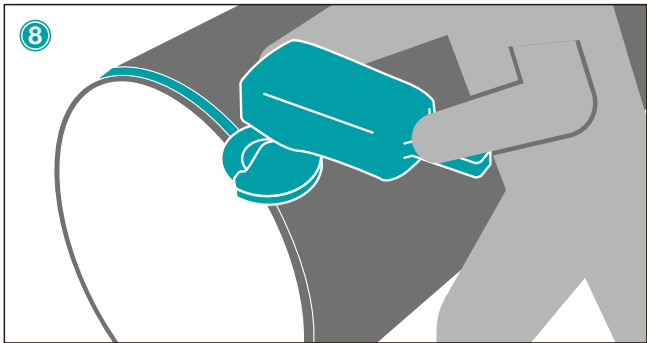
(7)**Taper** the edge of the spigot with a portable disc grinder as per the dimensions specified in Table 2 of page 7. (Picture ⑧)

*Taper gauge can be used to easily check the angle of the tapered end.

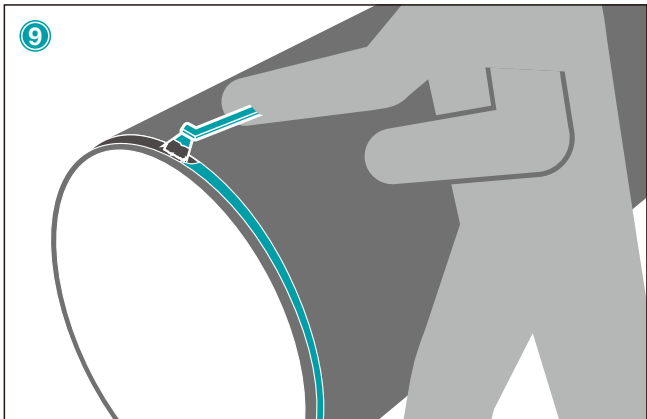
(8)**Apply** the zinc rich paint to the exposed iron surface. And then, apply the bituminous paint to the dried zinc rich coating. (Picture ⑨)

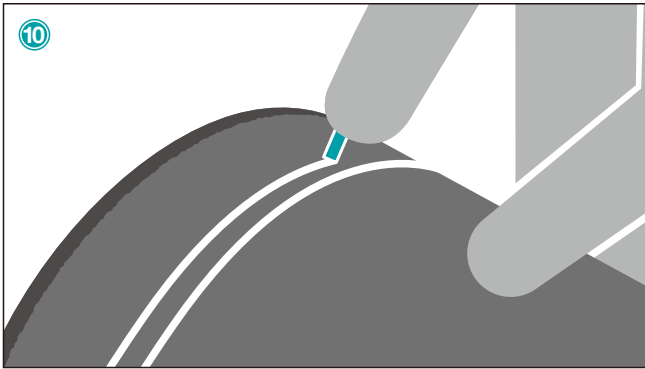
(9)**Draw** white lines for jointing as per the dimensions specified in Table 2 of page 7. (Picture ⑩)
*Stenciled lines may be drawn also by spray painting.

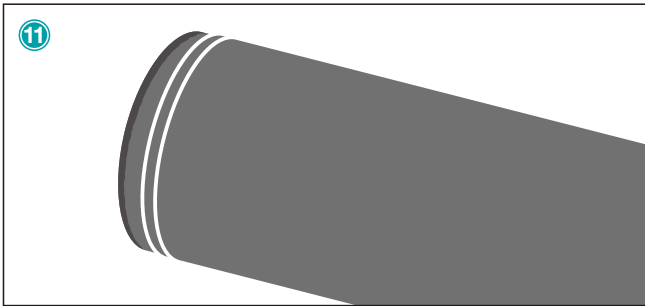
(10)**Completion** of cutting work.(Picture ⑪)

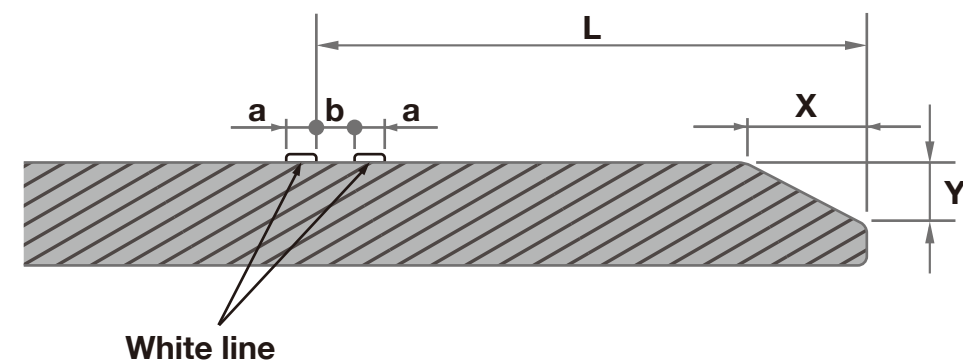
■ Dimensions of Tapered Spigot for Push-on Joint

DN	Taper		White lines		
	Y	X	L	a	b
80	3	9	82	10	13
100	3	9	86	10	13
150	3	9	95	10	13
200	3	9	110	10	13
250	3	9	115	10	13
300	3	9	120	10	13
350	5	14	135	10	13
400	5	14	135	10	13
450	5	14	135	10	13
500	5	14	140	10	13
600	5	14	145	10	13
700	6	15	160	15	20
800	6	15	165	15	20
900	6	15	180	15	20
1000	7.5	19	190	15	20
1100	7.5	19	205	15	20
1200	7.5	19	220	15	20
1400	8.5	23	250	15	20
1500	8.5	23	265	15	20
1600	8.5	23	280	15	20
1800	9.5	26	310	15	20
2000	9.5	26	340	15	20

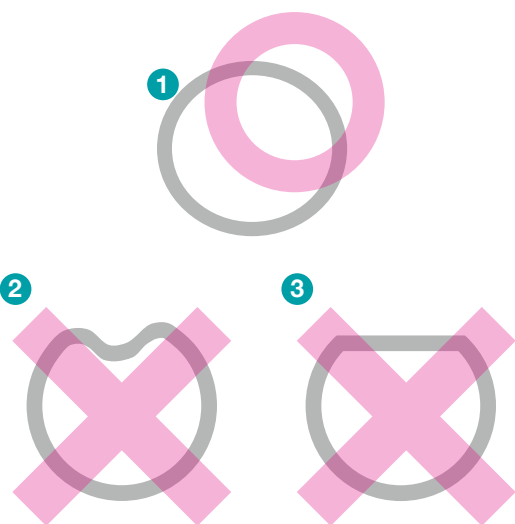
Generally only ellipse on the spigot end can be corrected. (Picture ①) However, if the spigot is severely deformed and concave (Picture ②) or extensively flat (Picture ③), generally it can not be corrected. In such a case, the deformed portion need to be cut.

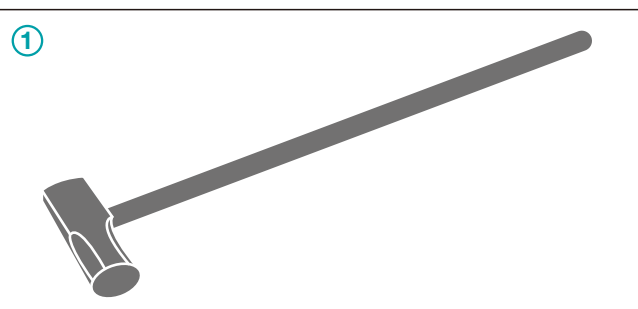
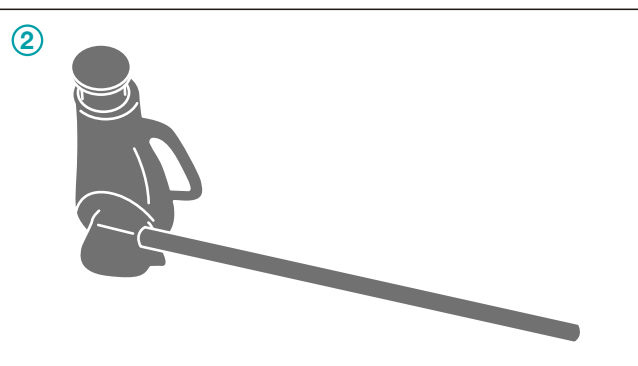
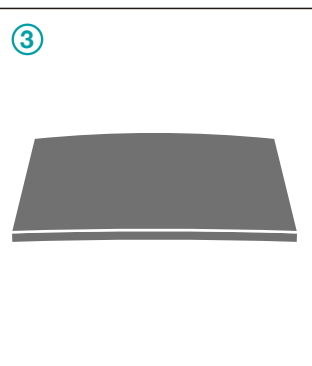
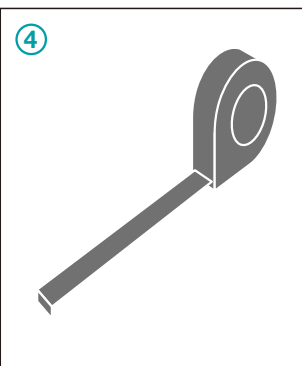
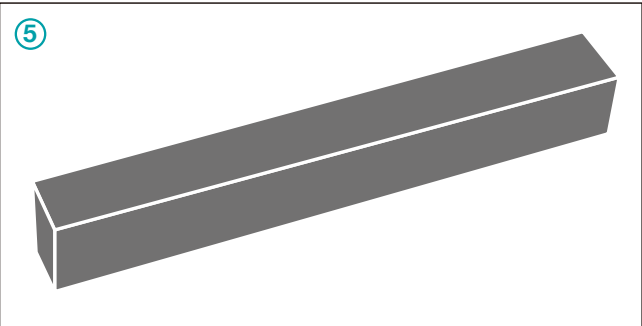
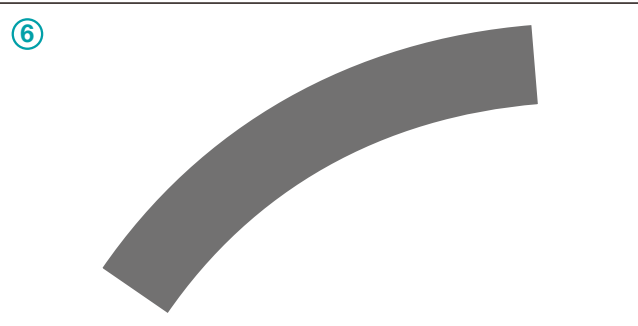
- Hammer (Large) (Picture ①)
- Hydraulic jack (Picture ②)
- Iron plate with curvature that conforms to the inner wall of the repairing pipe. (Picture ③)
**This can be made on site by cutting out pieces from rejected pipe or cut pipe, etc.*
- Measuring tape (Picture ④)
- Wood block (Picture ⑤)
- Curvature gauge (Picture ⑥) made of plywood, tin plate, plastic, etc.
**This can be made on site using available materials.*

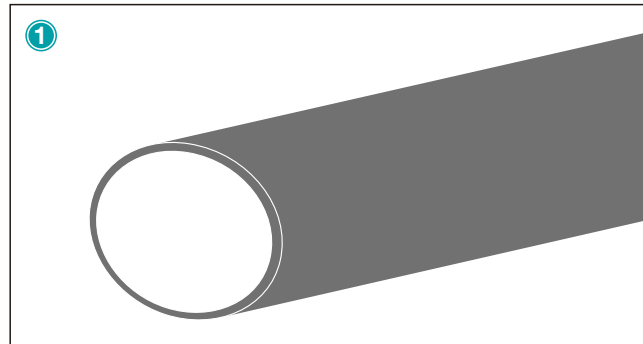
(1) **Position** the pipe so that the minimum diameter point is located vertically. (Picture ①)

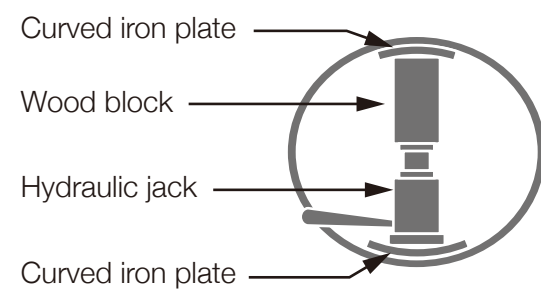
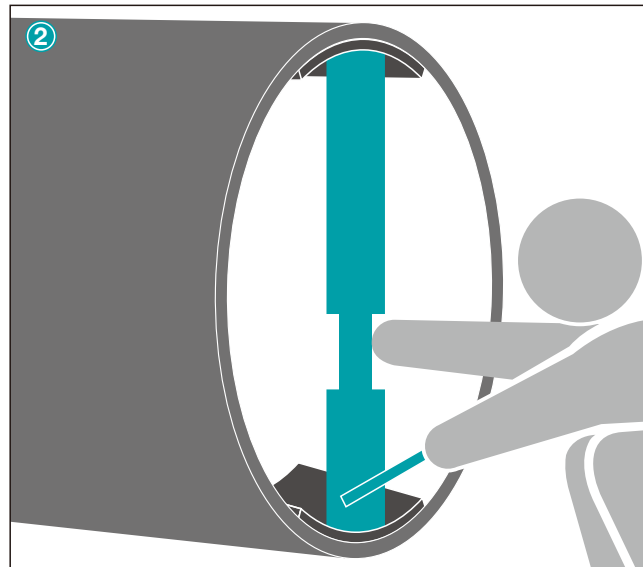
(2) **Set** the hydraulic jack, a wood block and iron plates in the pipe. (Picture ②)

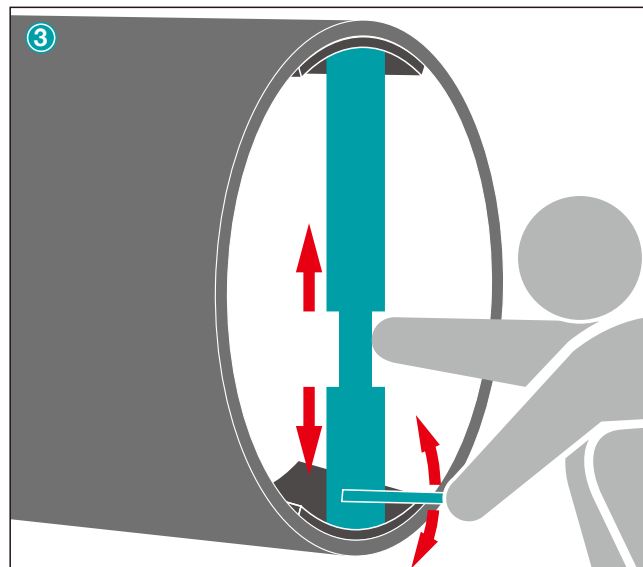
(3) **Gradually** expand the diameter until the diameter slightly exceeds the required dimensions. (Picture ③)

*Excessive expansion of the pipe diameter will cause the damage to the mortar lining.

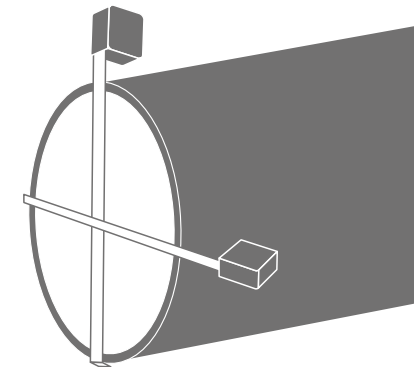
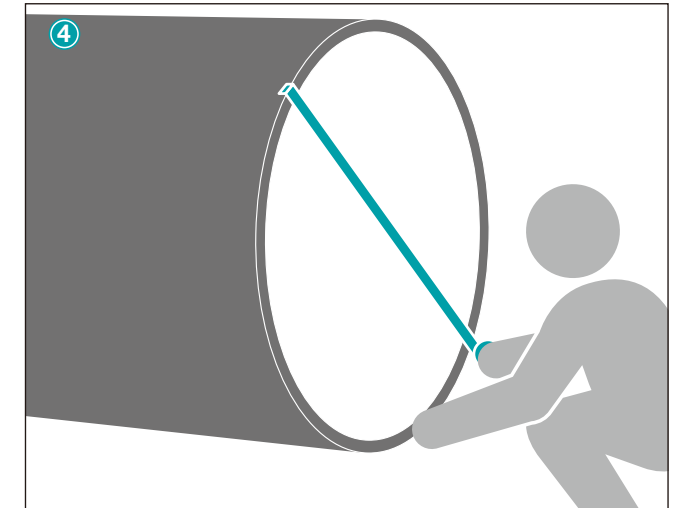
(4) **Release** pressure of the hydraulic jack and measure the diameters in two or more directions and see if they are within the tolerance specified in Table 1 of page 6. (Picture ④) If they are not, repeat (3) and (4).

*This procedure may be repeated several times until a correct circle is obtained.

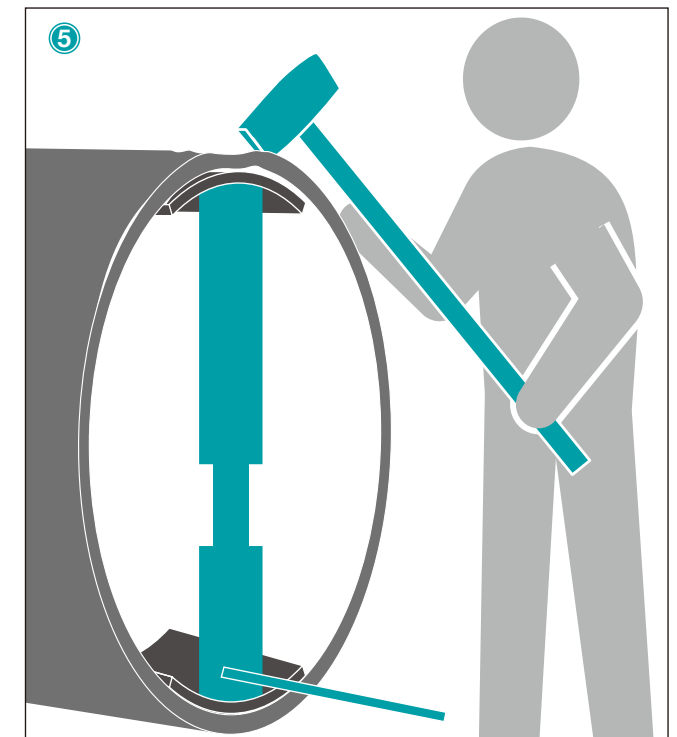
In case there is a deformation on the pipe, correct the deformation with a hammer while expanding the diameter. (Picture ⑤)

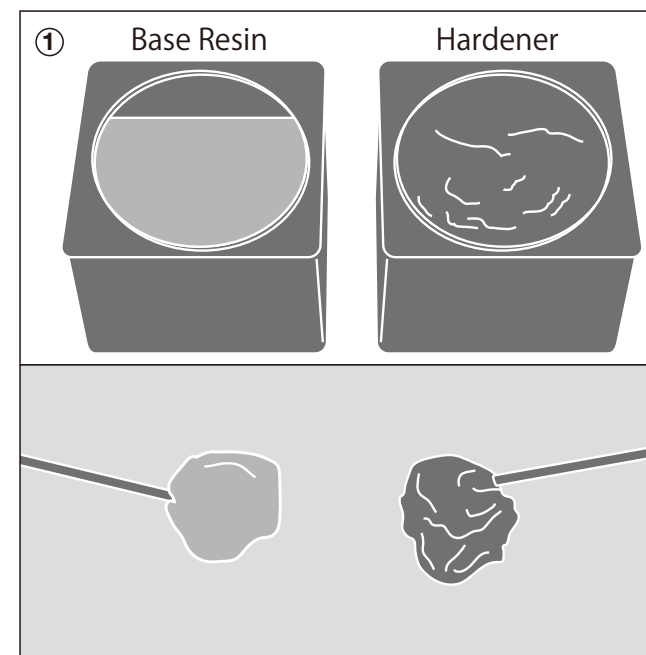
(1)**Prepare** Epoxy Resin compound. And take out appropriate ratio of "Base Resin" and "Hardener" with different spoons. (Picture ①)

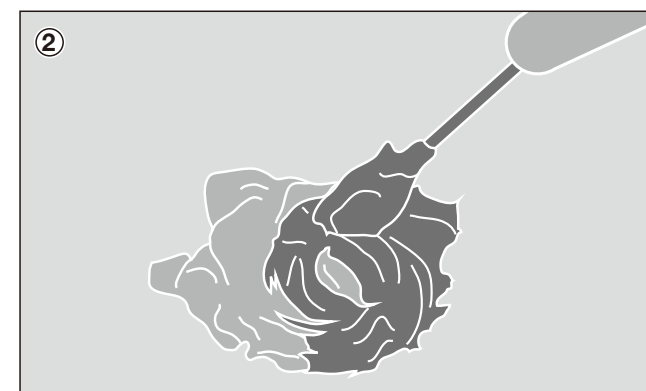
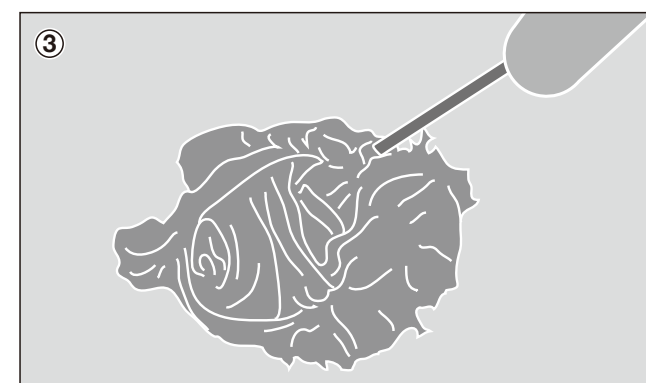
(2)**Mix** them well until they become uniform in color (Picture ② and ③).

*The pot life and condition of the materials vary according to the materials and temperature.

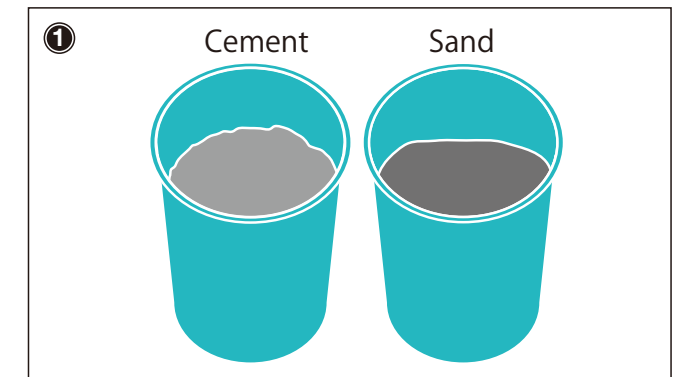
(1)**Prepare** cement and sand in the ratio of 1:1 by weight. (Picture ①)

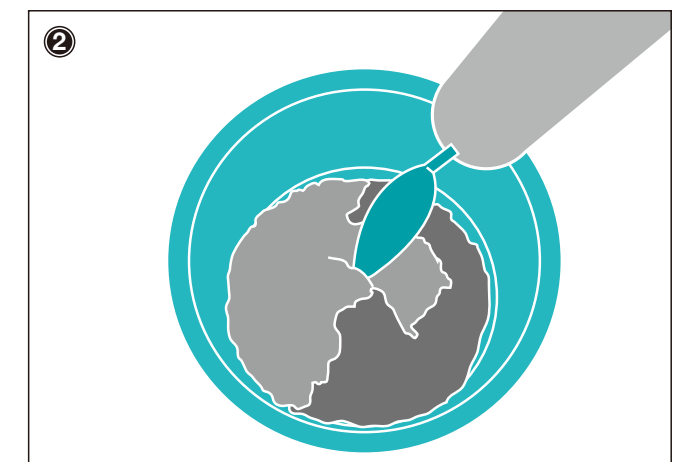
(2)**Mix** them well in a container. (Picture ②)

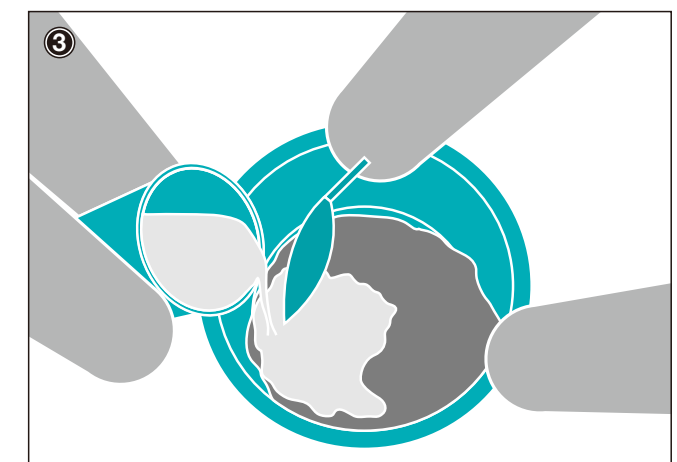
(3)**Add** water in small amounts to the mixture and continue to mix them. (Picture ③)

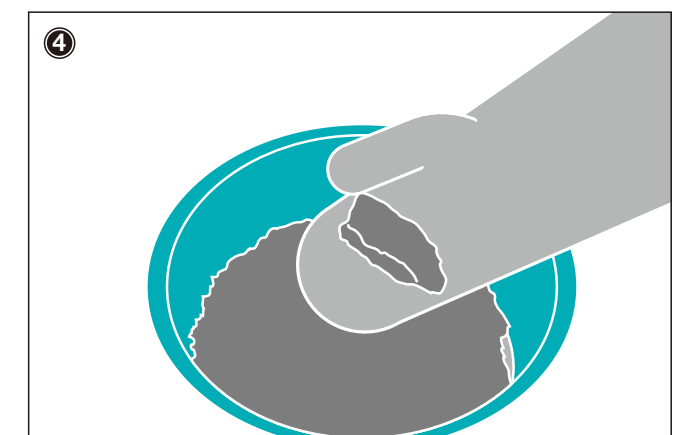
(4)**Keep** mixing until the mixture* becomes such that it can be formed into a lump when grasped firmly in one hand. (Picture ④)

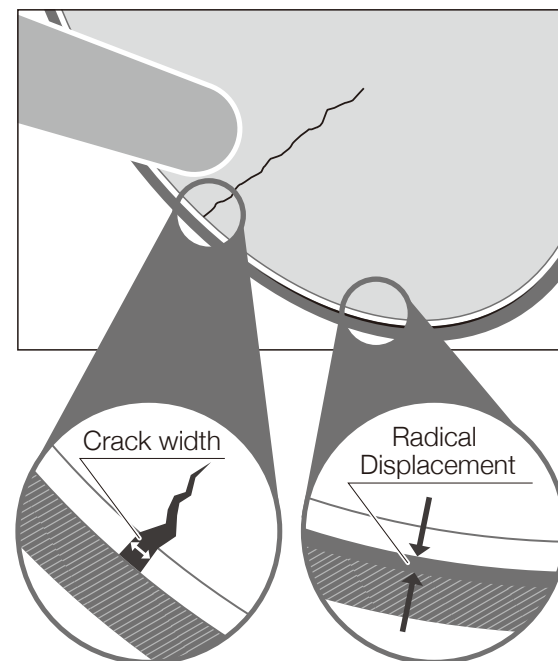
1. Inspect the cement mortar lining. When the cement mortar lining has large cracks, deformation of pipe body is expected. In this case, correction of the pipe is necessary prior to the repair of the lining.
2. After the concern of deformation is cleared, check the crack width and radical displacement. If the pipe has cracks and radical displacement less than the width given in Table 4, it is not necessary to repair the surface crazing and the small cracks.
3. If the cement mortar lining has cracks and radical displacement exceeding the width given in Table 4, Kubota would recommend repairing them. However, there is an exception mentioned in BS EN 545 2010.

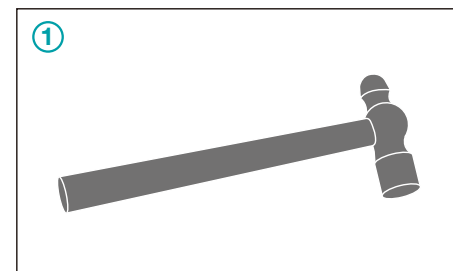
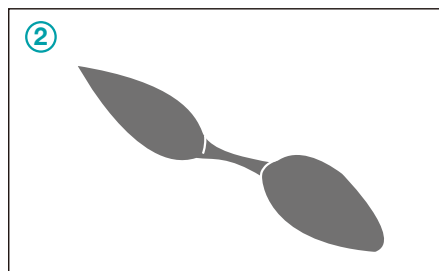
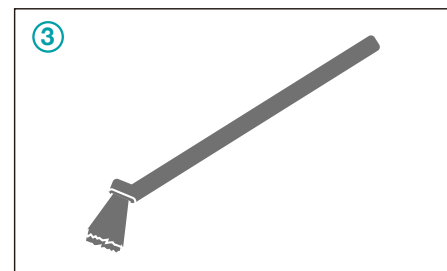
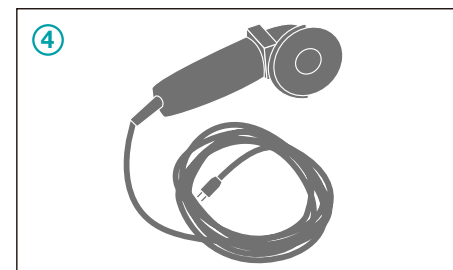
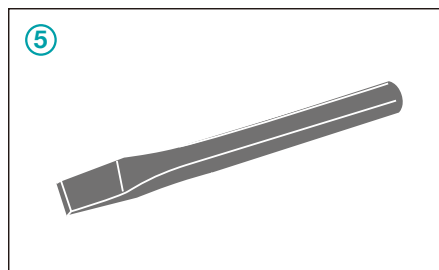
- Hammer (Picture ①)
- Spatula (Picture ②)
- Brush (Picture ③)
- Portable disc grinder (Picture ④)
- Chisel (Picture ⑤)

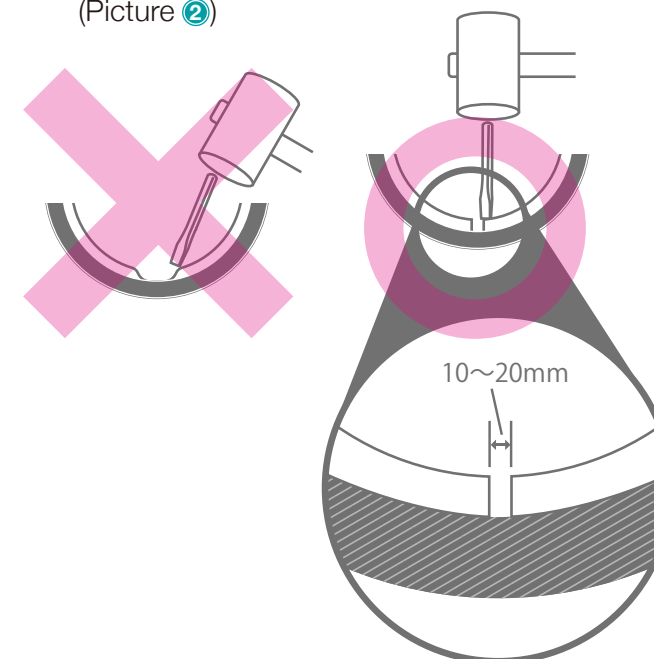
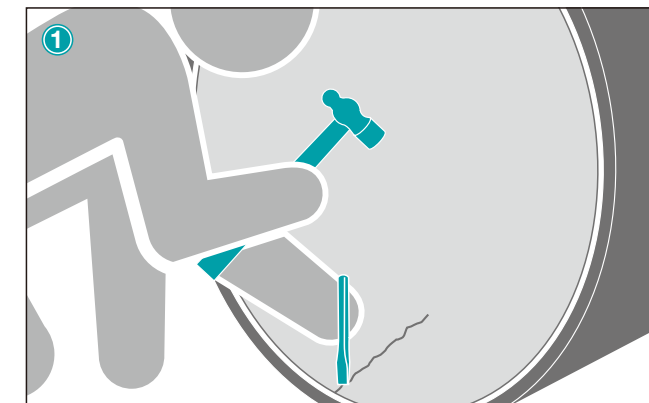
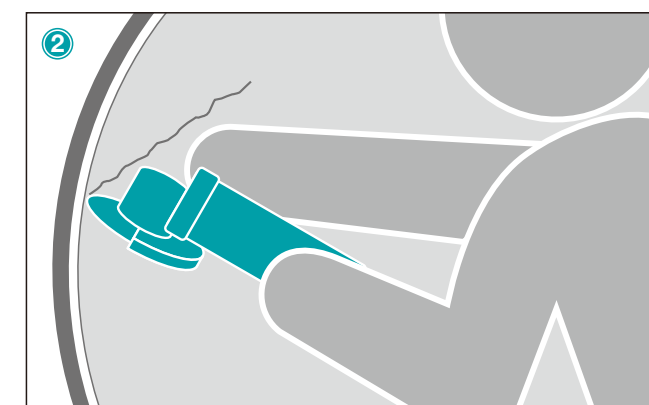
- (1) **Cut** back the lining about 10-20 mm in width with a chisel and hammer. (Picture ①) A portable disc grinder may be used instead of a chisel and hammer. (Picture ②)

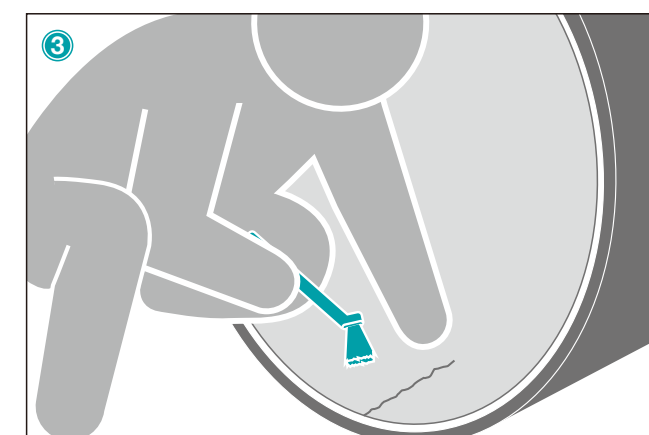
- (2) **Clean** the surface of the cut-back portion with a brush etc. (Picture ③)

*Remove moisture from the surface.

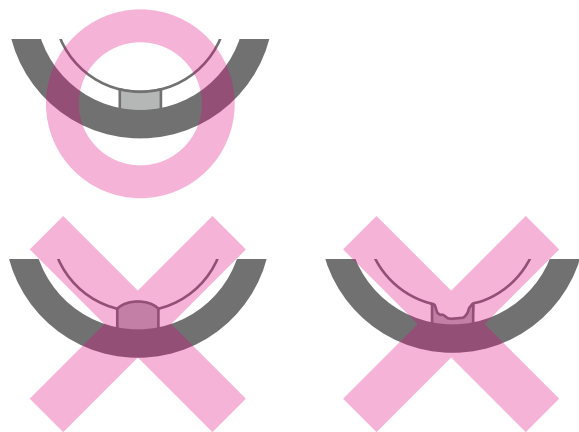
(3) **Fill** the cut-back portion with Epoxy Resin and smooth the surface with a spatula. (Picture ④)

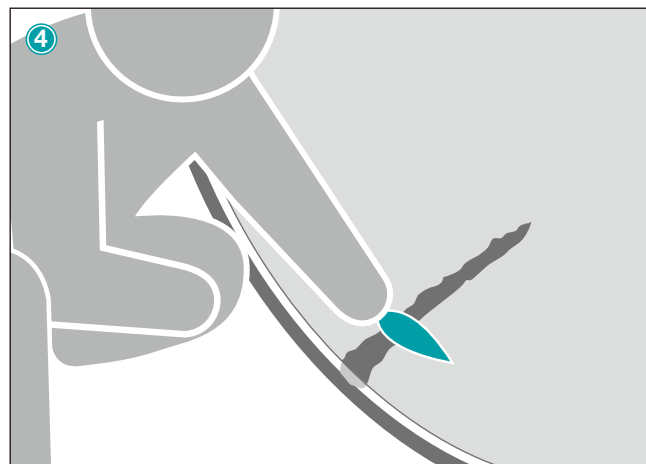
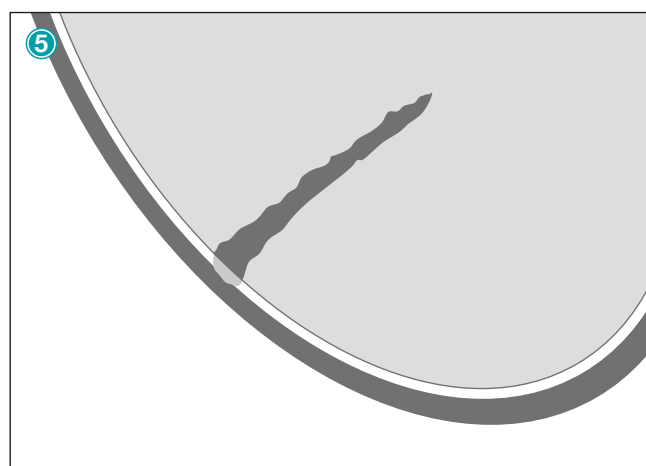
(4) **Inspect** the finished surface (Picture ⑤)

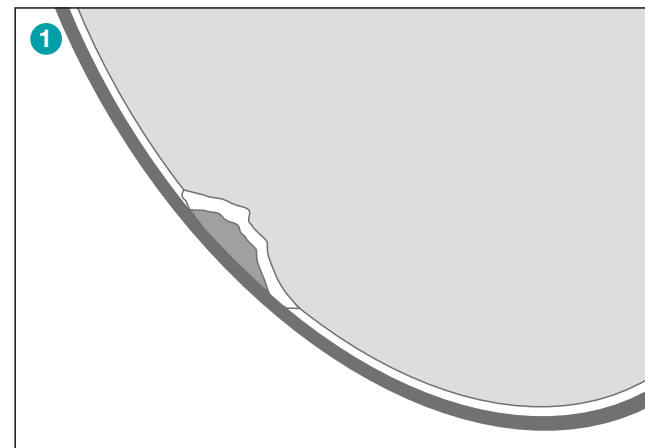
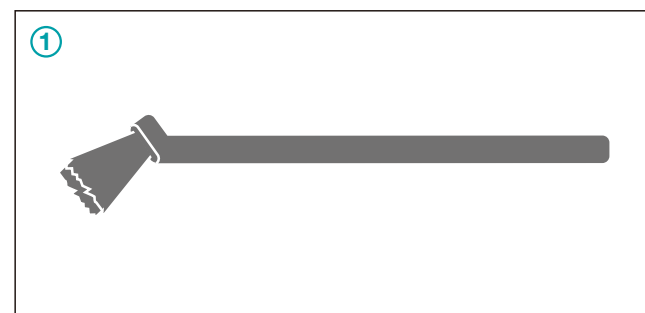
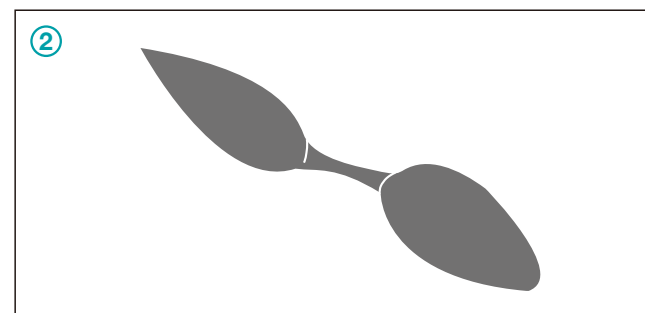
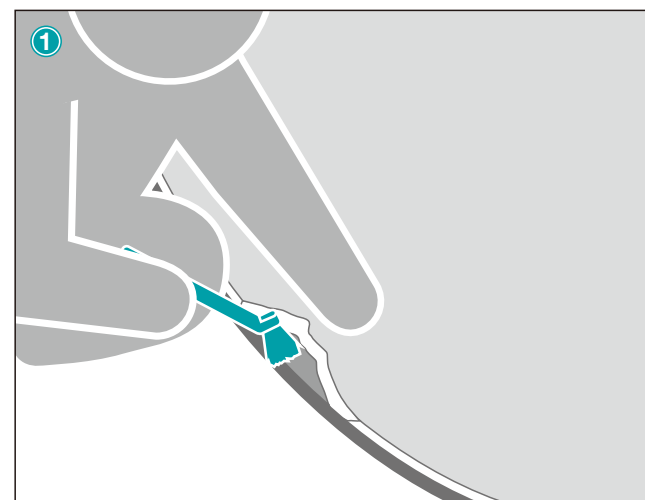
Inspect the damaged area carefully and confirm that there is no deformation or crack on the pipe body. (Picture ①)

- Brush (Picture ①)
- Spatula (Picture ②)

(1) **Clean** the surface of the damaged portion with a brush, etc. (Picture ①)
*Remove moisture from the surface.

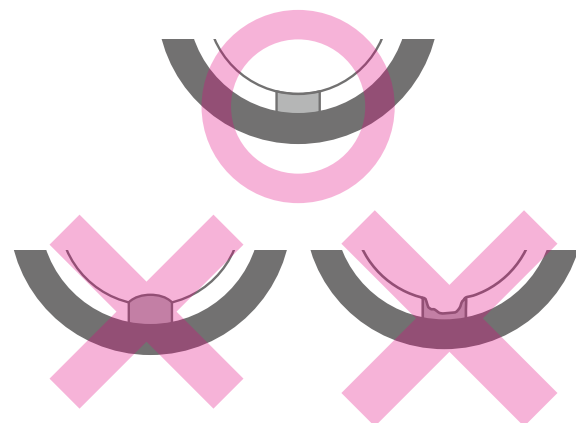
(2) **Fill** the chip with Epoxy Resin (See page 11) and smooth the surface with a spatula. (Picture ②)

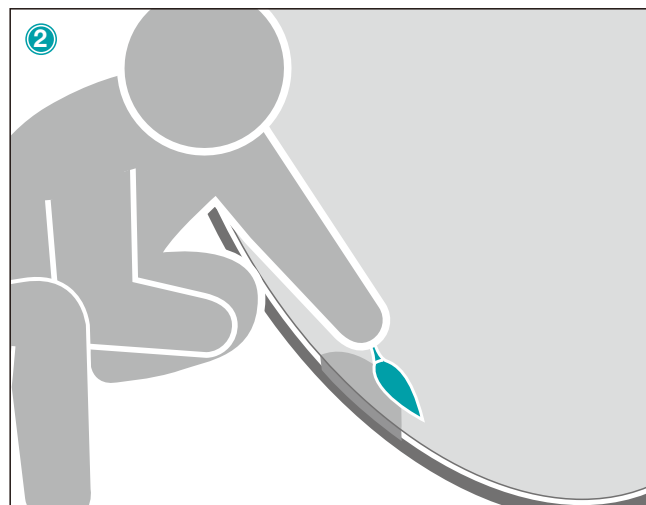
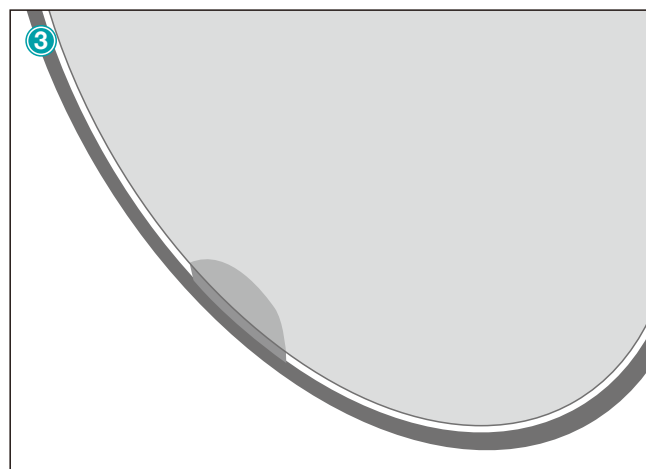
(3) **Inspect** the finished surface. (Picture ③)

Inspect the damaged area well. If the cement mortar lining is broken off in a large area, cut the pipe to remove the damaged portion. (Picture ①)

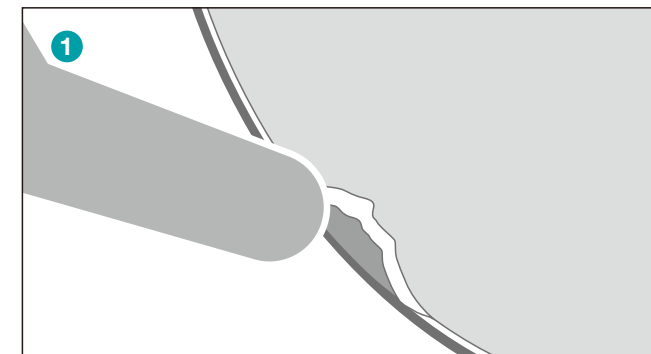
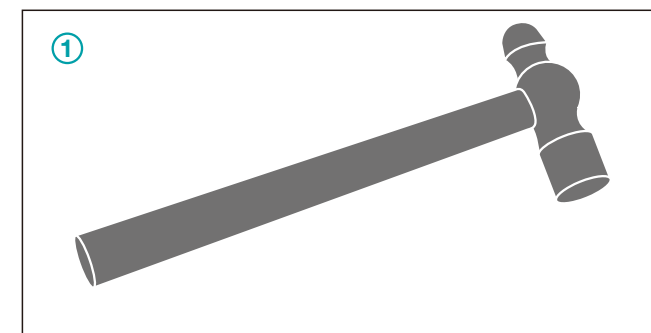
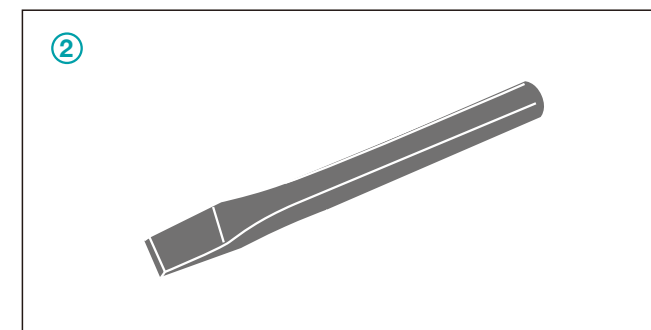
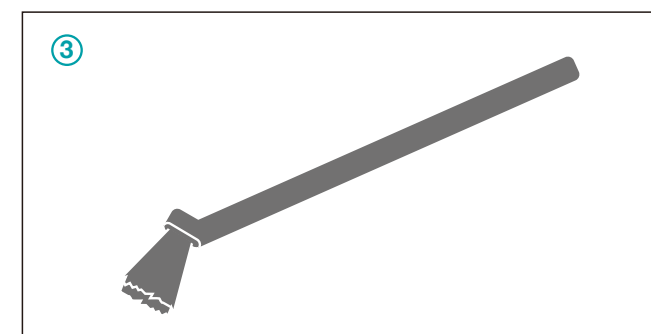
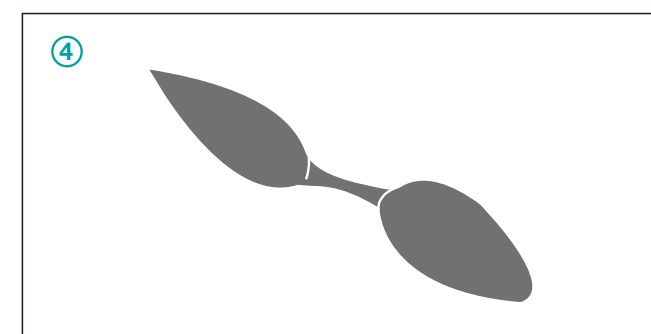
- Hammer (Picture ①)
- Chisel (Picture ②)
- Brush (Picture ③)
- Spatula (Picture ④)

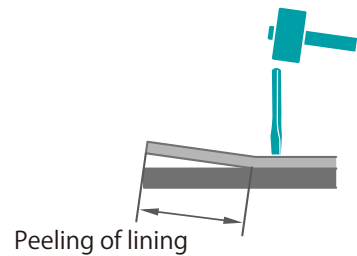
- (1) **Cut back** the damaged lining so that the edge of the lining is at right angles to the iron surface. (Picture ①)

*If the cement lining is peeled off from the iron surface, cut out the affected area.

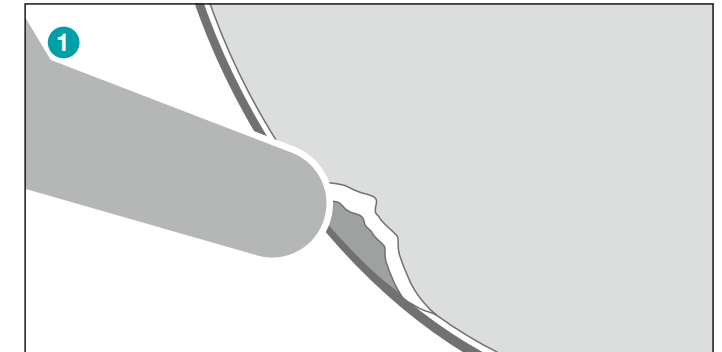
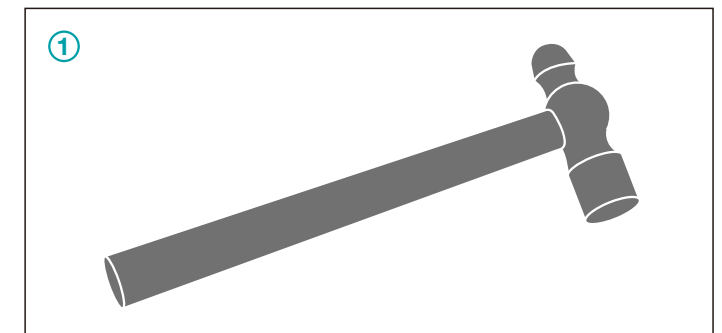
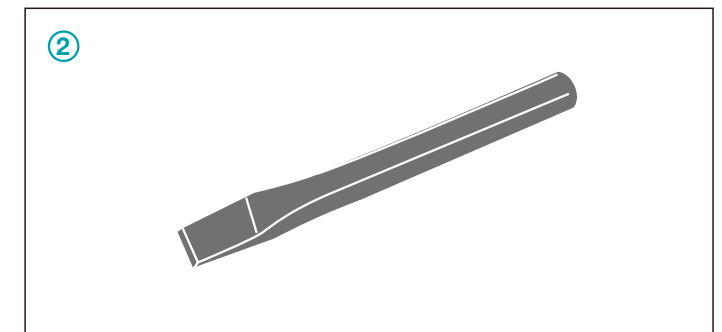
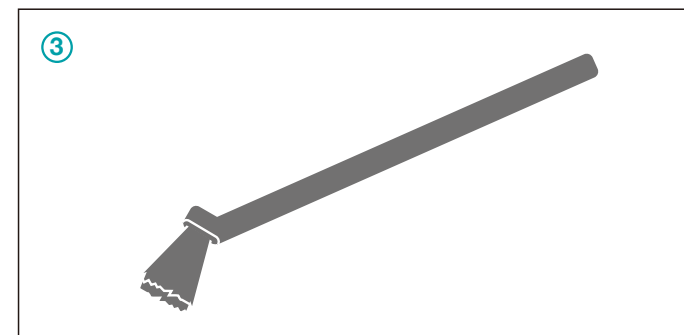
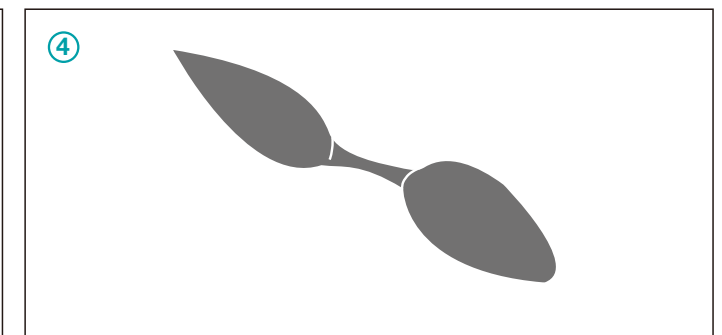
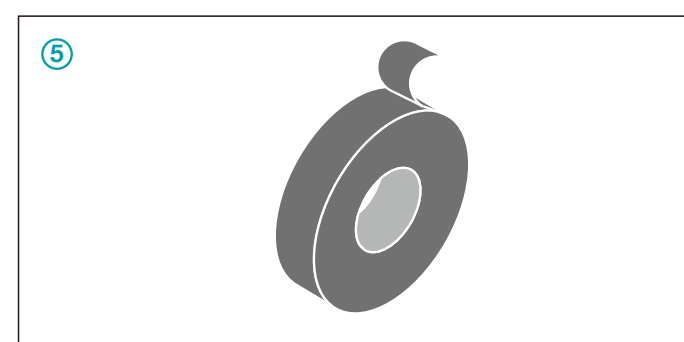
- Hammer (Picture ①)
- Chisel (Picture ②)
- Brush (Picture ③)
- Spatula (Picture ④)
- Adhesive tape (Picture ⑤)
- Plastic sheet (Picture ⑥)

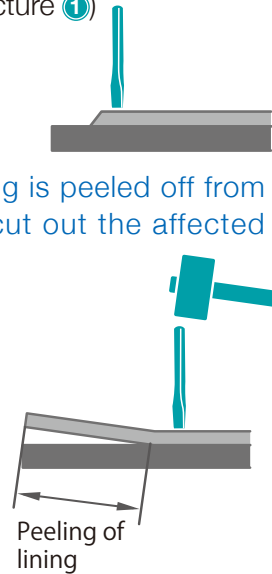
- (1) **Cut back** the damaged lining so that the edge of the lining is at right angles to the iron surface. (Picture ①)

*If the cement lining is peeled off from the iron surface, cut out the affected area.

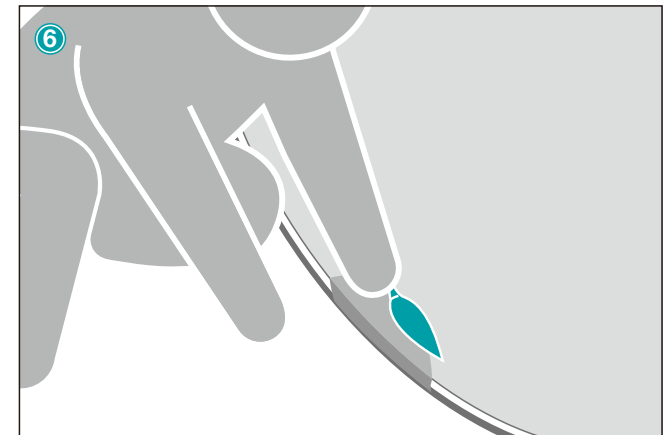
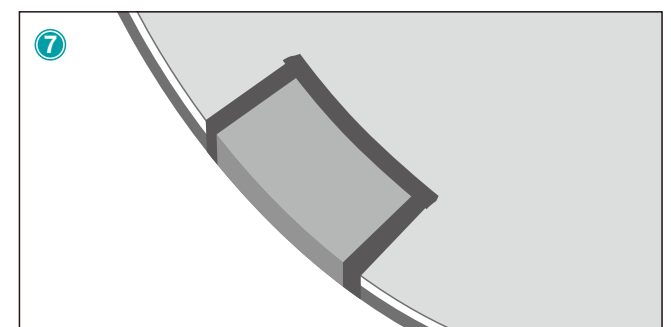
- (7) **Curing:**
Cover the repaired portion with a wet towel or wet paper, then seal up with plastic film and adhesive tape. Keep it on for more than 24 hours. (Picture ⑦)

*Other curing methods may be applied according to the condition on site and the supervisor's decision.

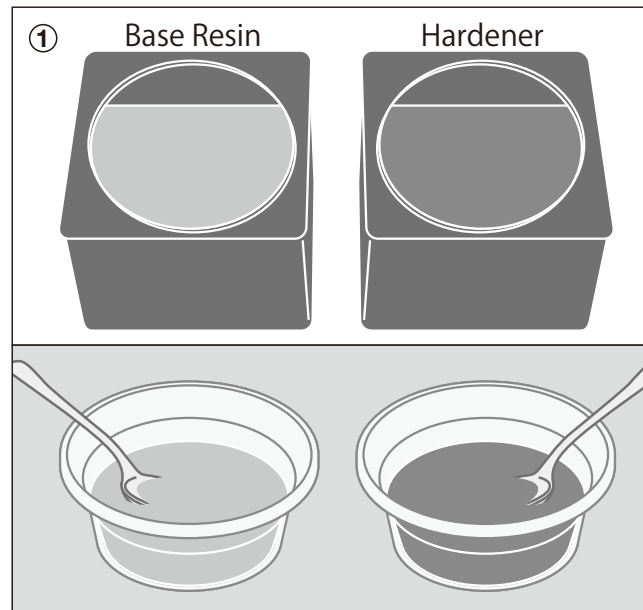
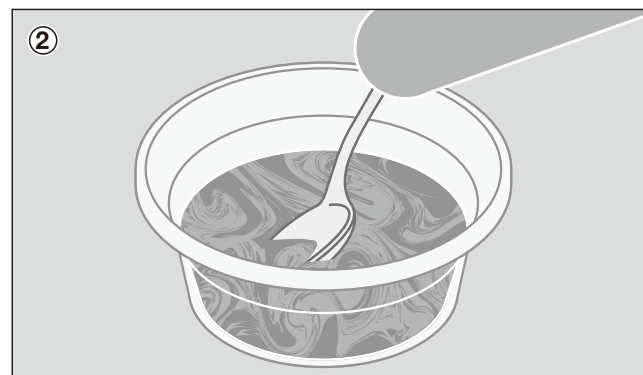
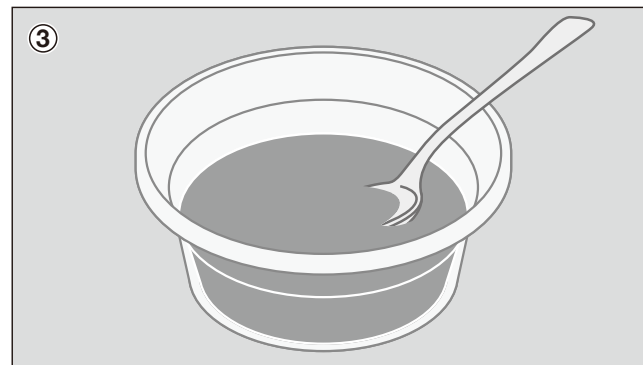
The two different materials are mixed together and used as paint. The mixing procedure is as follows:

(1)**Prepare** 2-pack epoxy paint. And take out appropriate ratio of “Base Resin” and “Hardener” with different spoons. (Picture ①)

(2)**Mix** them well in a container until they become uniform in color. (Picture ② and ③)

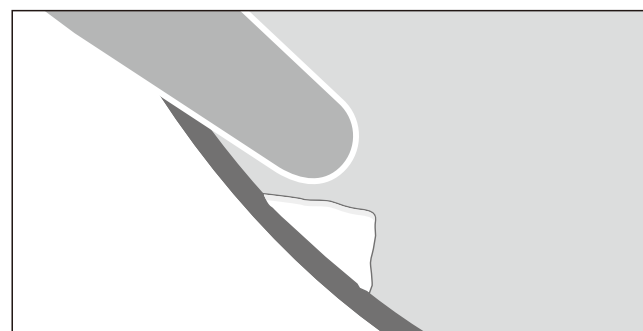
Inspect the fusion bonded epoxy coating. If the fusion bonded epoxy coating is damaged, repair of the fusion bonded epoxy coating is required.

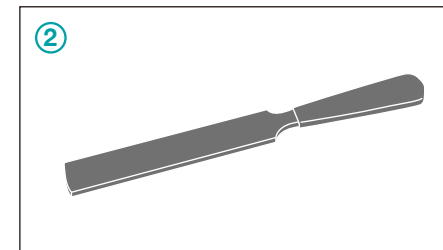
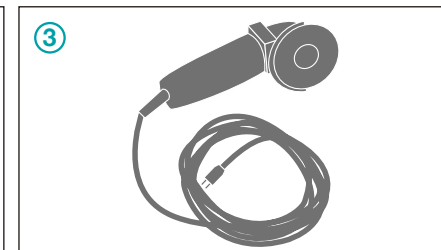
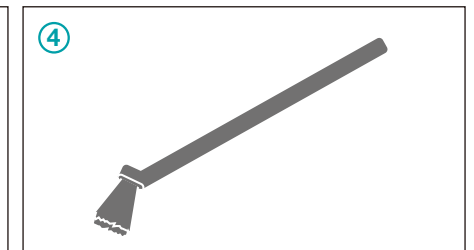
- Sandpaper (Picture ①)
- File (Picture ②)
- Portable disc grinder (Picture ③)
- Brush (Picture ④)

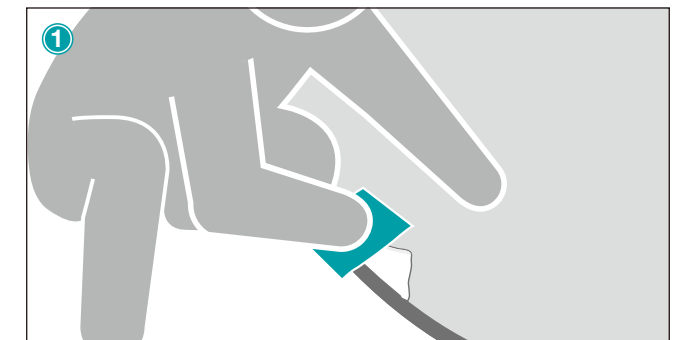
(1)**Roughen** the sound coating around the damaged area with a sandpaper, file or portable disc grinder to the extent of 10mm to 20mm. (Picture ①)

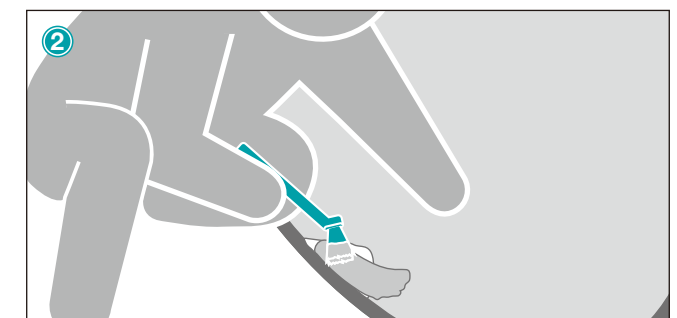
(2)**Clean** the surface of the damaged area with a brush, etc. (Picture ②)

*The area to be repaired shall be clean and free from sand, dust, moisture, etc.

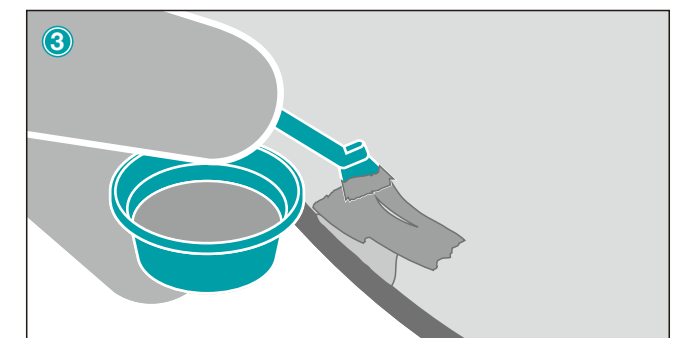
(3)**Apply** the 2-pack epoxy paint to the damaged area and the roughened surrounding coating with a brush. (Picture ③)

*Paint several times at intervals to obtain the specified dry film thickness.

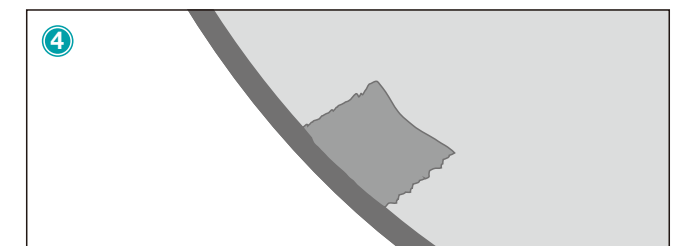
(4)**Inspect** the finished surface. (Picture ④)

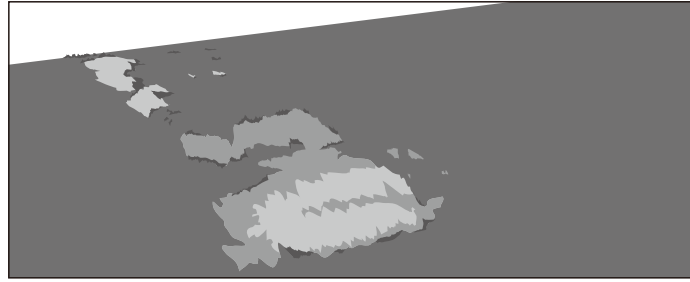
Inspect the external coating. If the external coating is damaged, repair of the external coating is required.

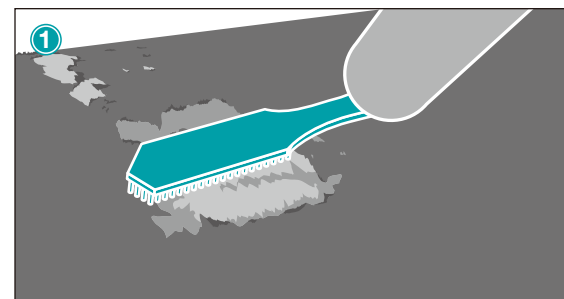
(1)**Remove** foreign materials and clean the surface. (Picture ①)

*If the surface is rusted, use wire brush or sandpaper to remove the rust, then wipe off with a cloth.

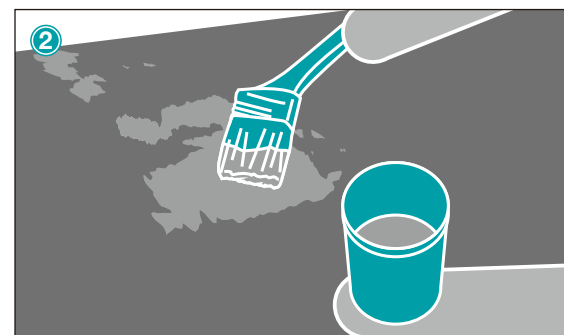
(2)**Apply** the zinc rich paint to the cleaned iron surface with a brush. (Picture ②)

*Zinc rich paint shall not be applied to the wet or moist iron surface or over the existing bitumen coating.
