KUBOTA DUCTILE IRON PIPE

Repair Manual

■ PREFACE	1
■ REPAIR FLOWCHART	2
■ CUTTING OF PIPE	3
■ CORRECTION OF DEFORMED SPIGOT	8
■ REPAIR OF INTERNAL LINING (CEMENT MORTAR LINING)	11
□ Crack	13
□ Chip	16
□ Break	18
■ REPAIR OF INTERNAL LINING (FUSION BONDED EPOXY COATING)	23
■ REPAIR OF EXTERNAL COATING	25

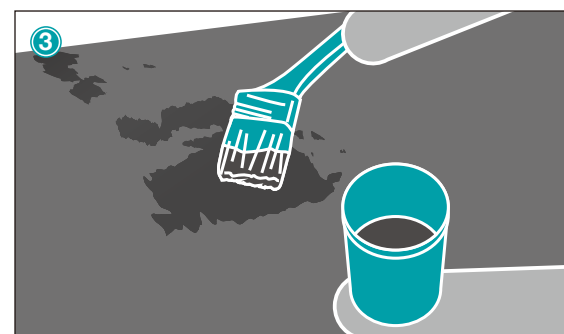
(3)**Apply** the bituminous paint to the dried zinc rich coating with a brush. (Picture ③)

*The bituminous paint can be thinned with the specific thinner when the viscosity of the bituminous paint is too high to apply with a brush.

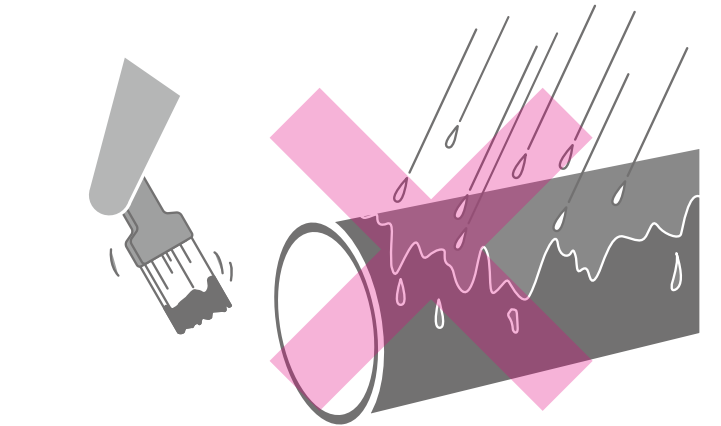
(1)**Do not apply** coating when the pipe surface is wet. The coated surface has to be completely dried before installation.
